FACILITY REPORT UPDATES

March 3, 2016

ARROWHEAD UNION HIGH SCHOOL DISTRICT

March 3, 2016: Findings from EUA'S Updated Facilities Report

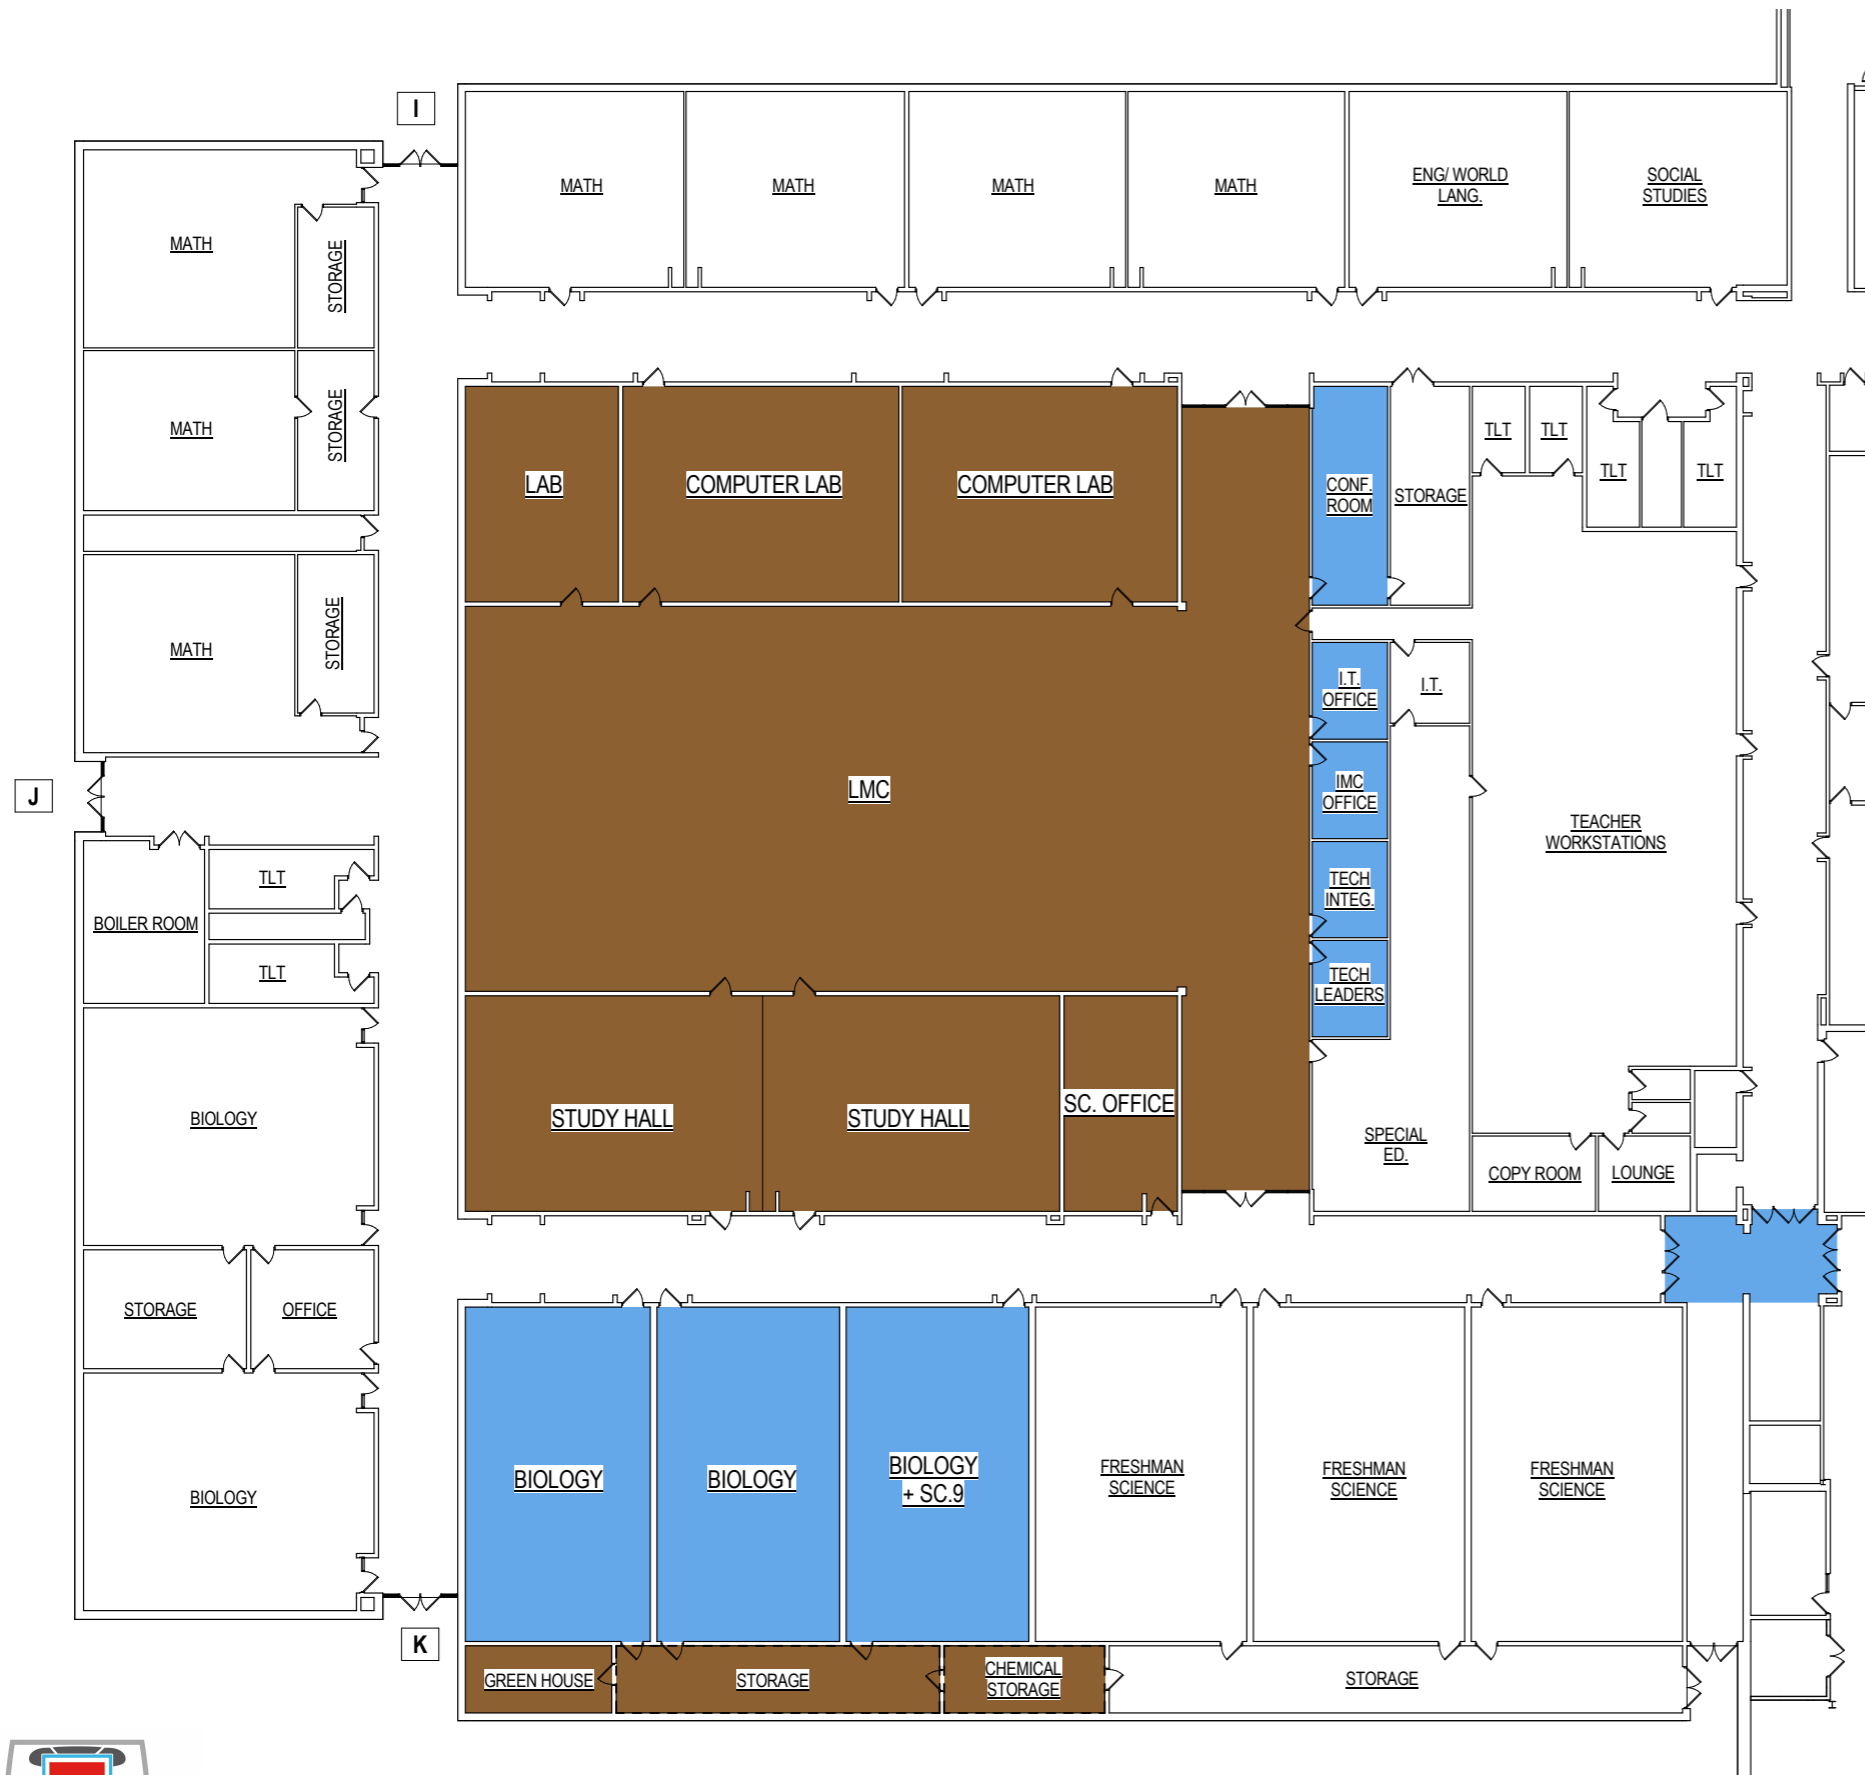
EDUCATIONAL PROGRAMMING - SCIENCE / LMC

- Undersized, irregularly shaped classrooms create congestion, safe exiting concerns, visibility issues, and limit access to in-room storage
- No large group instruction/common space for collaboration and large student body programs and assemblies
- Many spaces lack flexibility and transparency and are inadequate for today's teaching and learning strategies
- Technology infrastructure is inadequate and outdated
- Many spaces lack natural light
- Student lockers are outdated and in poor condition
- Building signage is outdated and inconsistent

- Lacks flexibility, transparency, and collaboration areas for small and large group activities
- Support spaces are undersized
- Additional study hall space is needed

- Undersized, irregularly shaped classrooms create congestion, safe exiting concerns, visibility issues, and limit access to in-room storage
- Furniture and equipment are outdated
- Spaces lack natural light
- Lacks storage
- Greenhouse requires significant exterior improvements

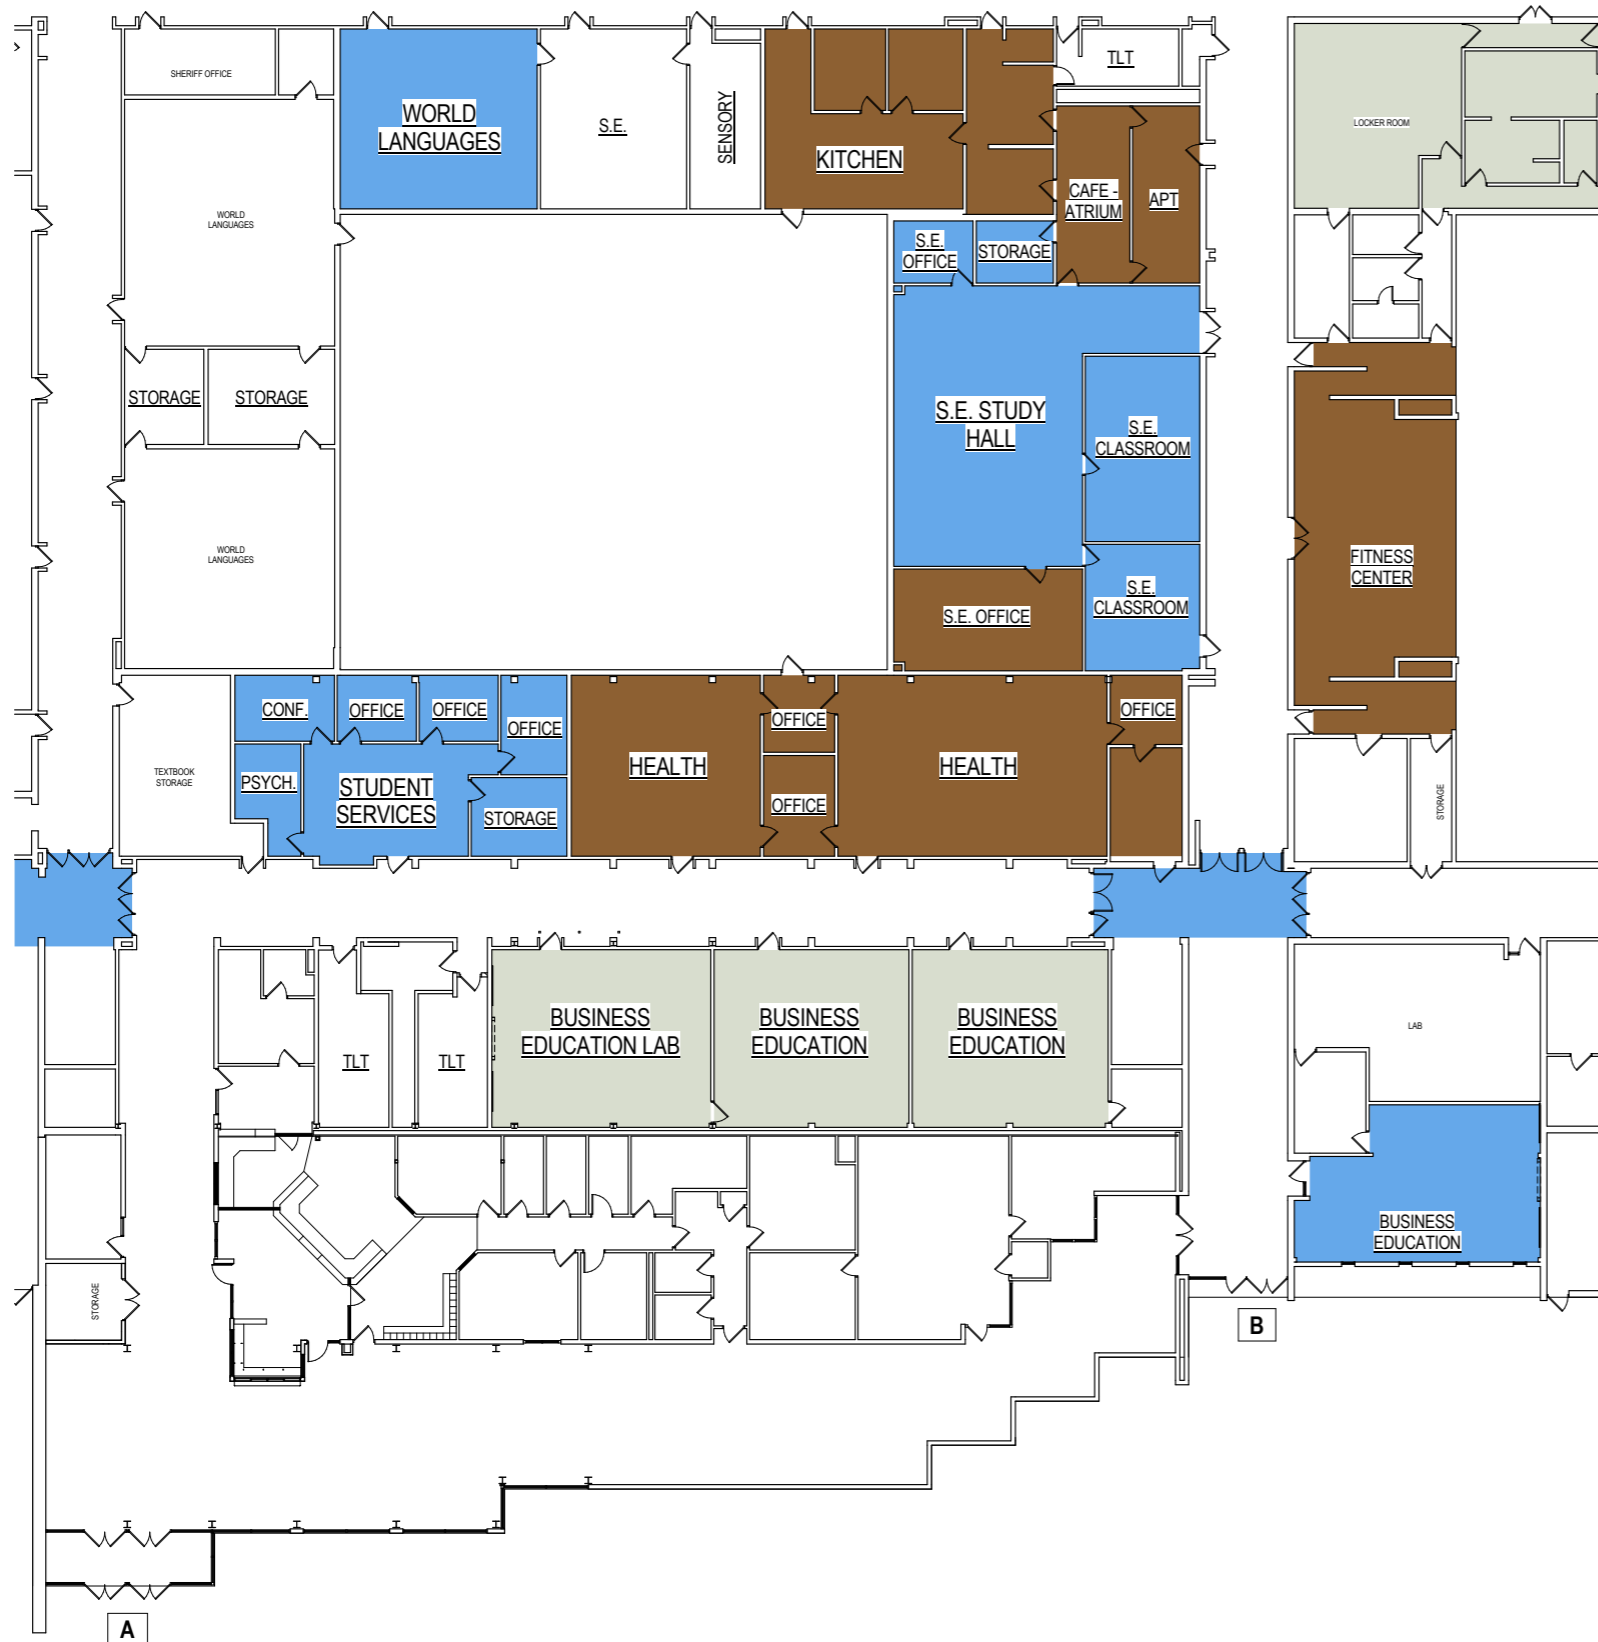
EDUCATIONAL PROGRAMMING - STUDENT SERVICES / HEALTH / SPECIAL EDUCATION / BUSINESS EDUCATION

- Undersized, irregularly shaped classrooms create congestion, safe exiting concerns, visibility issues, and limit access to in-room storage
- No large group instruction/common space for collaboration and large student body programs and assemblies
- Many spaces lack flexibility and transparency and are inadequate for today's teaching and learning strategies
- Technology infrastructure is inadequate and outdated
- Many spaces lack natural light
- Student lockers are outdated and in poor condition
- Building signage is outdated and inconsistent

- Undersized for current student population
- Lacks acoustic privacy
- Lacks flexibility, transparency, and collaboration areas for small and large group activities
- Lacks individual space for students to decompress
- Lacks storage

- Space is outdated and in disrepair
- Lacks storage

- Undersized, irregularly shaped classrooms create congestion, safe exiting concerns, visibility issues, and limit access to in-room storage
- Lacks small group rooms with adequate visibility for supervision
- OT/PT needs additional equipment
- Spaces are dispersed throughout the building
- Lacks storage

- Undersized, irregularly shaped classrooms create congestion, safe exiting concerns, visibility issues, and limit access to in-room storage
- Classrooms are outdated and furniture is in poor condition
- Proximity to Wellness Center is inadequate for current programming
- Lacks storage

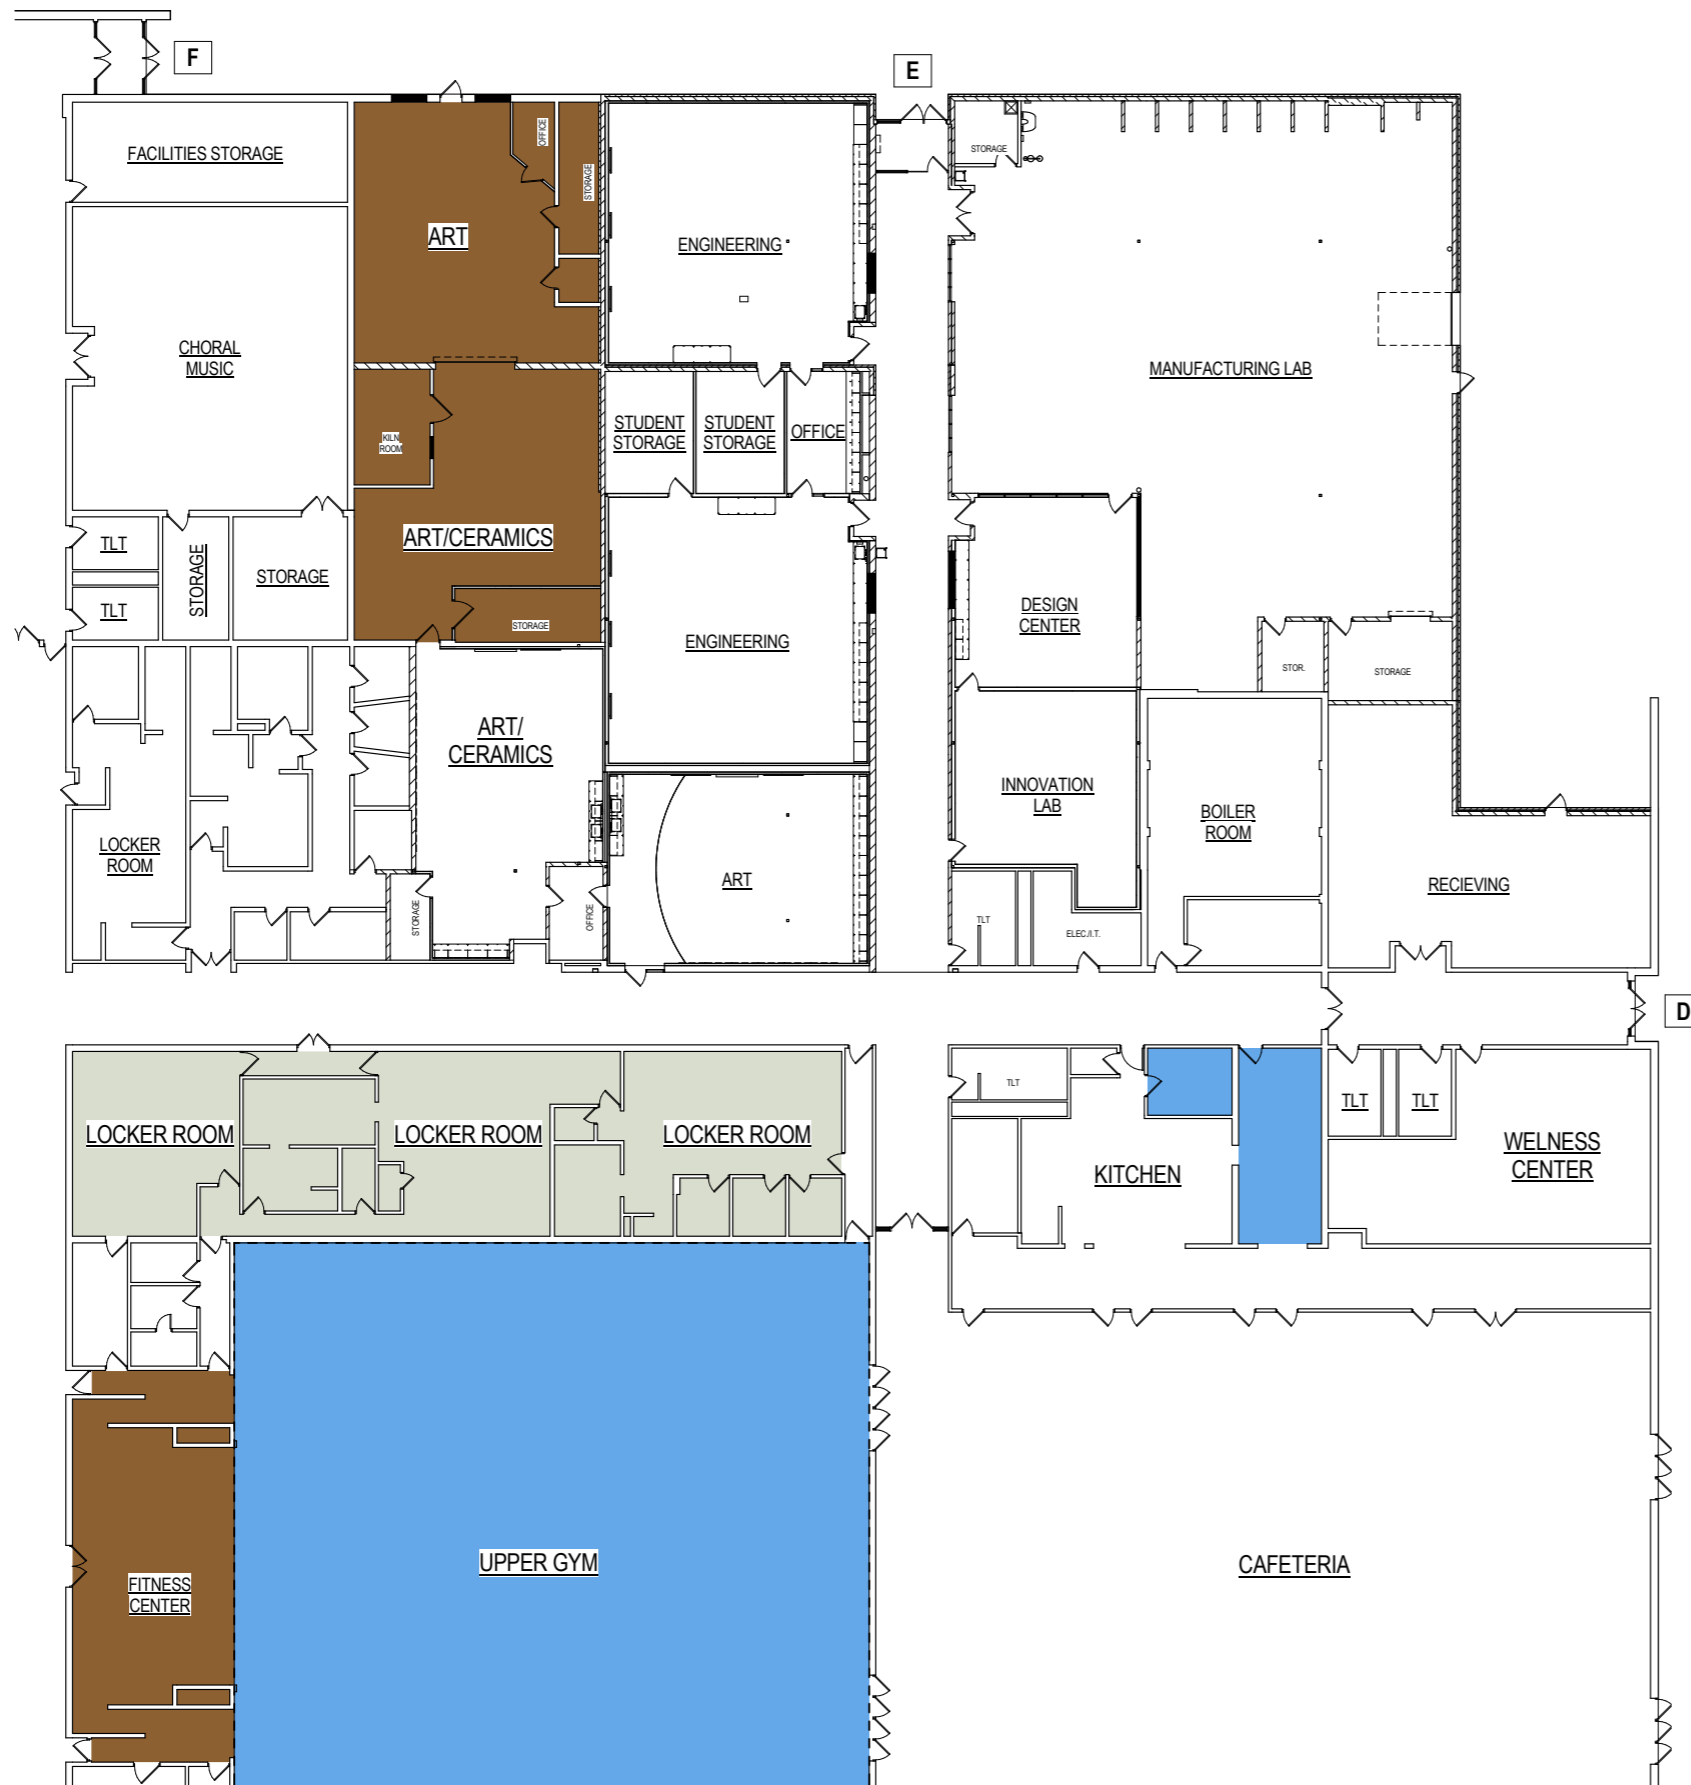
EDUCATIONAL PROGRAMMING - ART / GYM AND FITNESS / FOOD SERVICE

- Undersized, irregularly shaped classrooms create congestion, safe exiting concerns, visibility issues, and limit access to in-room storage
- No large group instruction/common space for collaboration and large student body programs and assemblies
- Many spaces lack flexibility and transparency and are inadequate for today's teaching and learning strategies
- Technology infrastructure is inadequate and outdated
- Many spaces lack natural light
- Student lockers are outdated and in poor condition
- Building signage is outdated and inconsistent

- Undersized, irregularly shaped classrooms create congestion, safe exiting concerns, visibility issues, and limit access to in-room storage
- Lacks access to corridor
- Lacks presentation areas for student display
- Lacks storage

- Fitness center is undersized and outdated

- Freezer space is inadequate
- Lacks dry storage

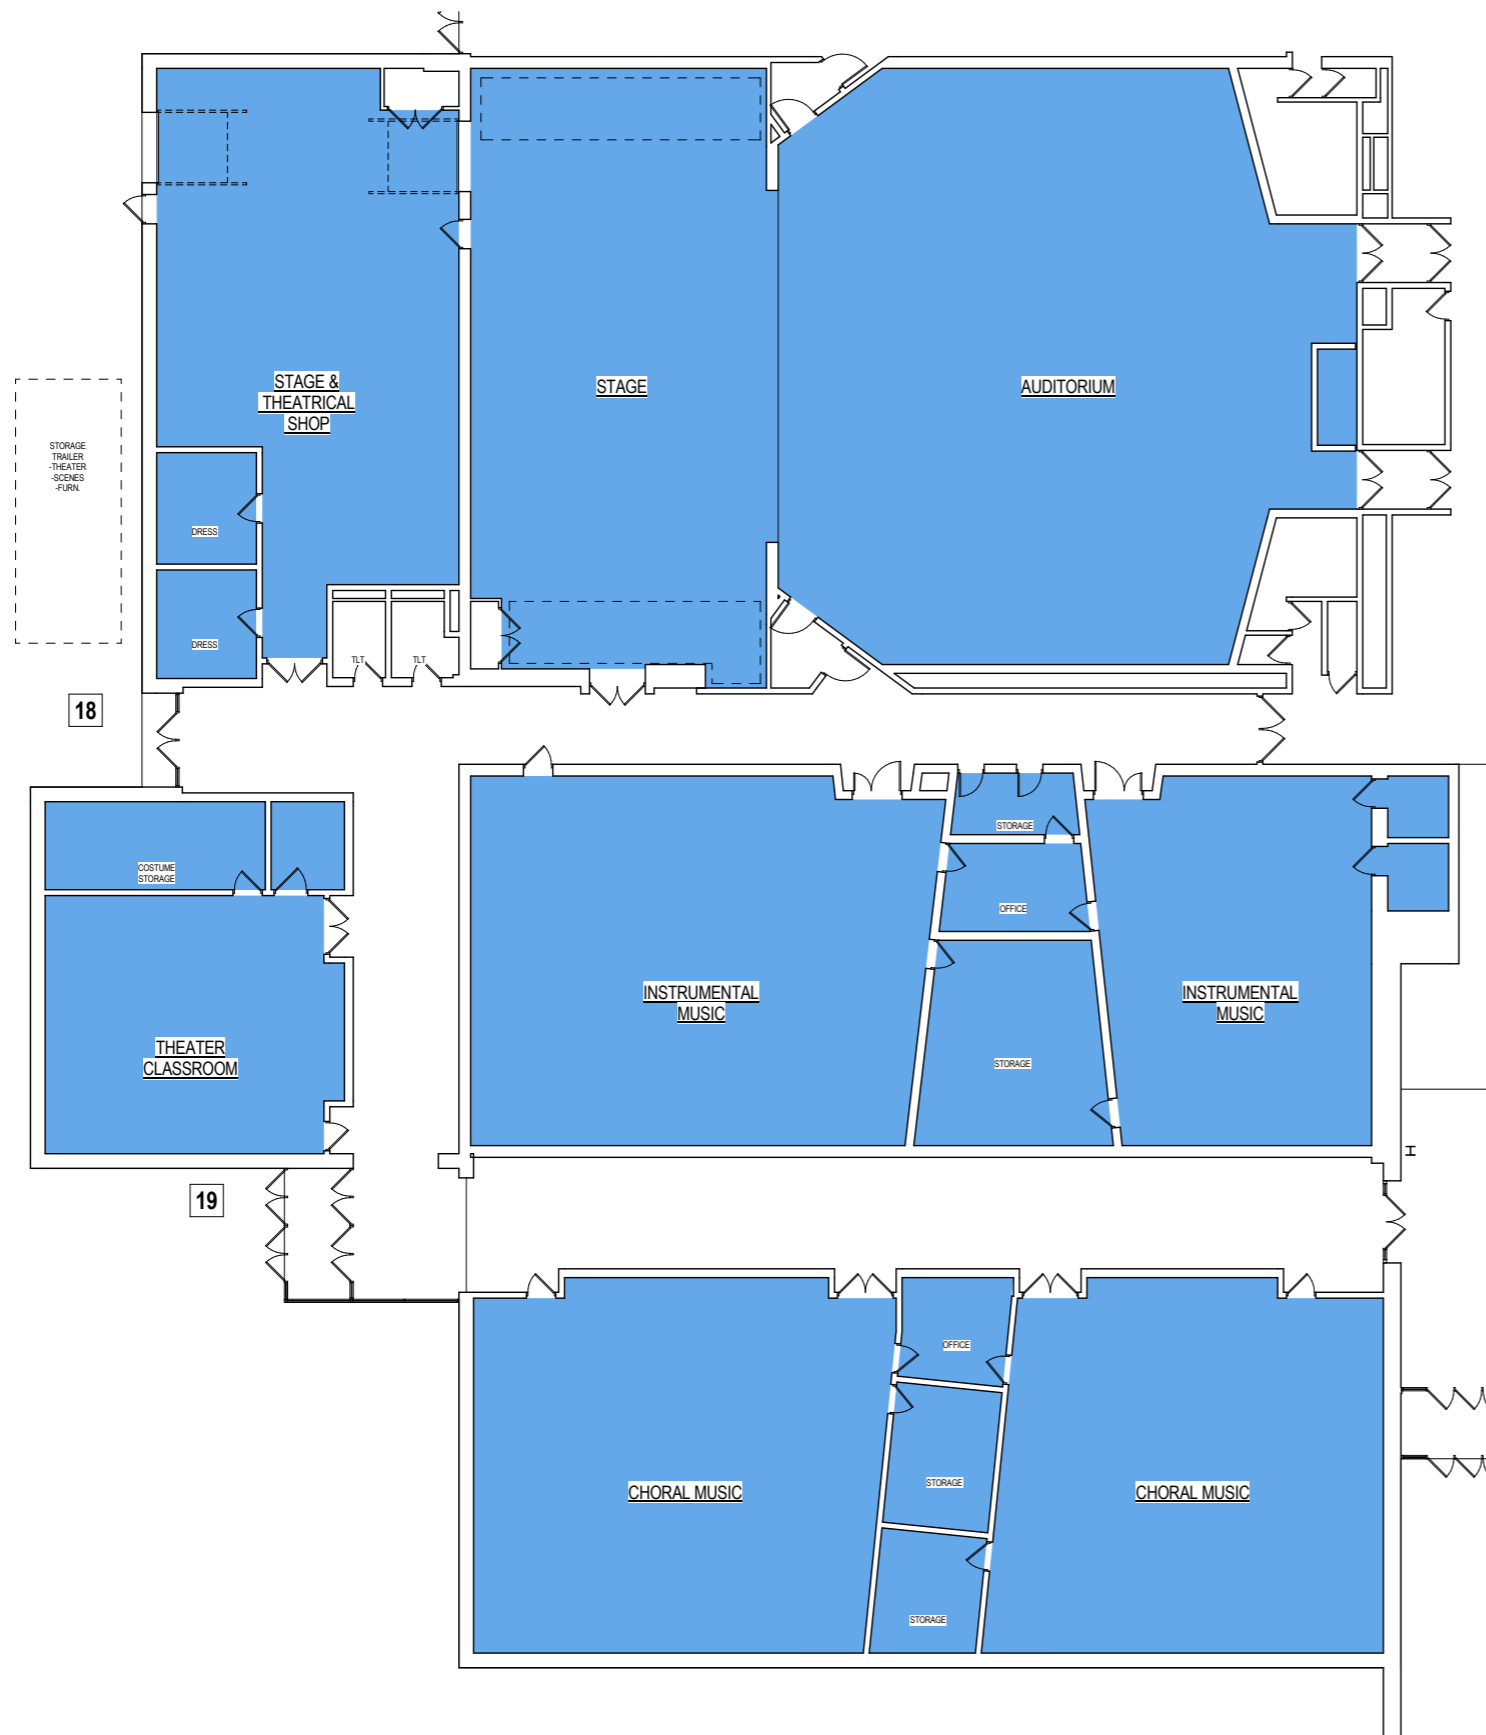
EDUCATIONAL PROGRAMMING - MUSIC / DRAMA

- Undersized*, irregularly shaped classrooms create congestion, safe exiting concerns, visibility issues, and limit access to in-room storage
- No large group instruction/common space for collaboration and large student body programs and assemblies
- Many spaces lack flexibility and transparency and are inadequate for today's teaching and learning strategies
- Technology infrastructure is inadequate and outdated
- Many spaces lack natural light
- Building signage is outdated and inconsistent

*General education classrooms identified as undersized average 23-25 square feet per student at North Campus. Current national education standards suggest 30-35 square feet per student in general education classrooms.

- Lacks large performance space
- Lacks practice rooms
- Lacks storage
- Poor acoustics
- Lacks an orchestra pit
- Sound booth is in poor condition

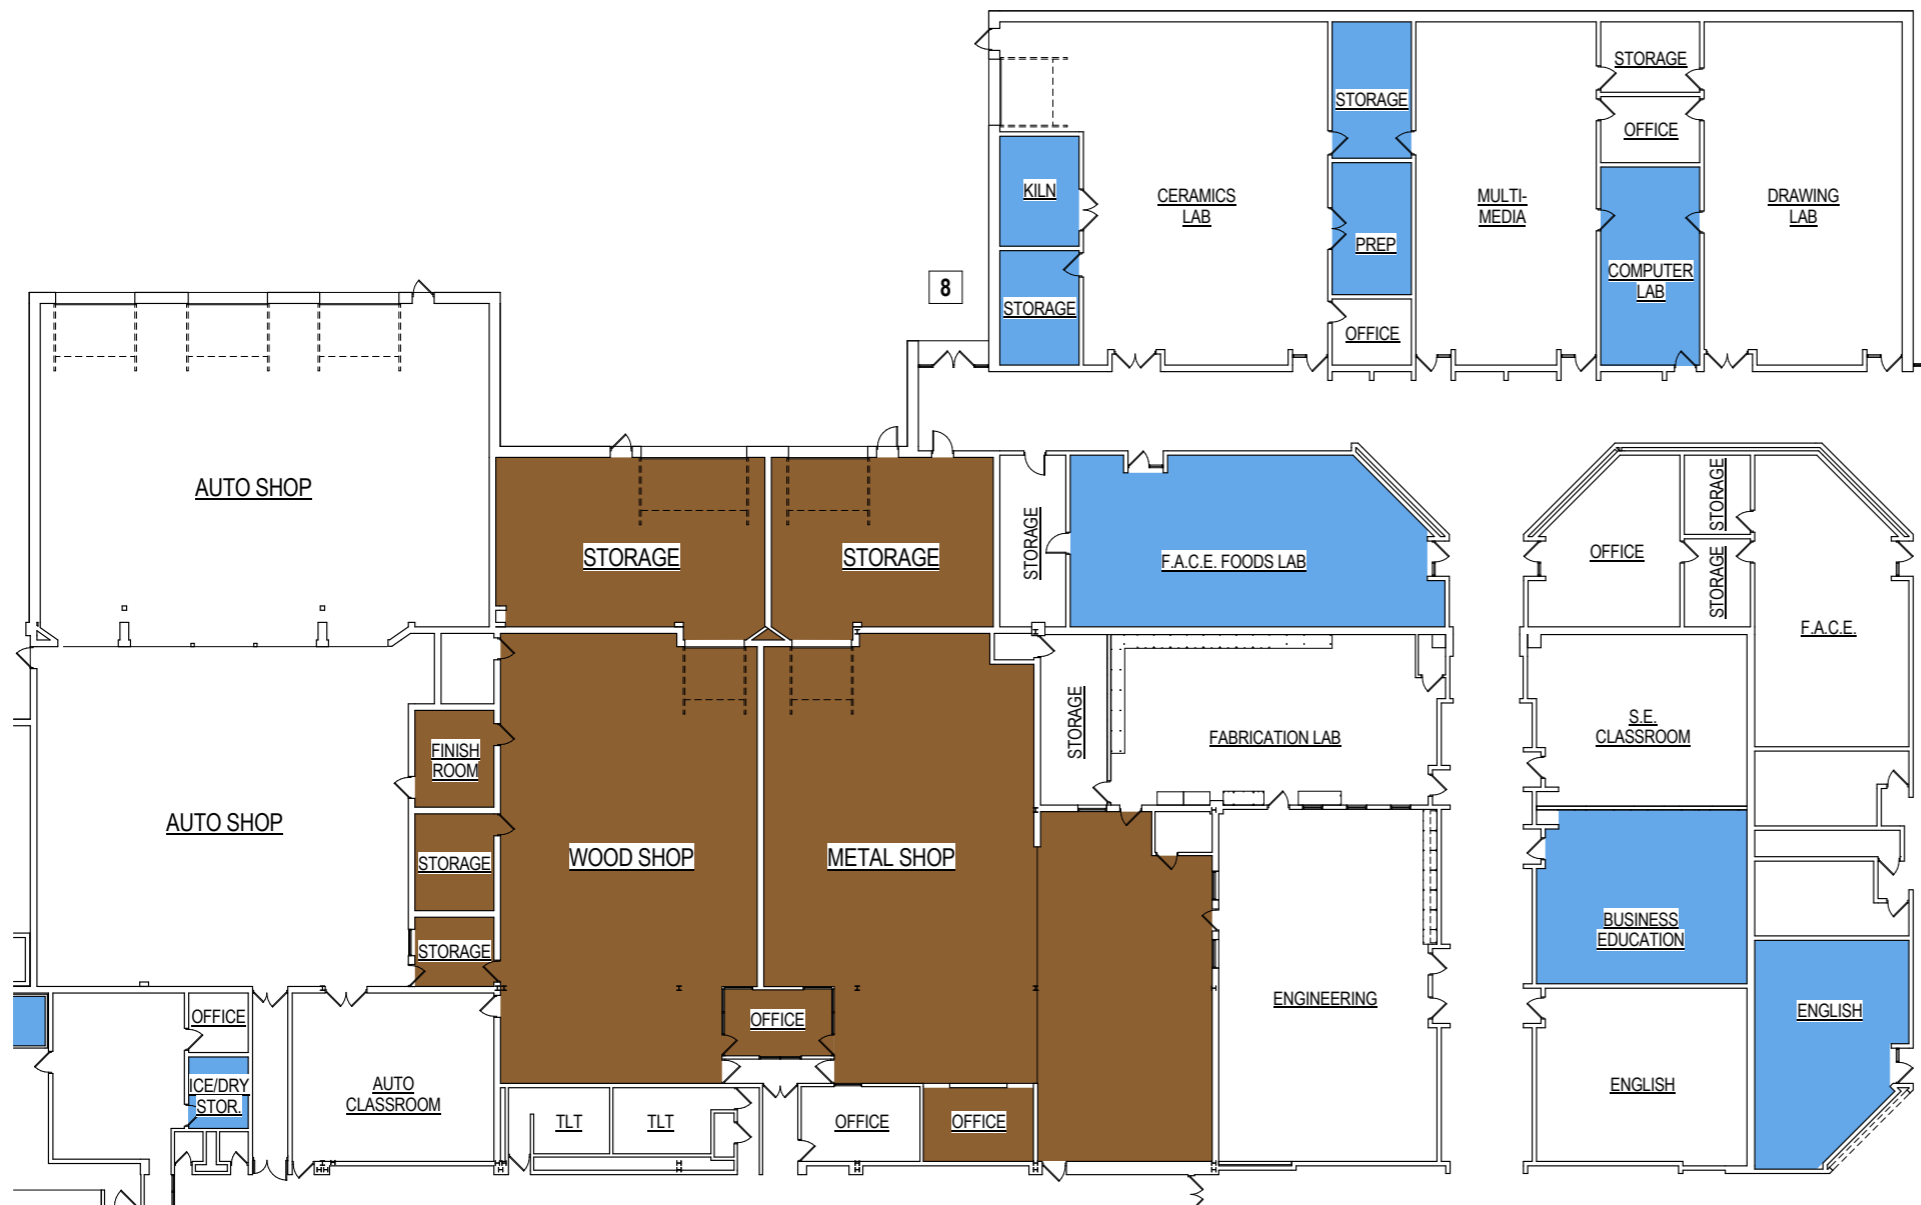
EDUCATIONAL PROGRAMMING - TECH ED / ART / F.A.C.E.

- Undersized*, irregularly shaped classrooms create congestion, safe exiting concerns, visibility issues, and limit access to in-room storage
- No large group instruction/common space for collaboration and large student body programs and assemblies
- Many spaces lack flexibility and transparency and are inadequate for today's teaching and learning strategies
- Technology infrastructure is inadequate and outdated
- Many spaces lack natural light
- Building signage is outdated and inconsistent

- Undersized, irregularly shaped classrooms create congestion, safe exiting concerns, visibility issues, and limit access to in-room storage
- Spaces lack flexibility and transparency and are inadequate for today's teaching and learning strategies
- Technology infrastructure is inadequate and outdated

- Lacks presentation areas for student display
- Computer lab is undersized and lacks visibility
- Clay mixing facilities are poor
- Lacks storage

- Spaces lack flexibility and transparency and are inadequate for today's teaching and learning strategies
- Lacks equipment to support curriculum
- Lacks storage
- Lacks air conditioning

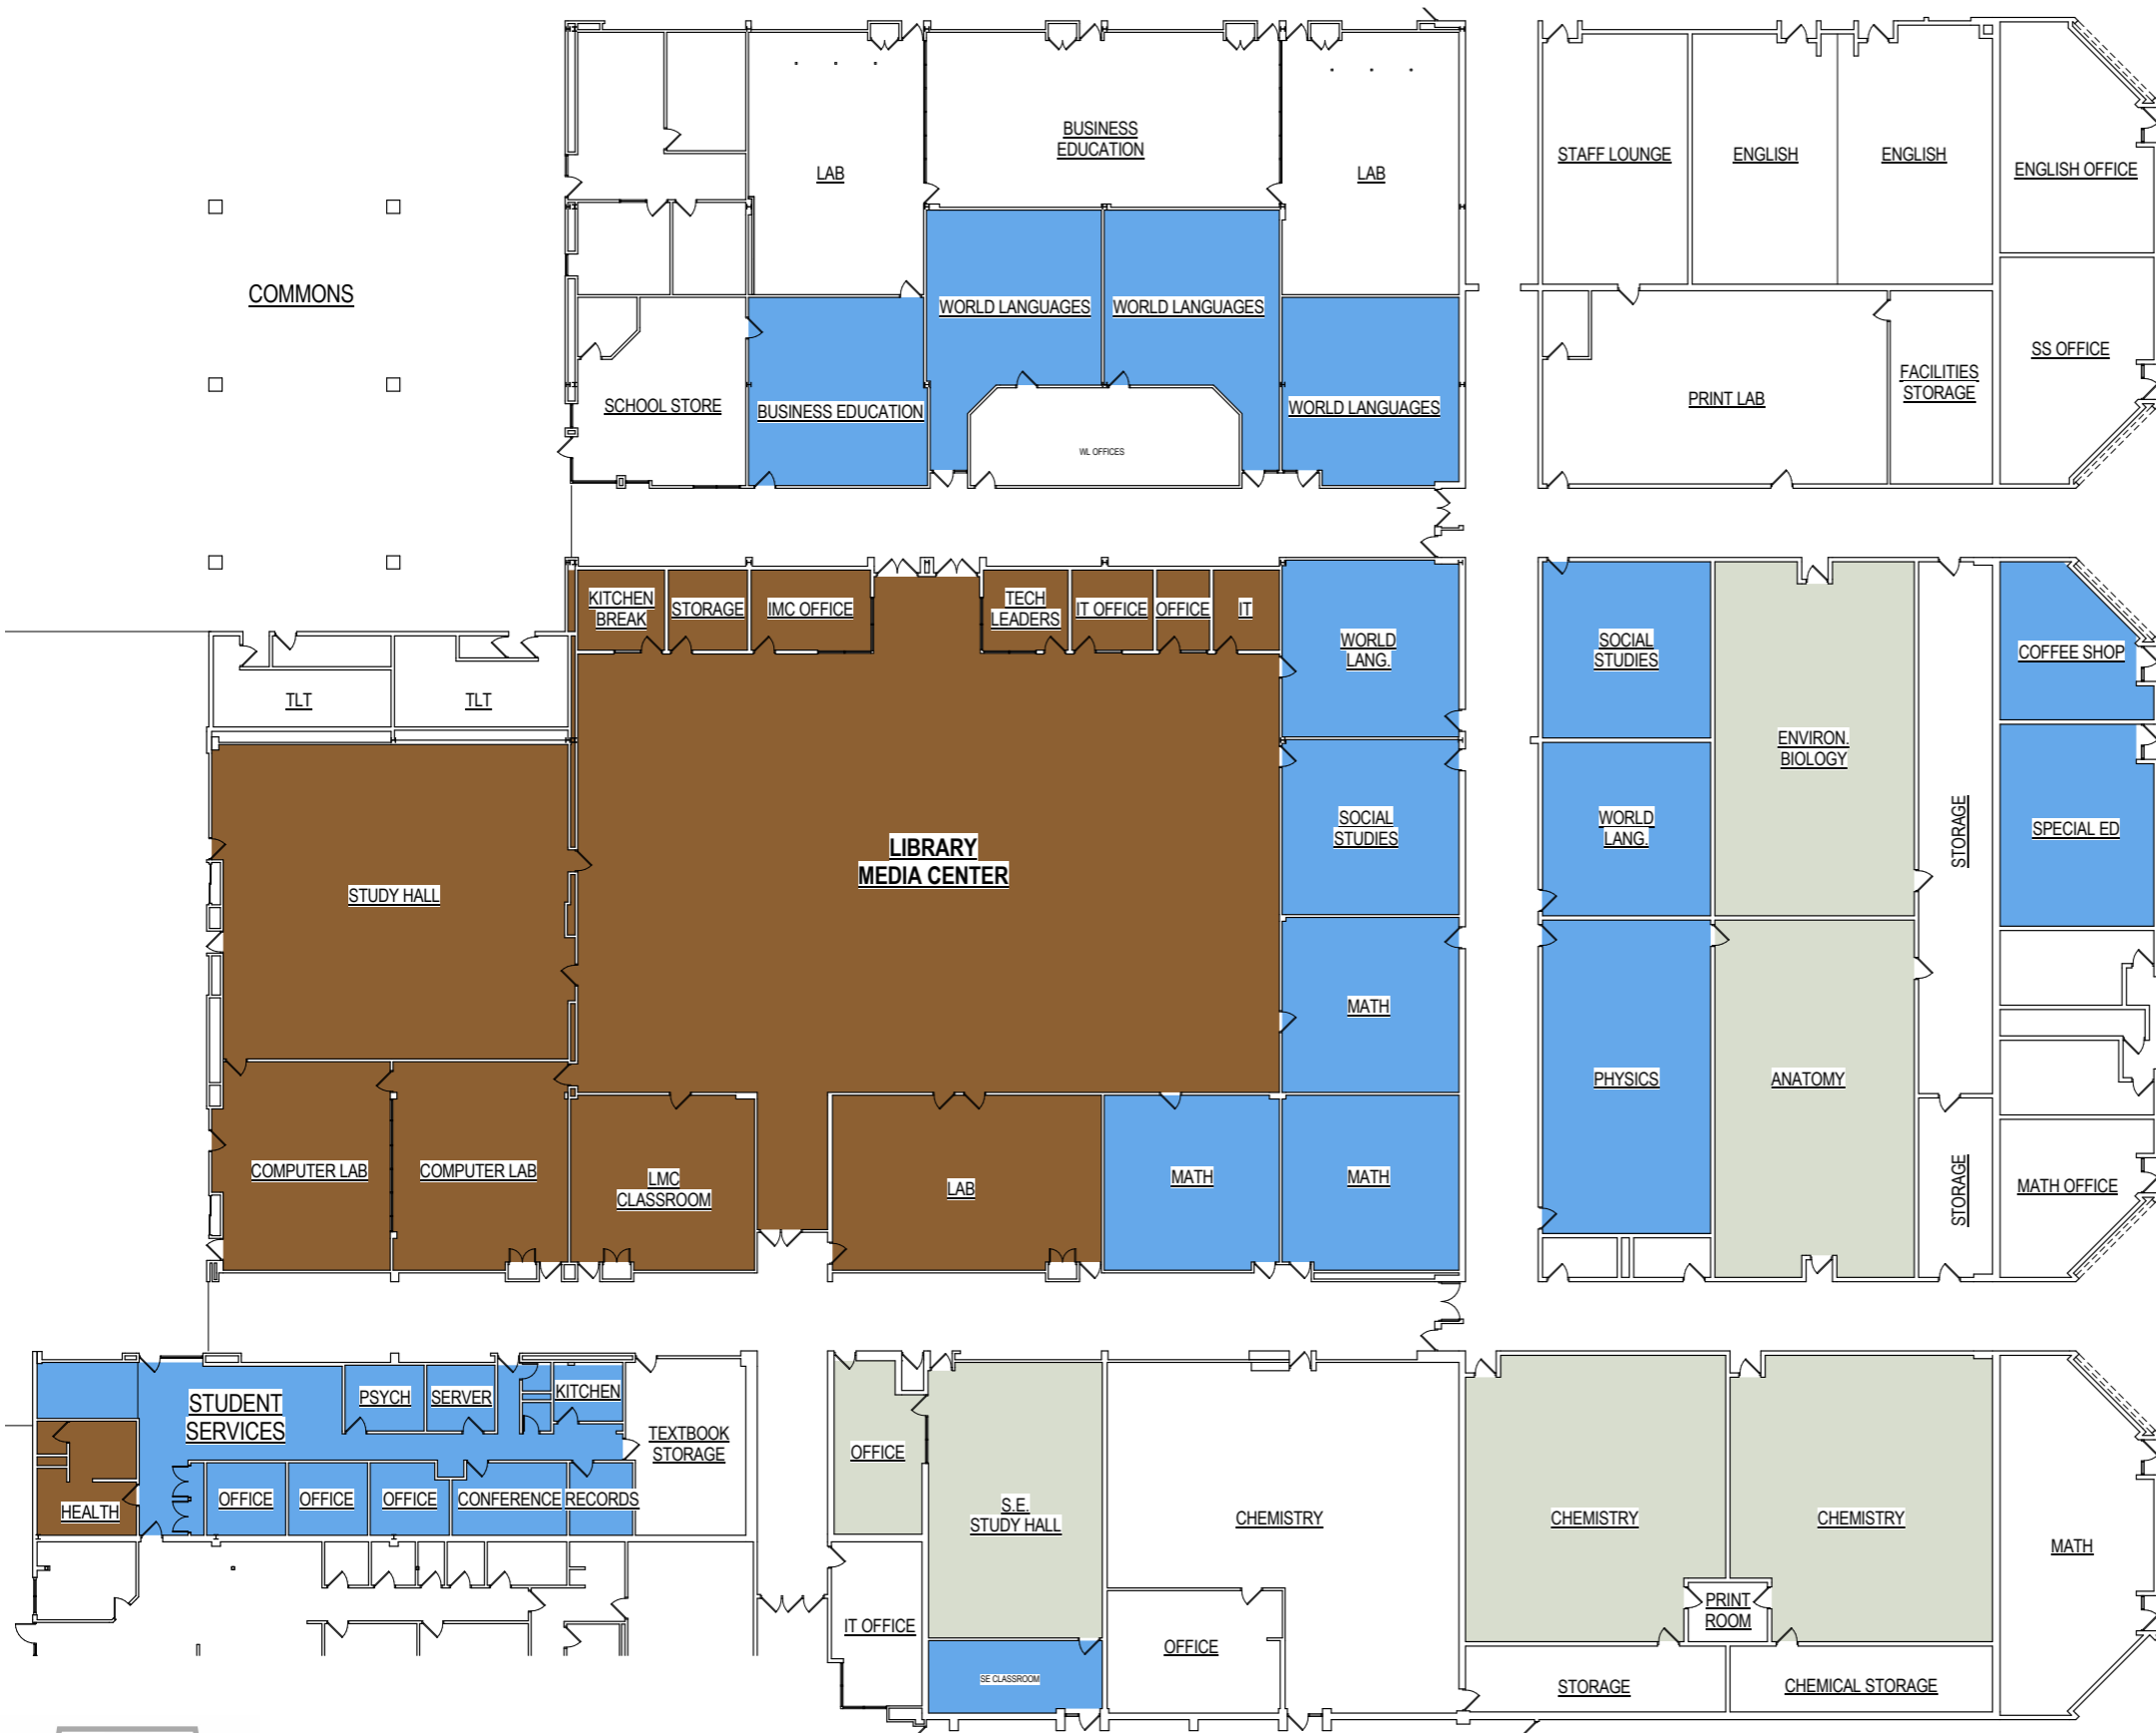
EDUCATIONAL PROGRAMMING - LMC - STUDENT SERVICES

- Undersized*, irregularly shaped classrooms create congestion, safe exiting concerns, visibility issues, and limit access to in-room storage
- No large group instruction/common space for collaboration and large student body programs and assemblies
- Many spaces lack flexibility and transparency and are inadequate for today's teaching and learning strategies
- Technology infrastructure is inadequate and outdated
- Many spaces lack natural light
- Building signage is outdated and inconsistent

- Lacks flexibility, transparency, and collaboration areas for small and large group activities
- Support spaces are undersized
- Additional study hall space is needed
- Lacks a maker space
- Lacks a quiet space
- Significant distance to print room

- Lacks a career center
- Lacks acoustic privacy
- Lacks flexibility, transparency, and collaboration areas for small and large group activities
- Lacks storage
- Proximity to the health room is poor

- Restroom is in disrepair and is not ADA accessible
- Lacks storage
