FACILITY REPORT UPDATES

March 3, 2016

ARROWHEAD UNION HIGH SCHOOL DISTRICT

March 3, 2016: Findings from EUA'S Updated Facilities Report

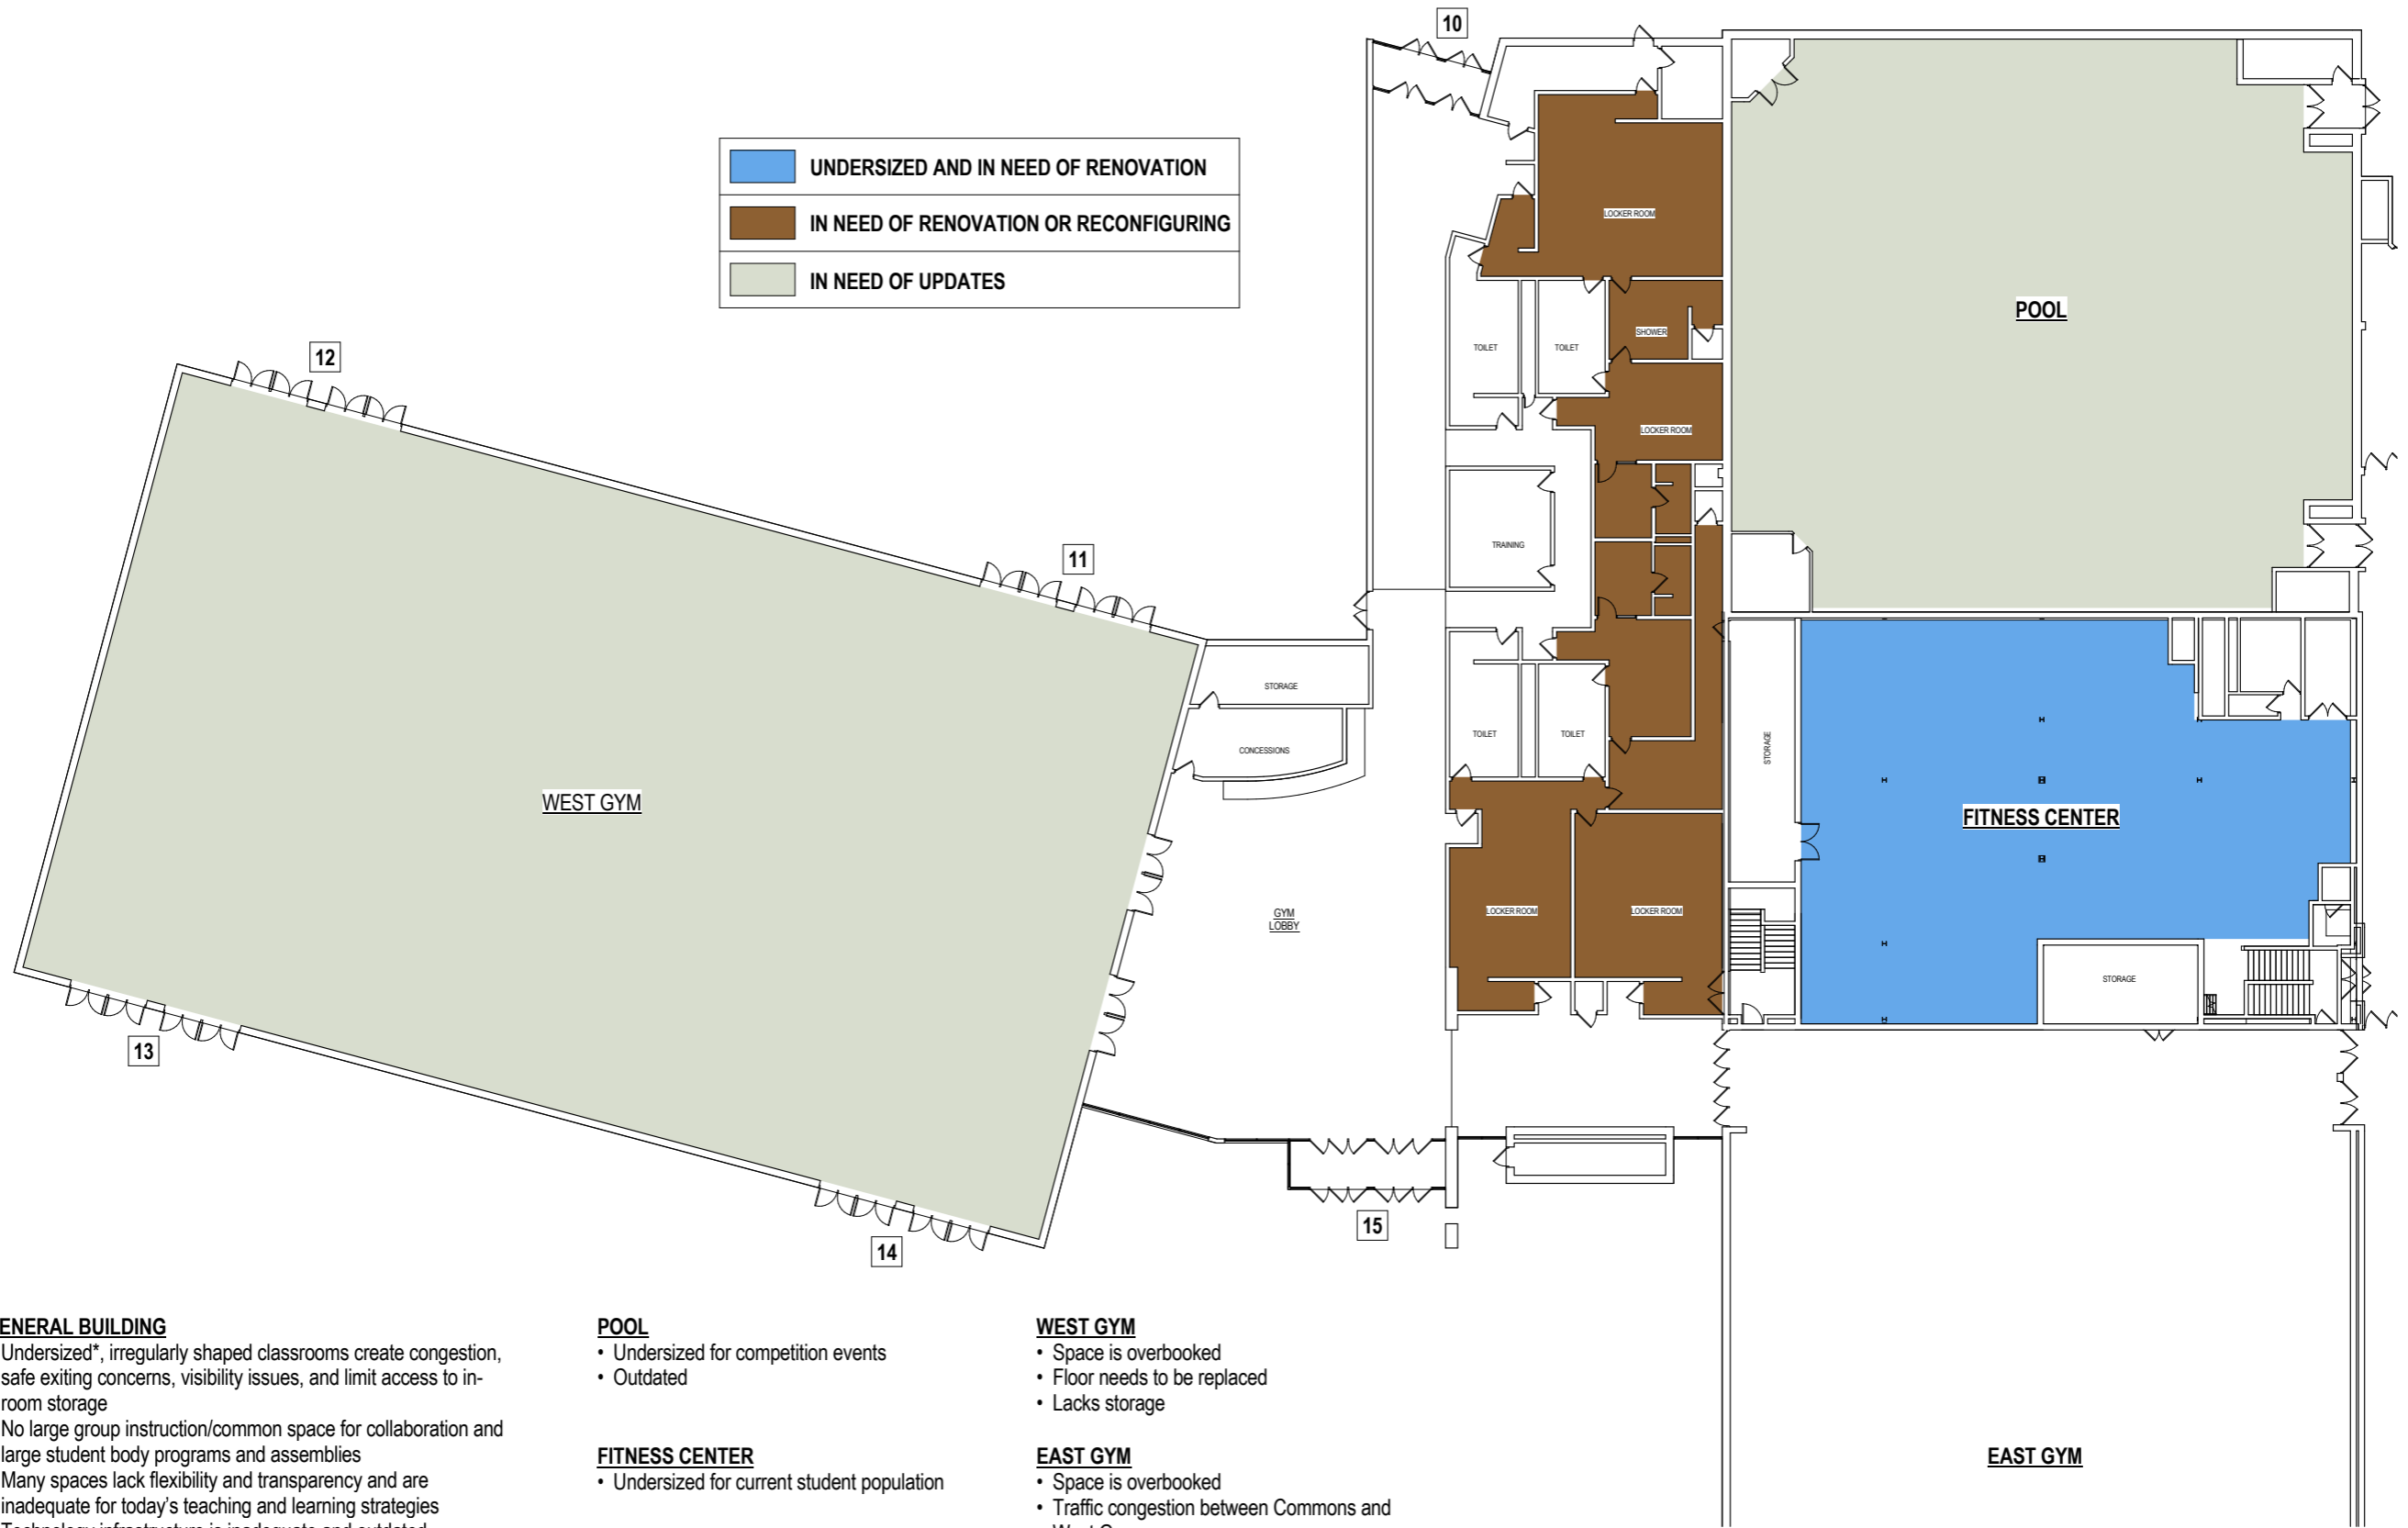
EDUCATIONAL PROGRAMMING - ATHLETICS

- Undersized*, irregularly shaped classrooms create congestion, safe exiting concerns, visibility issues, and limit access to in-room storage
- No large group instruction/common space for collaboration and large student body programs and assemblies
- Many spaces lack flexibility and transparency and are inadequate for today's teaching and learning strategies
- Technology infrastructure is inadequate and outdated
- Many spaces lack natural light
- Building signage is outdated and inconsistent

- Undersized for competition events
- Outdated

- Undersized for current student population

- Space is overbooked
- Floor needs to be replaced
- Lacks storage

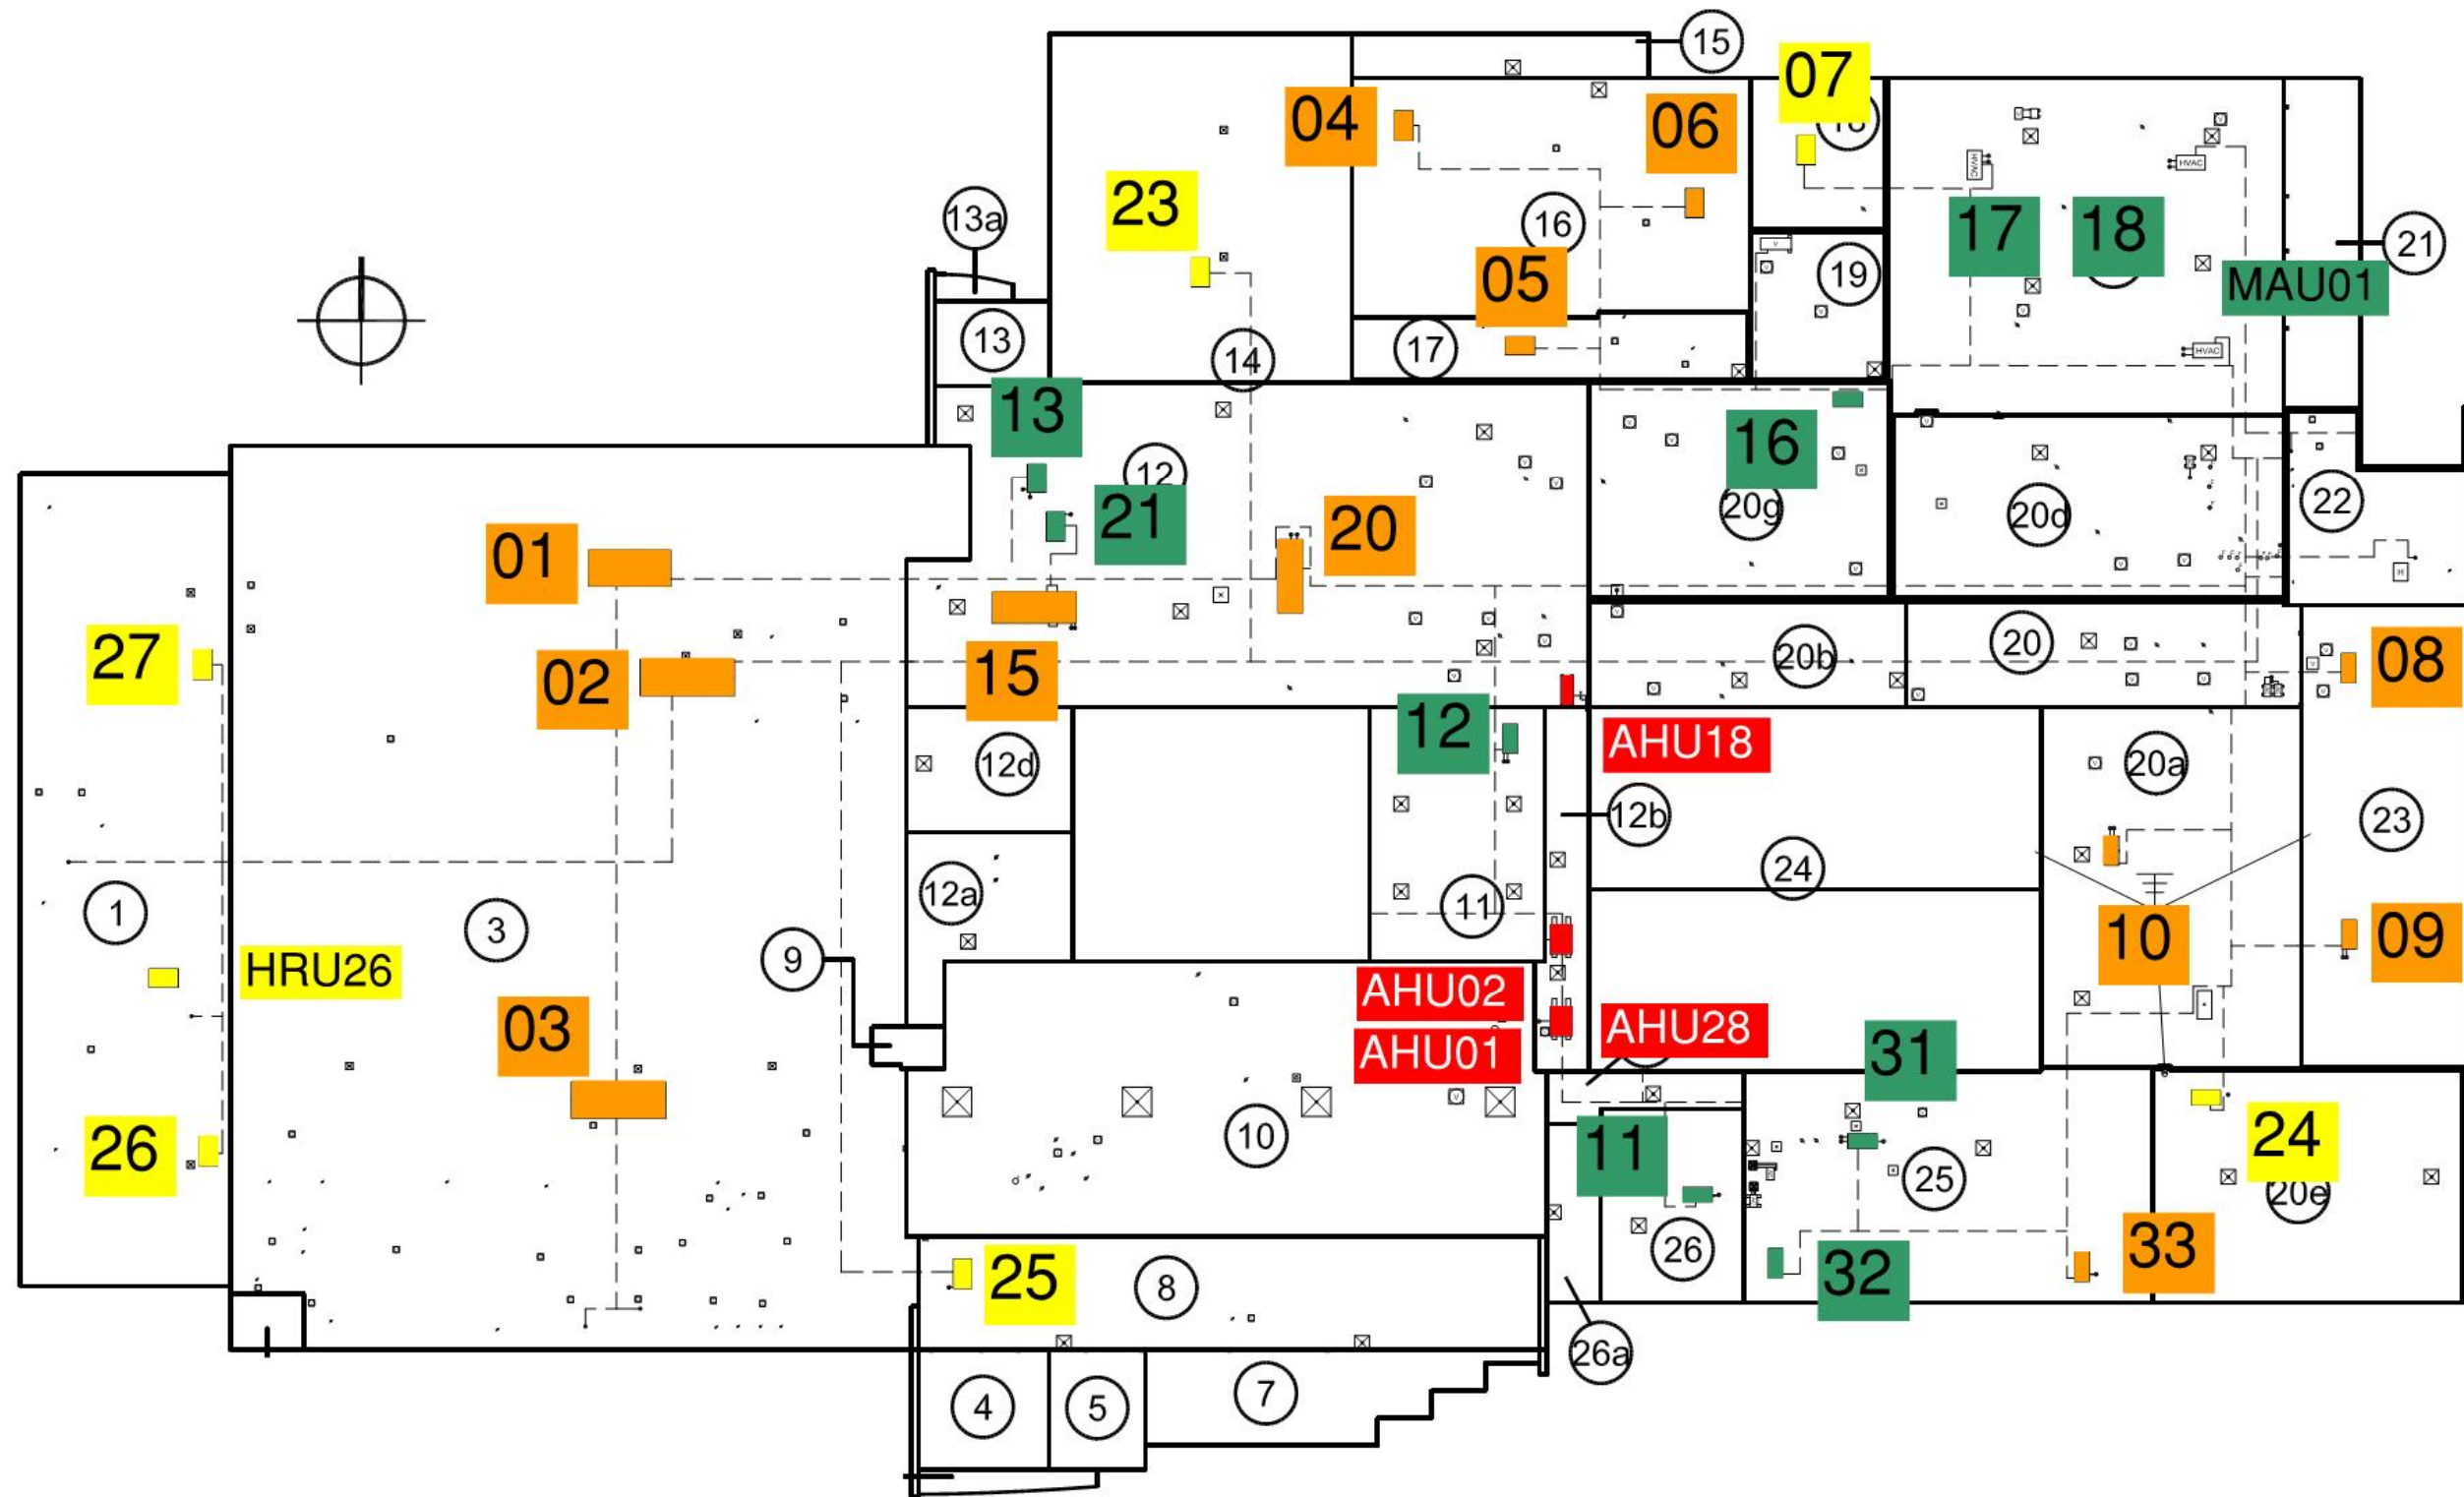
SOUTH CAMPUS HVAC EQUIPMENT

D: HVAC INSPECTION REPORT				
INSPECTION ITEM	CONDITION			LOCATION/DESCRIPTION of DEFECTS
	GOOD	FAIR	POOR	
1D. Boilers	X			Boilers are less than 15 years old, have been well maintained and are in very good condition.
2D. Circulating pumps	X			Pumps are variable flow using VFD's.
3D. Piping systems & insulation	X			Piping and associated insulation is in good condition.
4D. Rooftop Units		X		Some of the rooftop units are nearing their expected service life.
5D. Air handling units		X		While relatively old, the indoor air handling units have been well maintained and are in good condition. However, only one of the two gym units contains cooling and both units are in need of replacement.
6D. Filters	X			Filters are routinely maintained.
7D. Temperature controls			X	The majority of the existing DDC system is no longer supported by the manufacturer and can no longer be expanded.
Comments:				
1D. The boilers are sized to accommodate this building only and therefore are not capable of accommodating a large addition or expansion of the building.

4D. The rooftop units that were installed in 1994 are now over 20 years old and are at or near the end of their expected service life. Plans should be made for their replacement over the next 5 years. Units installed in 2000 are now over 15 years old and are nearing the end of their expected service life.				
7D. While the temperature controls have had some upgrades whenever remodeling projects have required it, the majority of the temperature controls date back to 1994 and are a system that is no longer supported by the manufacturer. Without manufacturer support future parts availability is not guaranteed making repairs difficult and expensive. Additionally, the District maintenance staff has been very proactive in implementing innovative control strategies to minimize energy use. The control system is now out of memory and can no longer be expanded to accommodate even greater innovation. The best short and long term solution is to obtain competitive bids for the replacement of the existing control system with a new system offering all of the latest advancements in digital control technology.

The current heating and distribution system is in good condition, however the boilers are at capacity and are not capable of accommodating any large expansion.

Indoor units are old but are in fair condition. Outdoor units that were installed in 1993 are at the end of their expected service life.

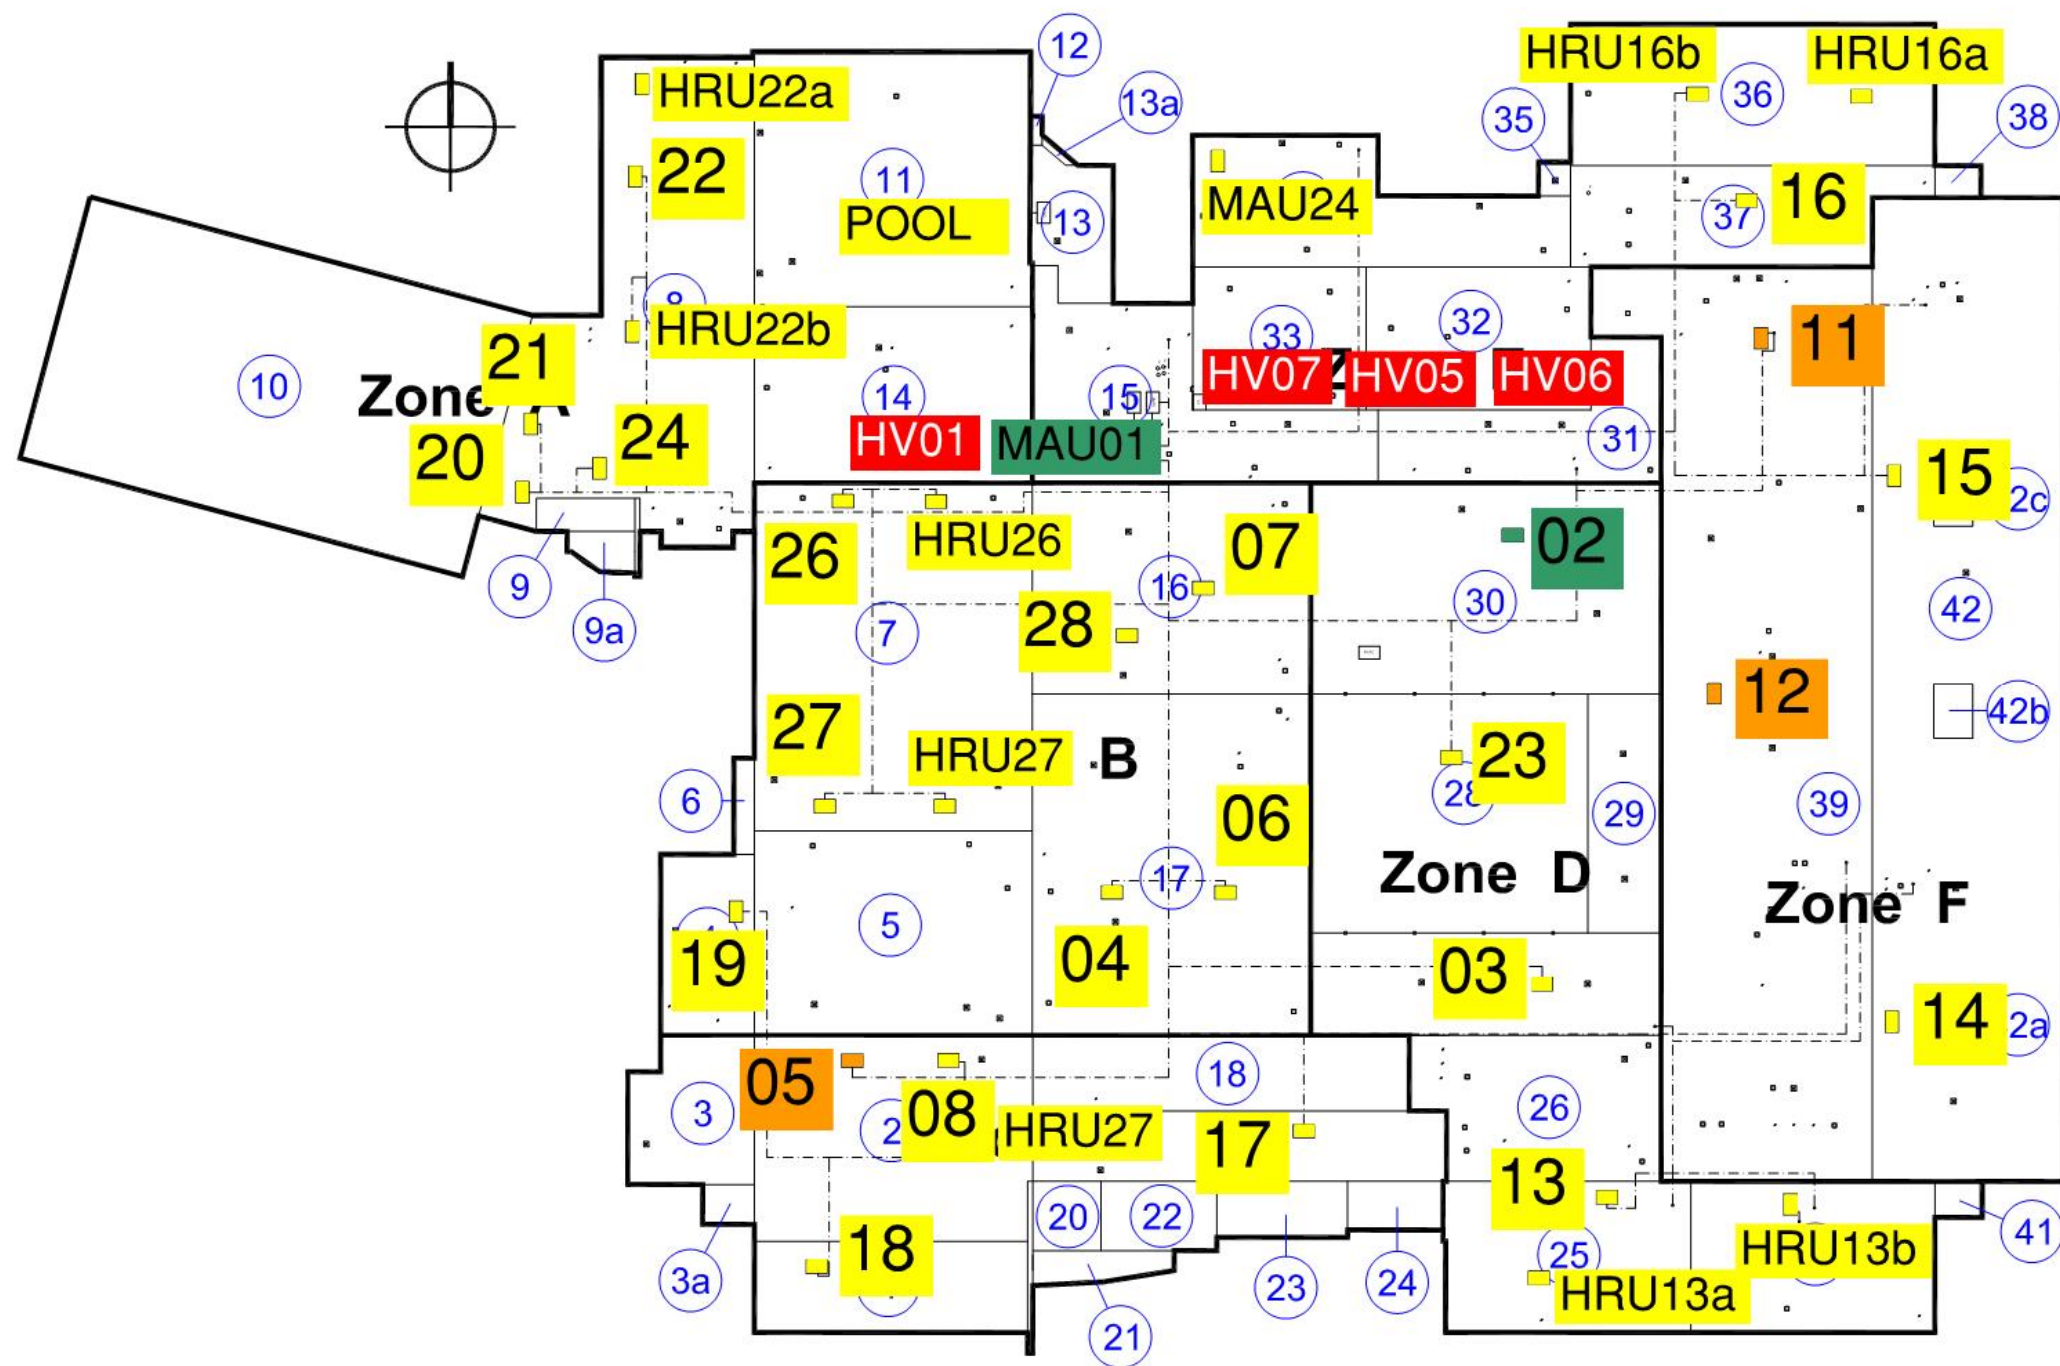
NORTH CAMPUS HVAC EQUIPMENT

D: HVAC INSPECTION REPORT				
INSPECTION ITEM	CONDITION			LOCATION/DESCRIPTION of DEFECTS
	GOOD	FAIR	POOR	
1D. Boilers	X			Boilers are less than 15 years old, have been well maintained and are in very good condition.
2D. Circulating pumps	X			Pumps are variable flow using VFD's.
3D. Piping systems & insulation	X			Piping and associated insulation is in good condition.
4D. Rooftop Units		X		Some of the rooftop units are nearing their expected service life.
5D. Air handling units		X		While relatively old, the indoor air handling units have been well maintained and are in satisfactory condition. However, the tech ed and fitness units are heating-only type units that are in need of replacement.
6D. Filters	X			Filters are routinely maintained.
7D. Temperature controls			X	The majority of the existing DDC system is no longer supported by the manufacturer and can no longer be expanded.
8D. Pool ventilation	X			The pool ventilation and dehumidification system was upgraded in 2009 and is in good condition.

<p>Comments:</p> <p>1D. The boilers are sized to accommodate this building only and therefore are not capable of accommodating a large addition or expansion of the building. These boilers also serve to heat domestic hot water.</p> <p>4D. The rooftop units that were installed in 1994 are now over 20 years old and are at or near the end of their expected service life. Plans should be made for their replacement over the next 5 years. Units installed in 2000 are now over 15 years old and are nearing the end of their expected service life.</p> <p>5D. Many areas of the building are served by rigid fiberglass board ductwork that is leaking and failing. There are also exceptionally long runs of flexible ductwork in these areas. Whenever these areas are scheduled to be remodeled, the fiberglass ductwork should be replaced with sheet metal ductwork and the flexible duct runs should be replaced with newer and shorter sections of flexible ductwork. It was also noted that many classrooms are lacking proper cooling capacity since these rooms now typically contain 30-34 students each with laptop computers.</p> <p>7D. While the temperature controls have had some upgrades whenever remodeling projects have required it, the majority of the temperature controls date back to 1994 and are a system that is no longer supported by the manufacturer. Without manufacturer support future parts availability is not guaranteed making repairs difficult and expensive. Additionally, the District maintenance staff has been very proactive in implementing innovative control strategies to minimize energy use. The control system is now out of memory and can no longer be expanded to accommodate even greater innovation. The best short and long term solution is to obtain competitive bids for the replacement of the existing control system with a new system offering all of the latest advancements in digital control technology.</p> <p>8D. The pool ventilation and dehumidification system was upgraded in 2009. The system utilizes mechanical refrigeration and recovered heat to provide dehumidification for the space. This system is exceptionally efficient and effective.</p>

The current heating and distribution system is in good condition, however the boilers are at capacity and are not capable of accommodating any large expansion. Cooling loads tend to be inadequate due to the number of students in classrooms.

Both the indoor and outdoor units are in fair condition. The oldest of the units are at or near their expected service life.
