JANUARY 10, 2024

LONG-RANGE CAPITAL MAINTENANCE PLAN

ARROWHEAD UNION HIGH SCHOOL DISTRICT

2025 - 2035

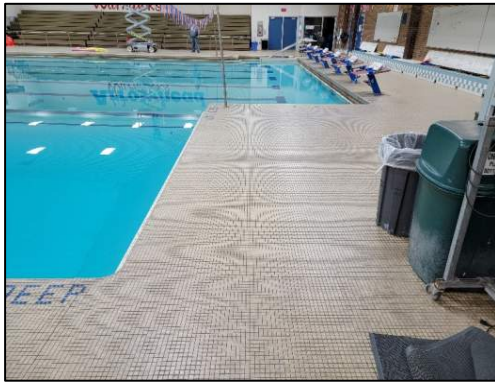
3. UNEVEN/WARPED DECKING

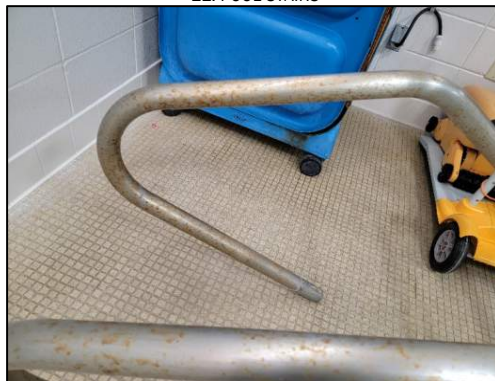
13. POOL LADDER CORROSION.

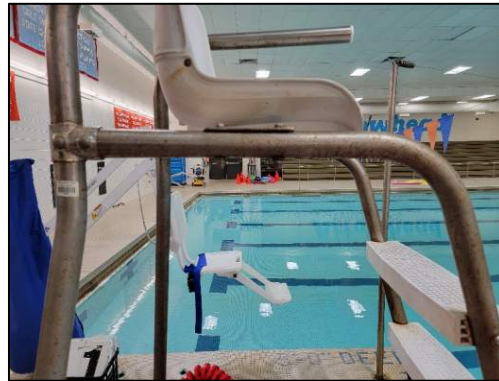
16. LIFEGUARD CHAIR CORROSION.

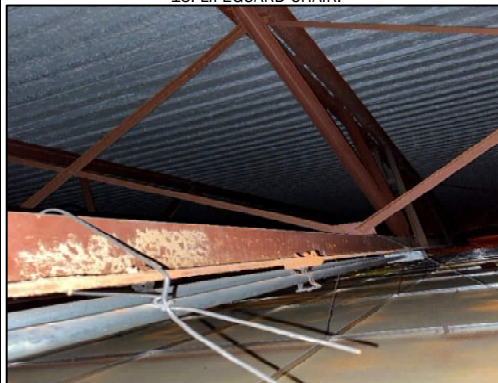
17. CORROSION ON DROP CEILING SUPPORT.

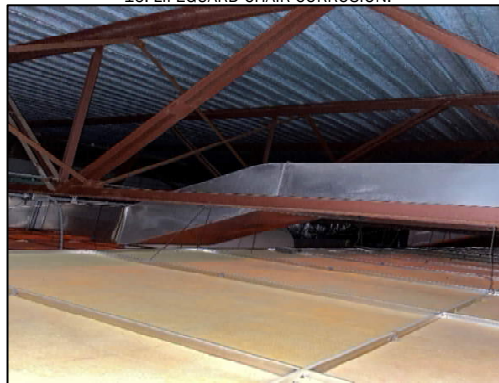
18. CORROSION ABOVE THE DROP CEILING.

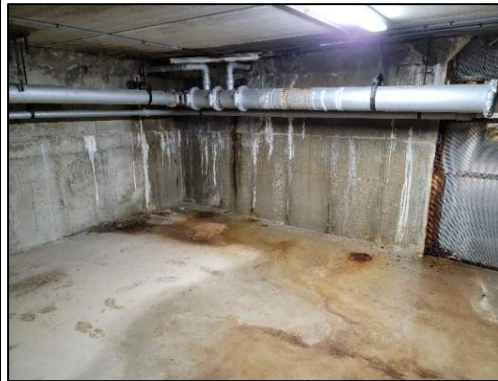
19. LEAK ON SOUTH SIDE OF DEEP WELL

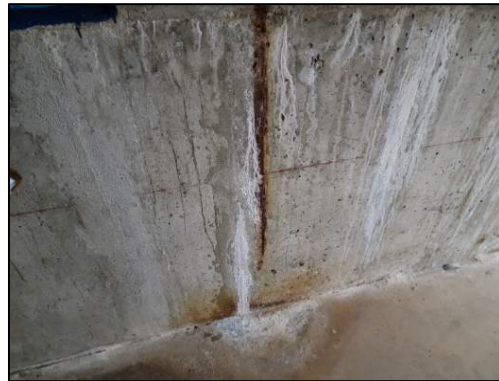
20. PRECIPITATE ON POOL BASIN WALL.

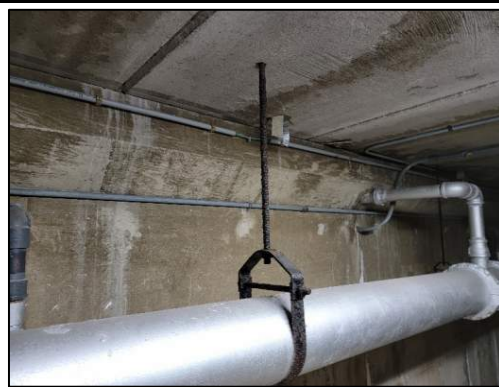
22. CORRODED PIPE HANGERS.

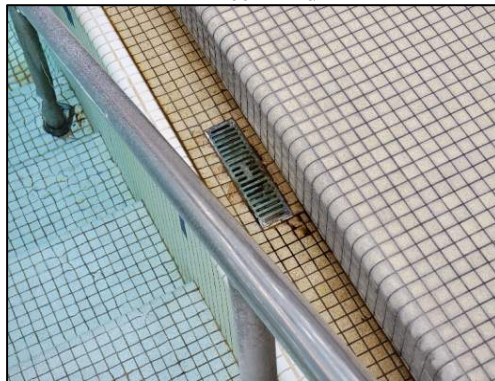
23. CORRODED GUTTER DRAIN

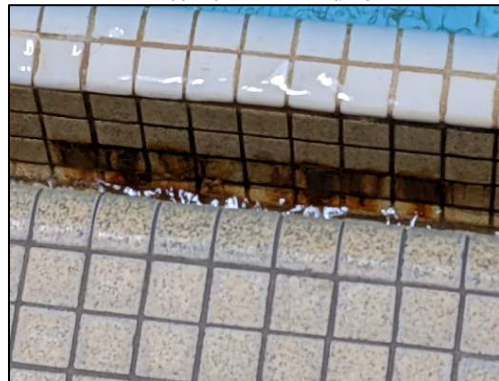
24. CORROSION IN GUTTER.

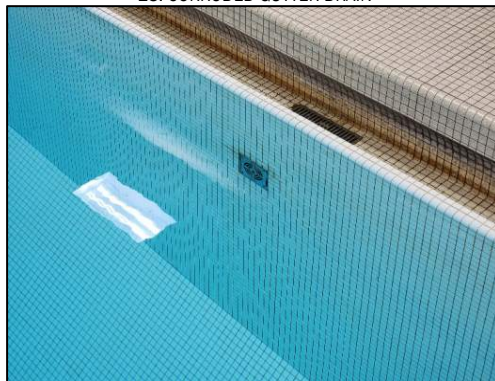
25. CORROSION AROUND AND ON INLET PLATE.

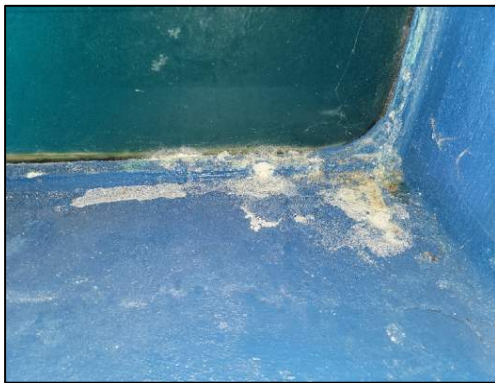
27. ALGAE IN VIEWING WINDOW.

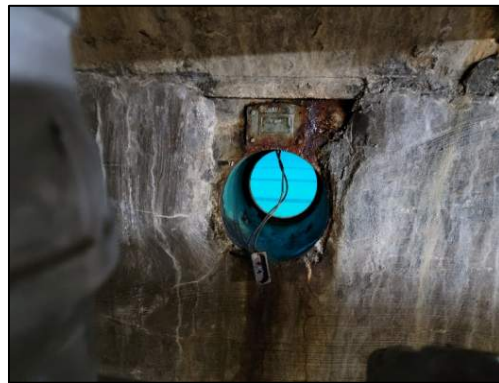
28. LEAKING AROUND LIGHT NICHE.

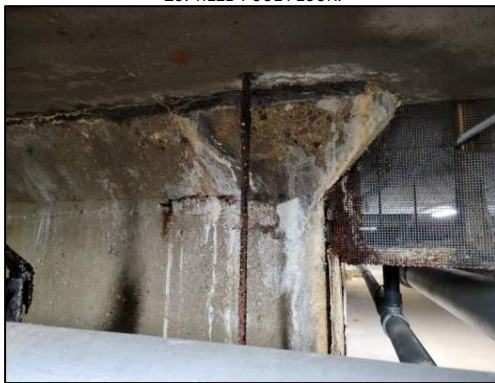
31. CONCRETE DETERIORATION.

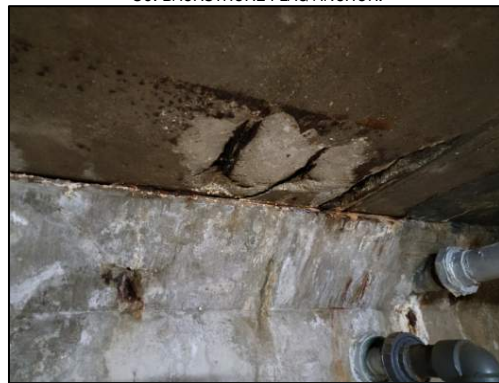
32. EXPOSED REBAR IN TUNNEL AND PRECIPITATE.

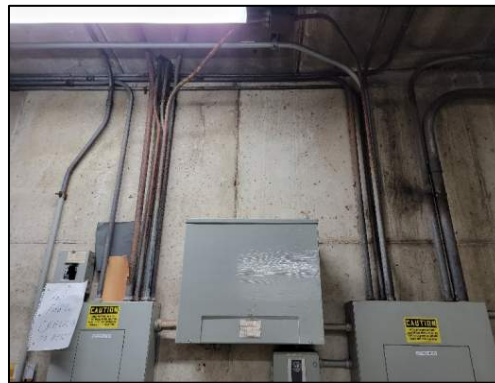
46. CORROSION ABOVE ELECTRICAL PANELS.

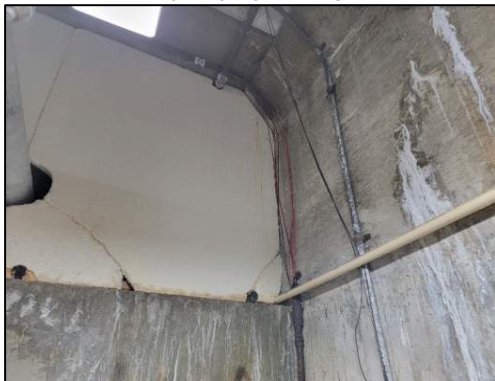
47. EXPOSED WIRES ABOVE SURGE TANK.

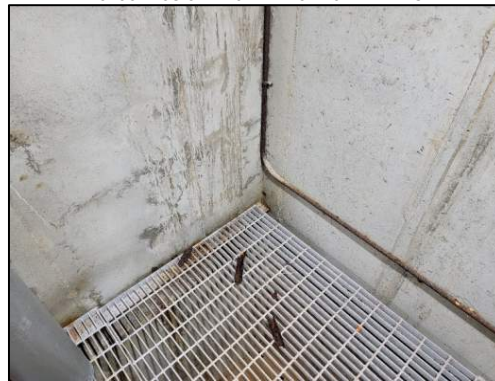
48. CORRODED CONDUIT SHEATHING ON THE FLOOR.

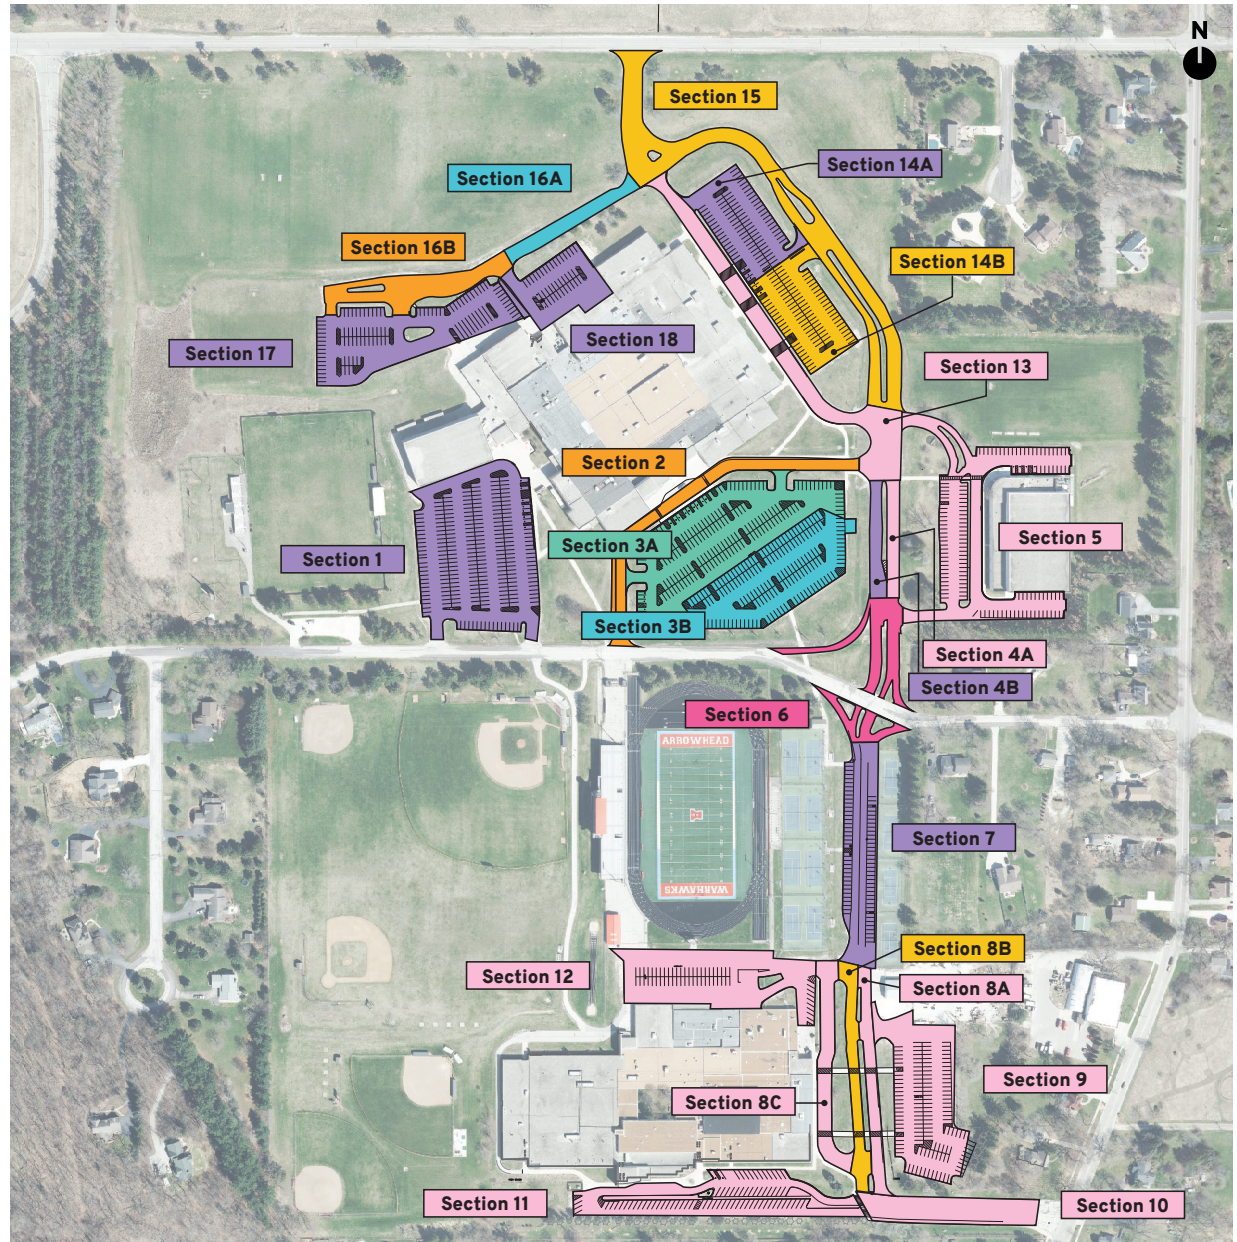
Arrowhead High School PASER Rating

1	
2	- Section 3B & 16A
3	- Section 3A
4	- Section 2 & 16B
5	- Section 8B, 14B, & 15
6	- Section 1, 4B, 7, 14A, 17, & 18
7	- Section 4A, 5, 8A, 8C, 9, 10, 11, 12, & 13
8	- Section 6
9	
10
