# FACILITIES ASSESSMENT BOARD PRESENTATION

ARROWHEAD UNION HIGH SCHOOL DISTRICT

#323398-01 | 12.13.2023

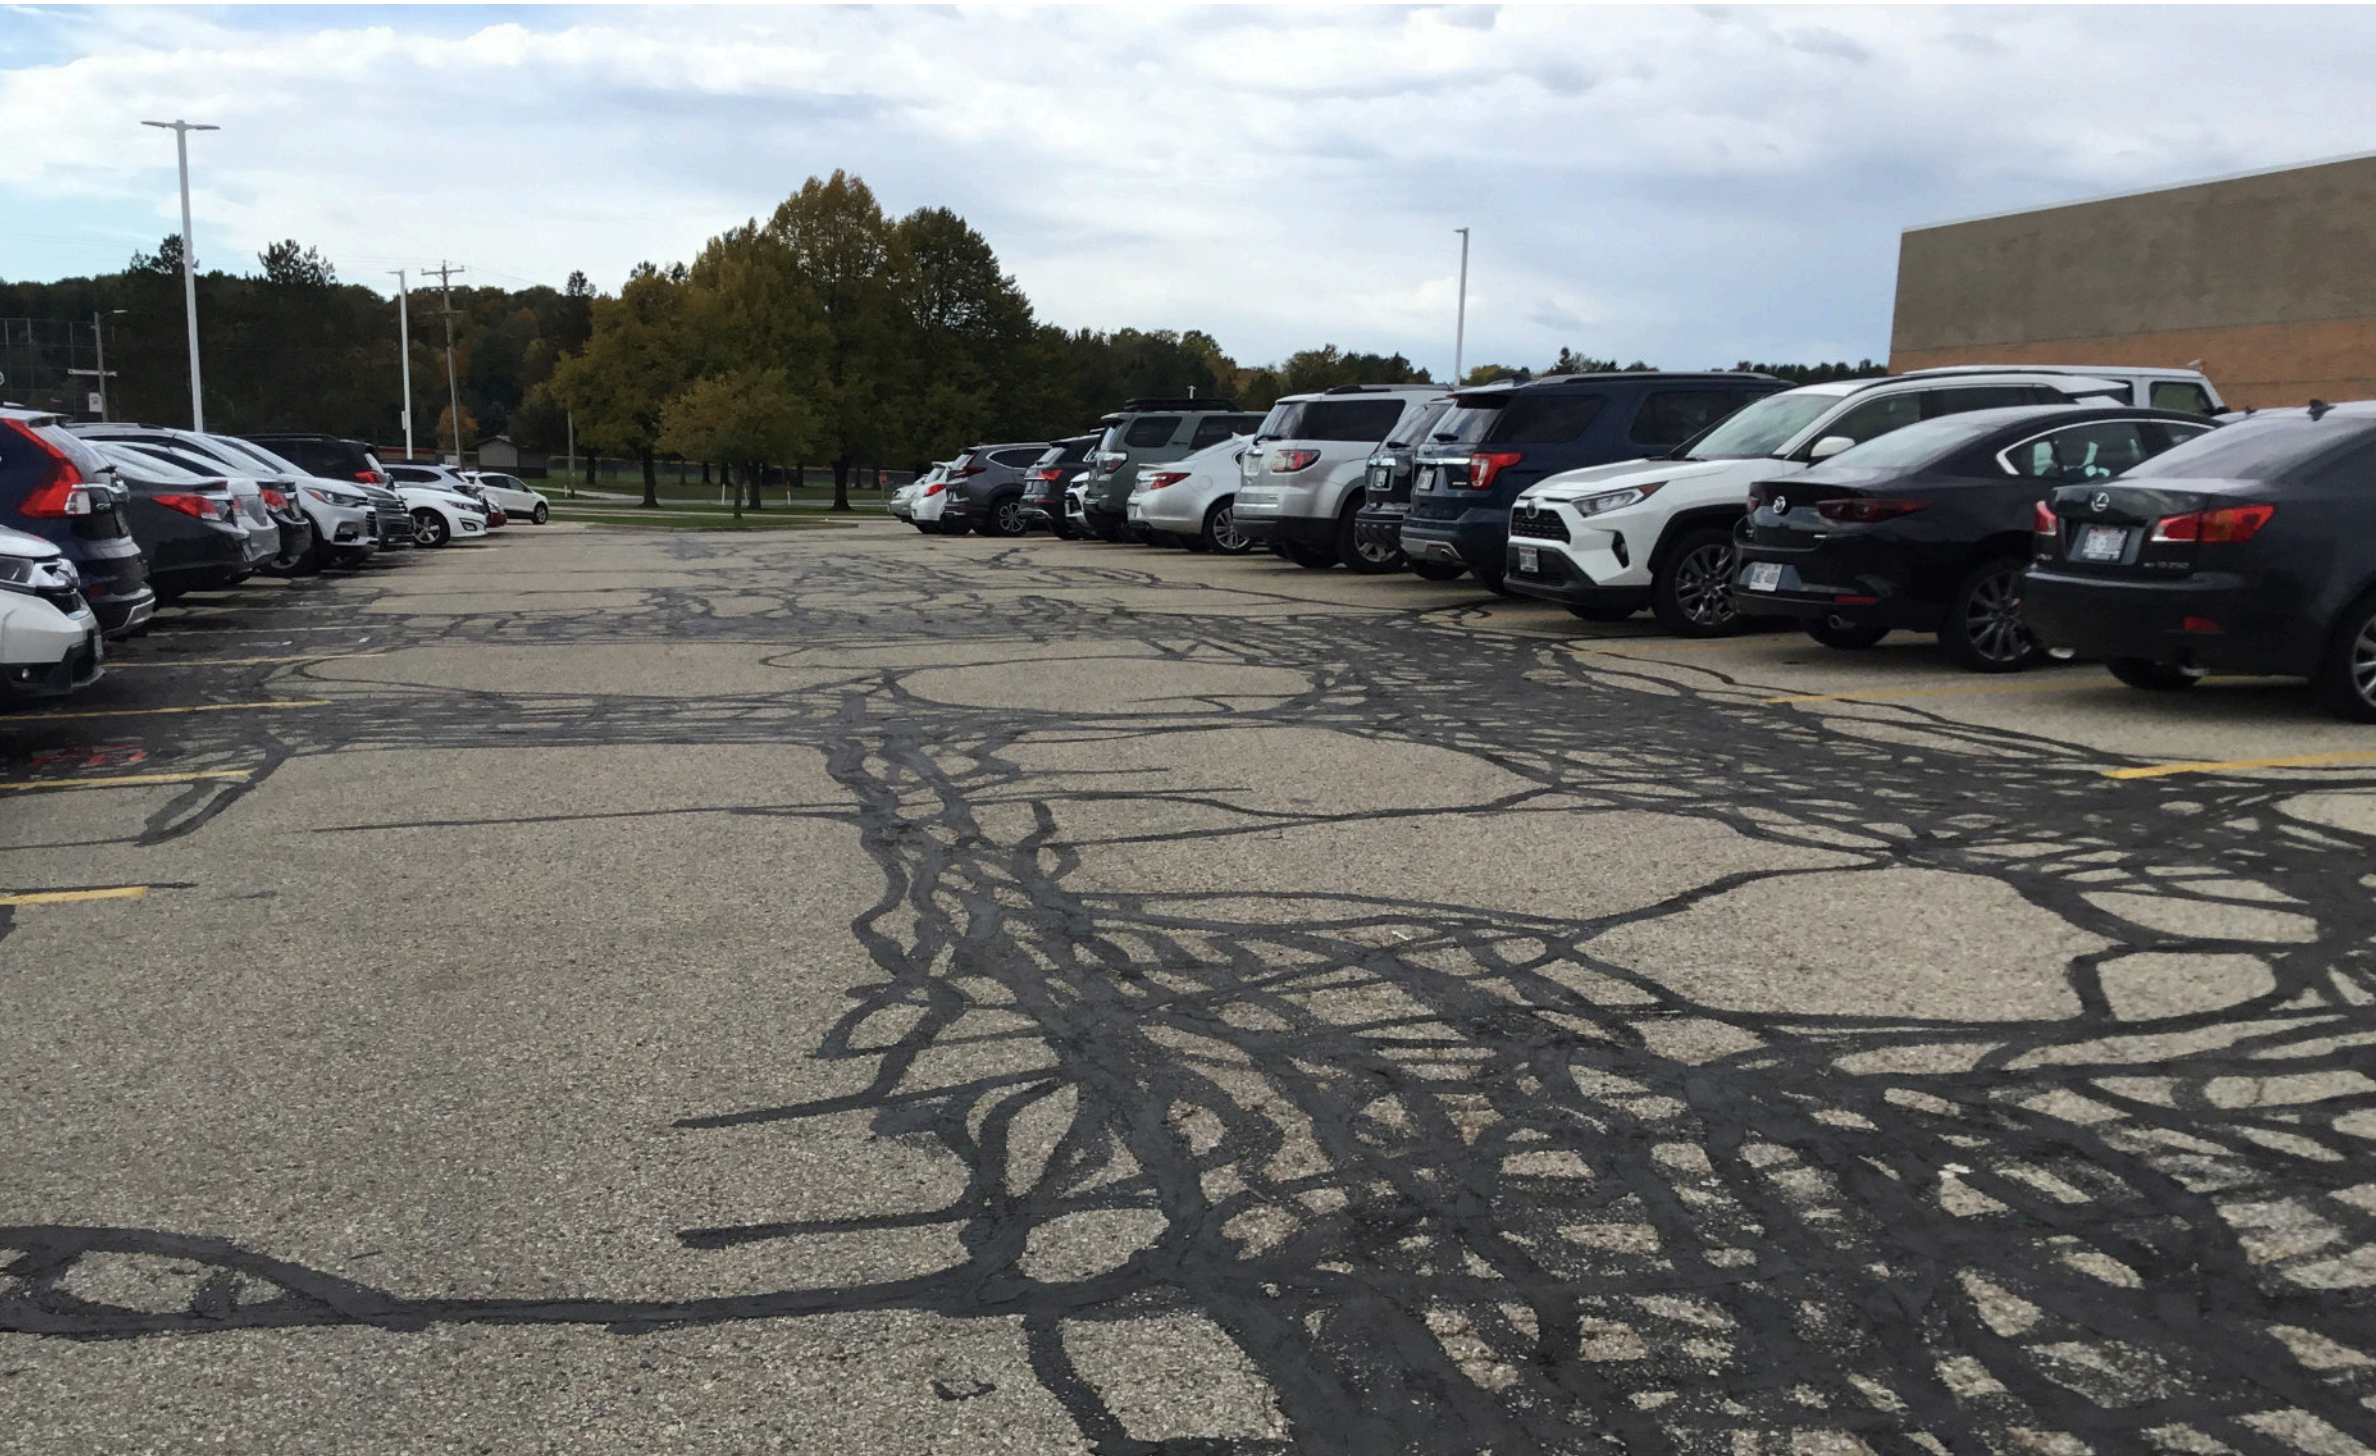
## DETERIORATING PAVEMENT

MUCH OF THE MAIN PARKING LOT ASPHALT IS IN POOR CONDITION, WITH A LARGE NUMBER OF CRACKS, ALLIGATORING, AND INDICATIONS OF SUB-BASE FAILURE.

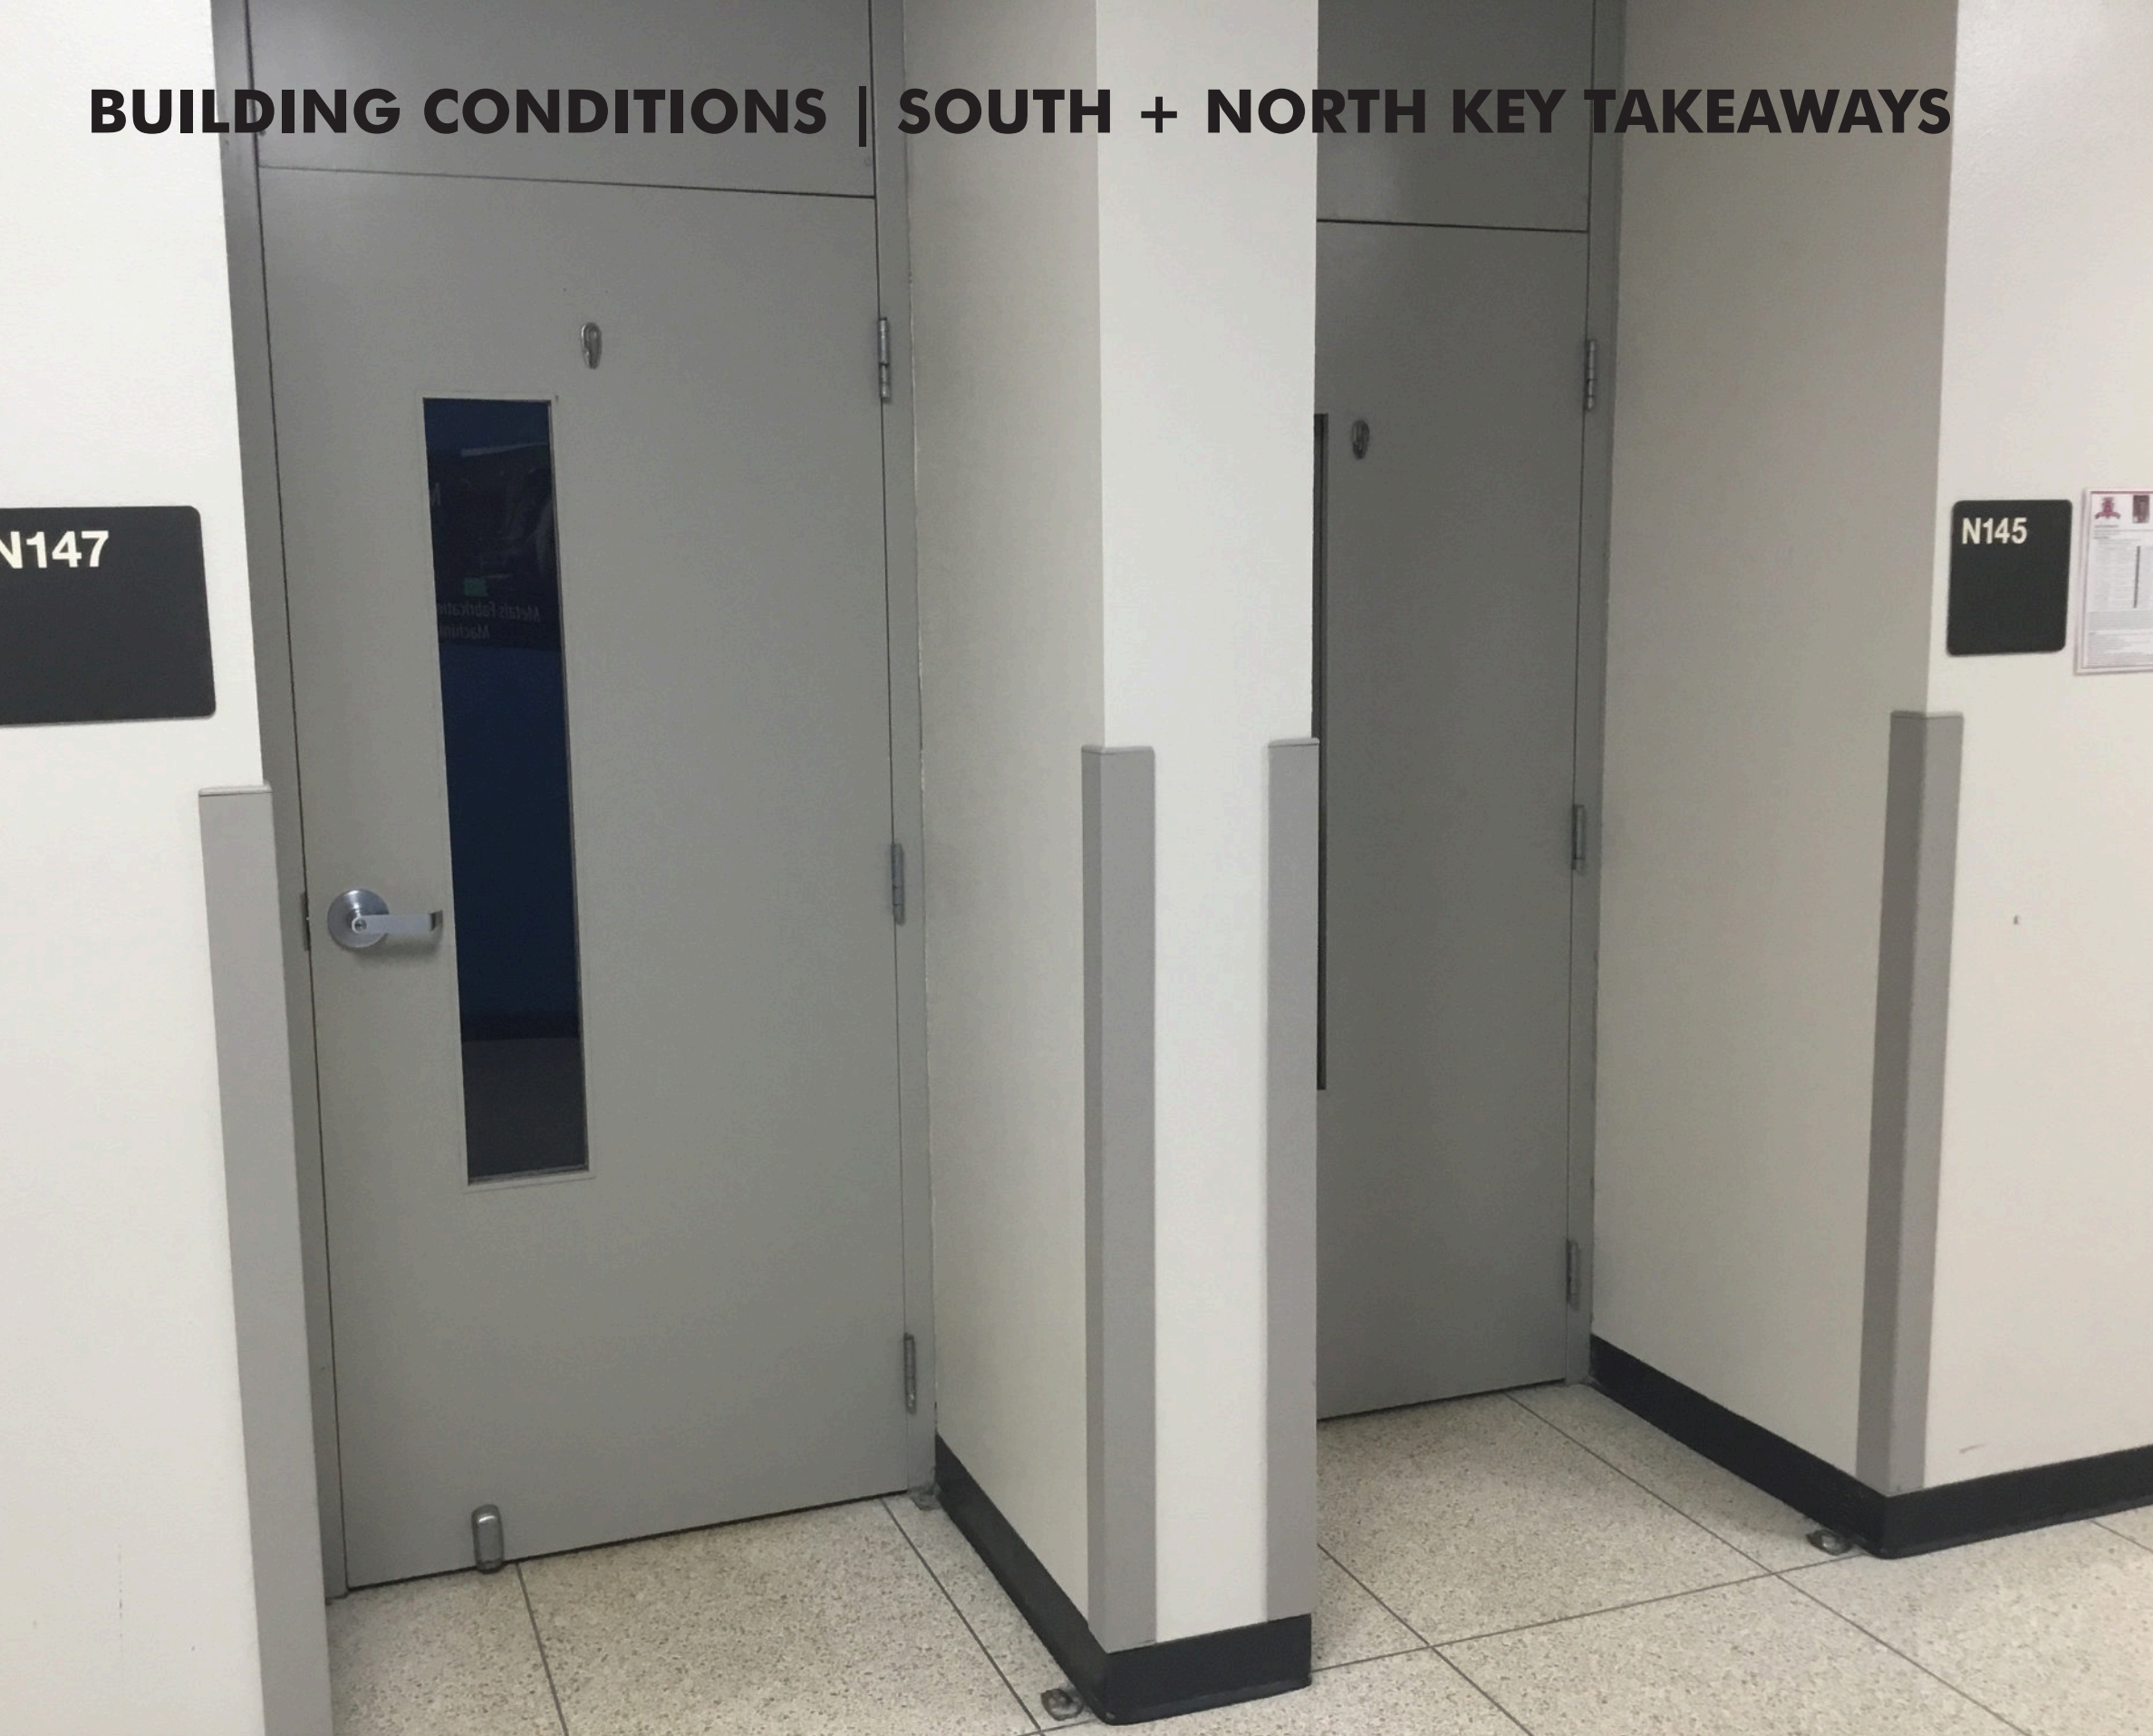
## ADA DEFICIENCIES

A NUMBER OF ADA DEFICIENCIES EXIST, INCLUDING INADEQUATE MANEUVERING CLEARANCES AT DOORS AND RESTROOMS, AND LACK OF ACCESSIBLE PLUMBING FIXTURES IN SCIENCE AND FACE ROOMS.

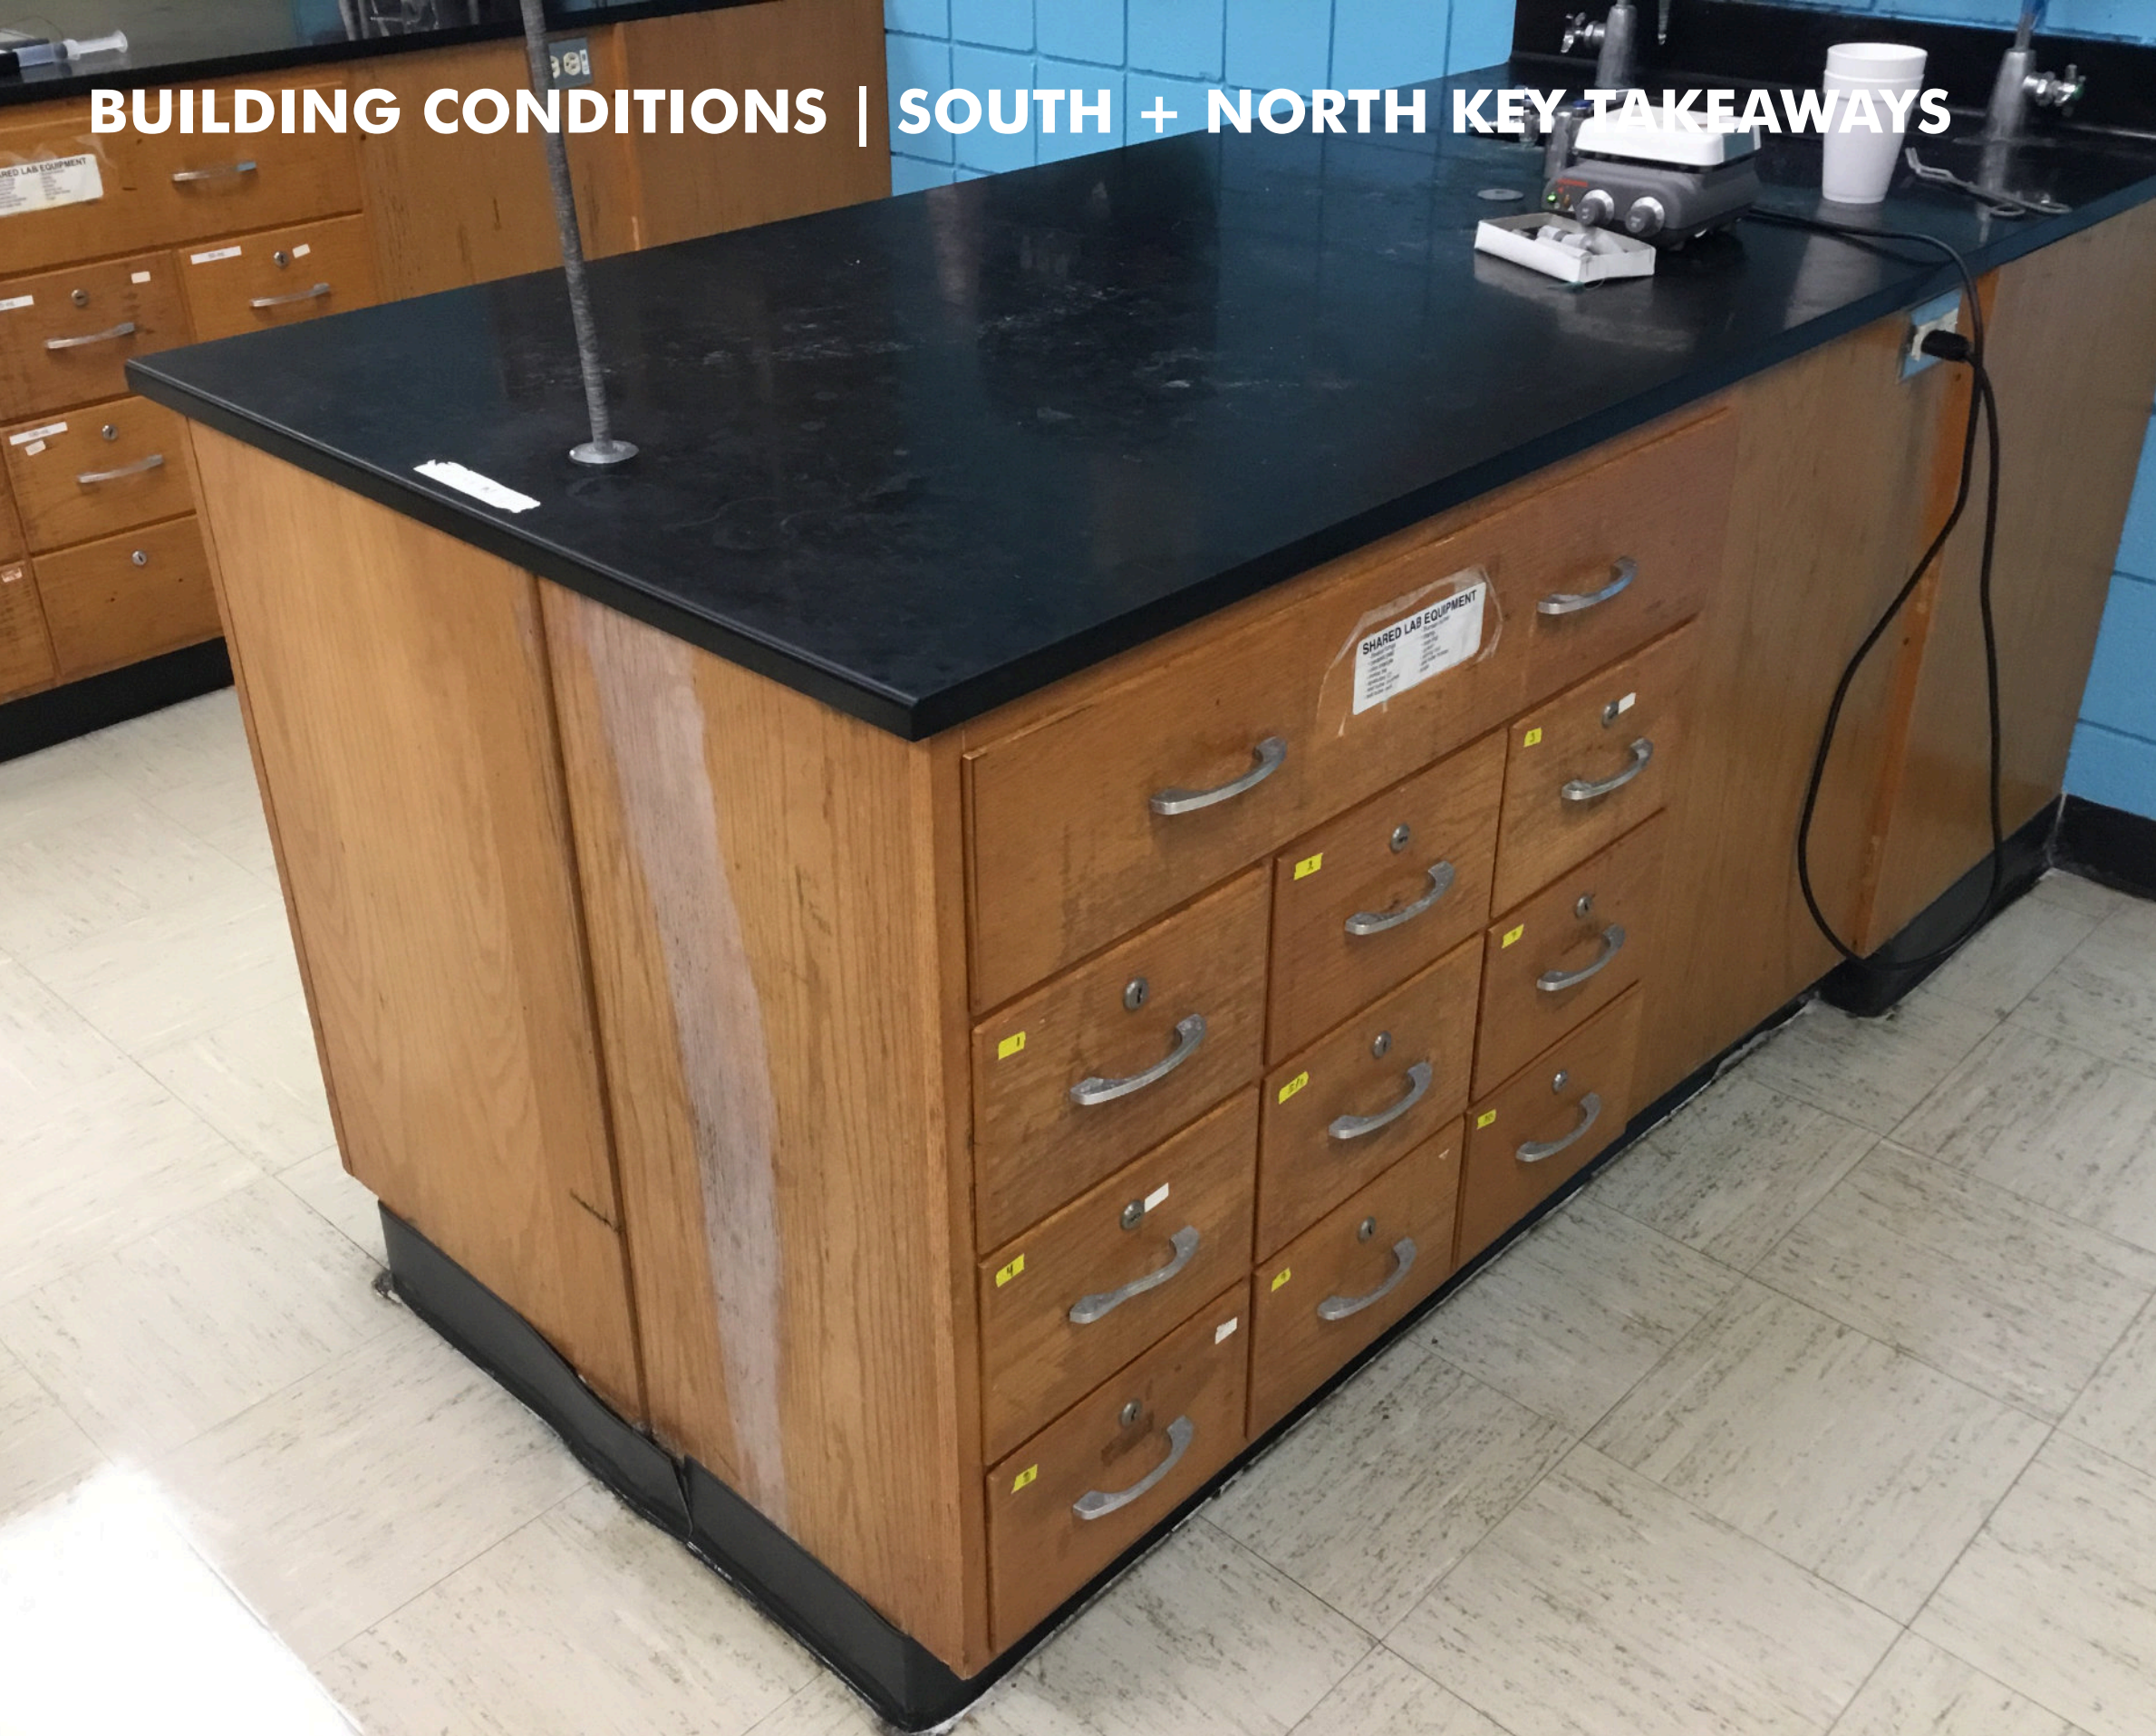
## DAMAGED CASEWORK

A MAJORITY OF THE CASEWORK IN THE BUILDING IS AGING, WITH MANY CASES OF DELAMINATION. MANY CLASSROOMS HAVE OLDER CARPETING THAT IS WORN & APPROACHING THE END OF ITS USEFUL LIFE.

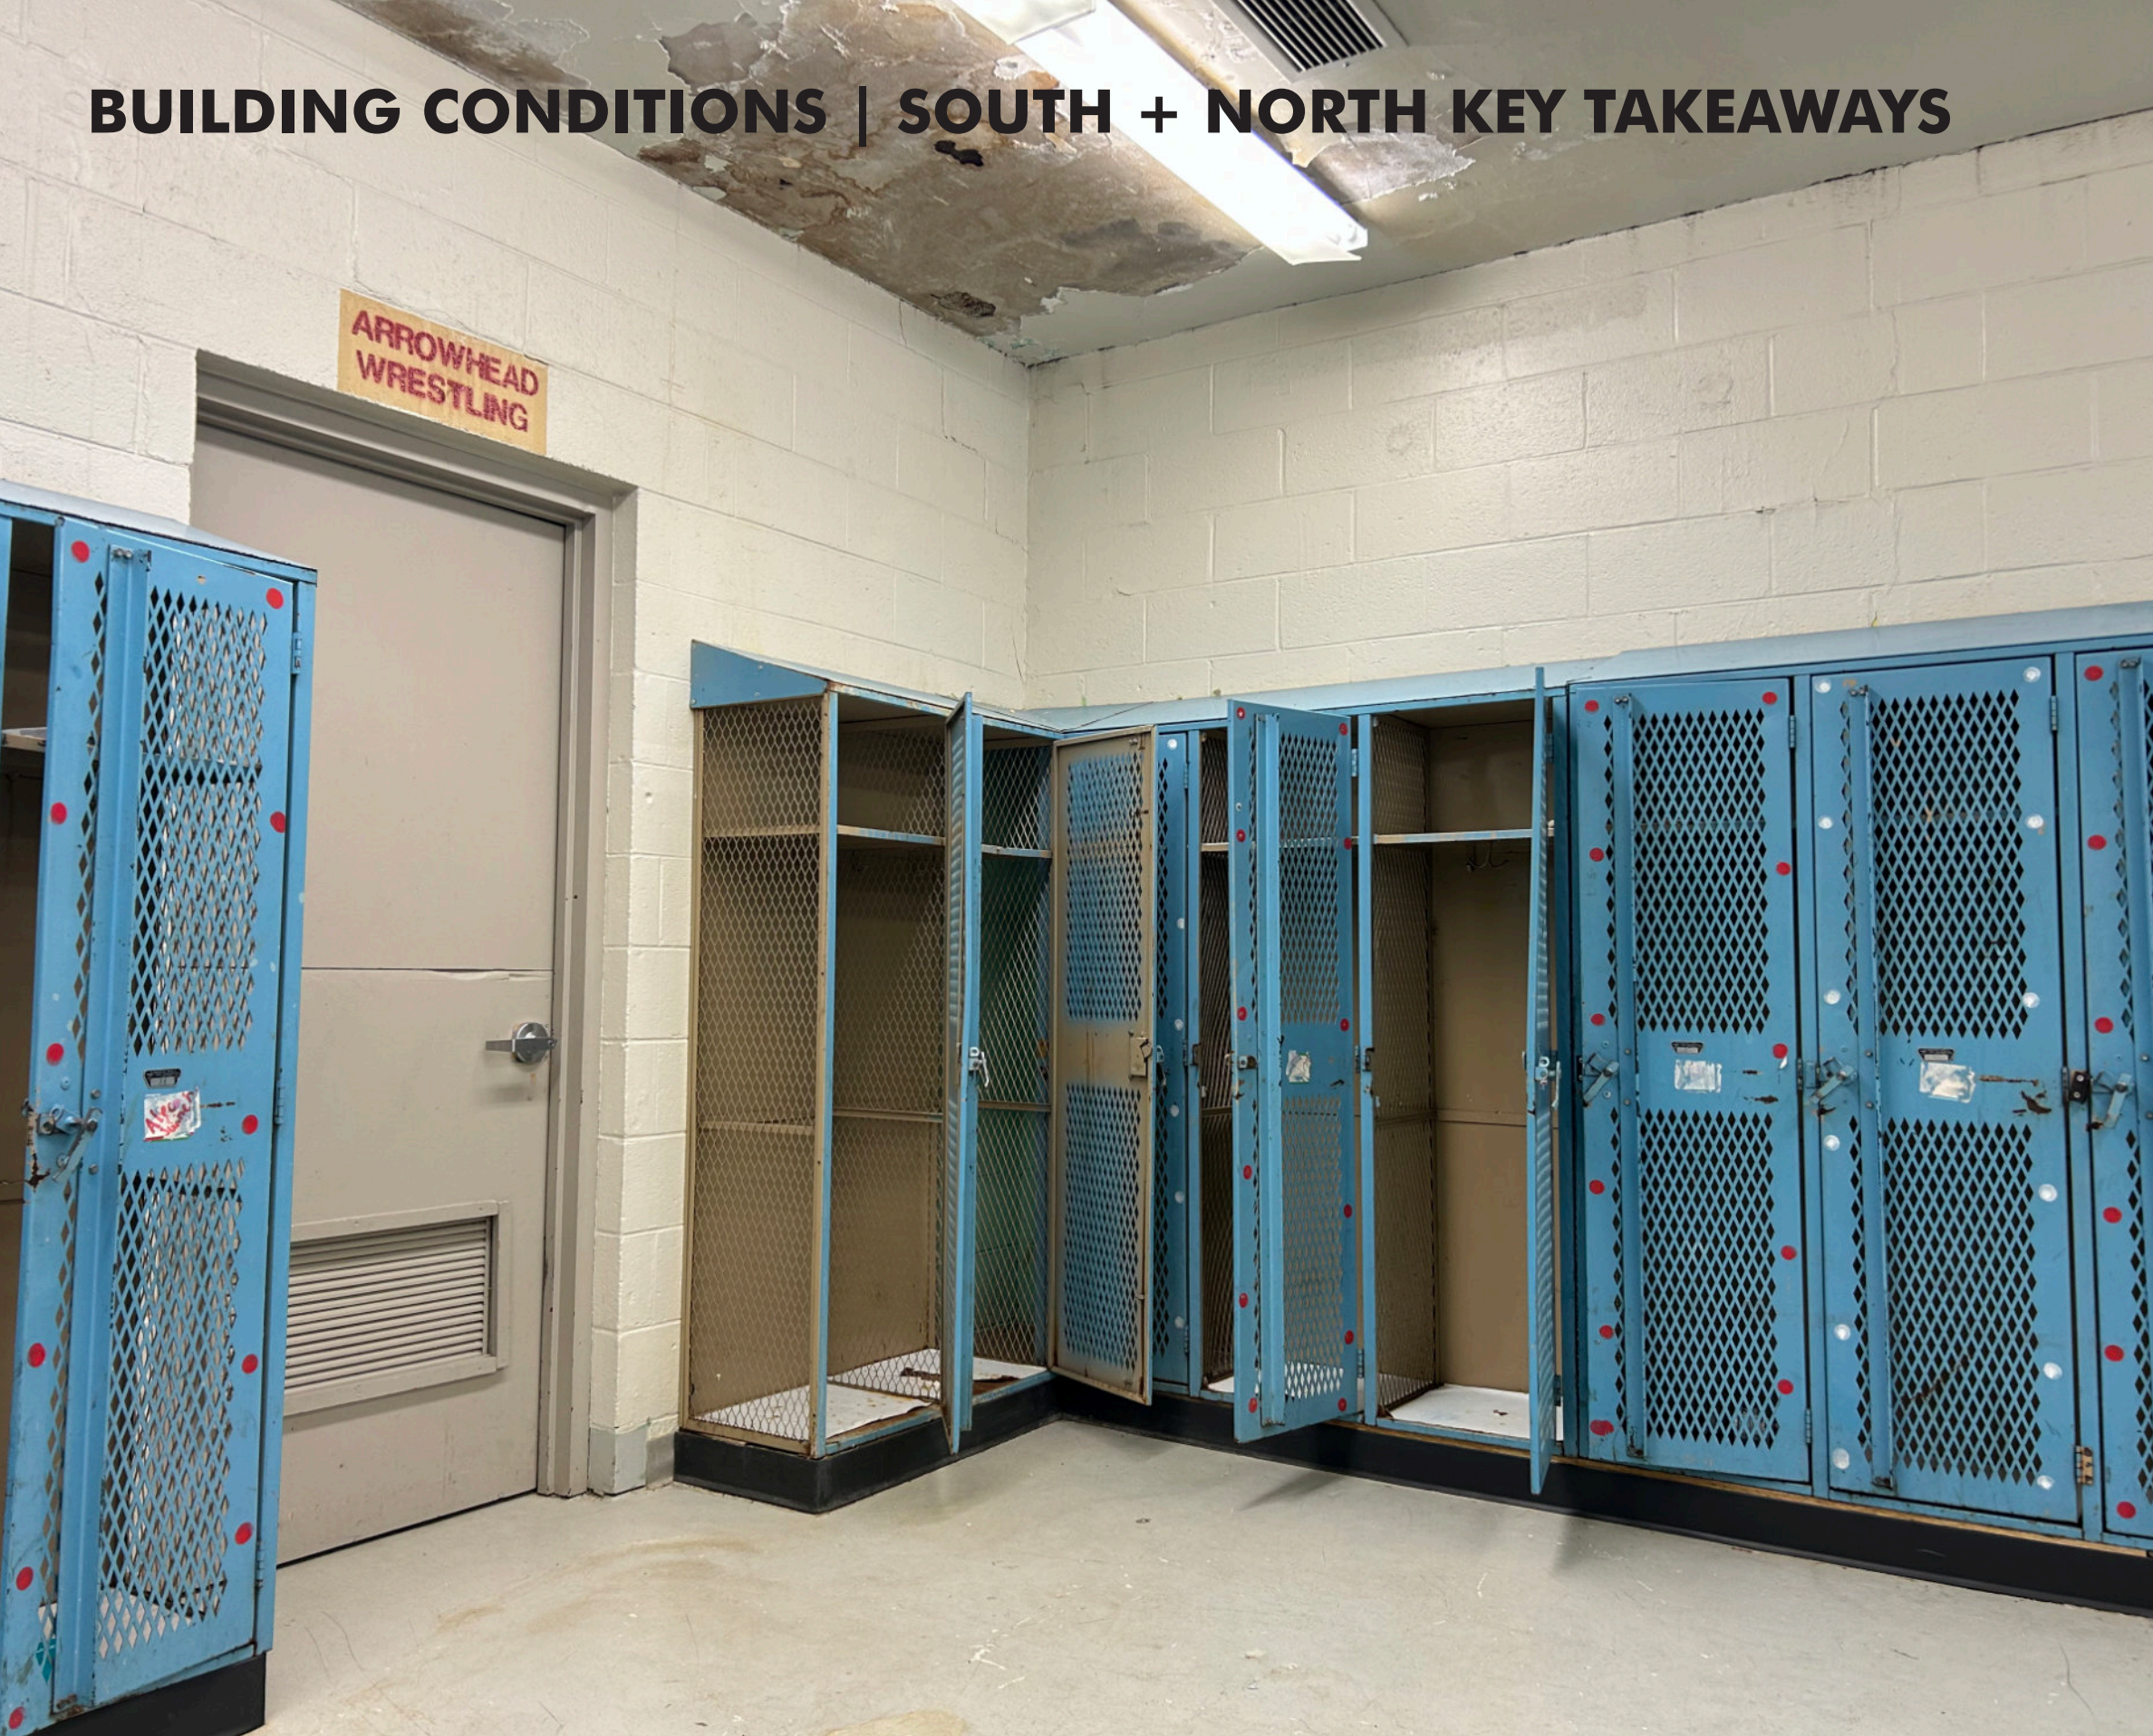
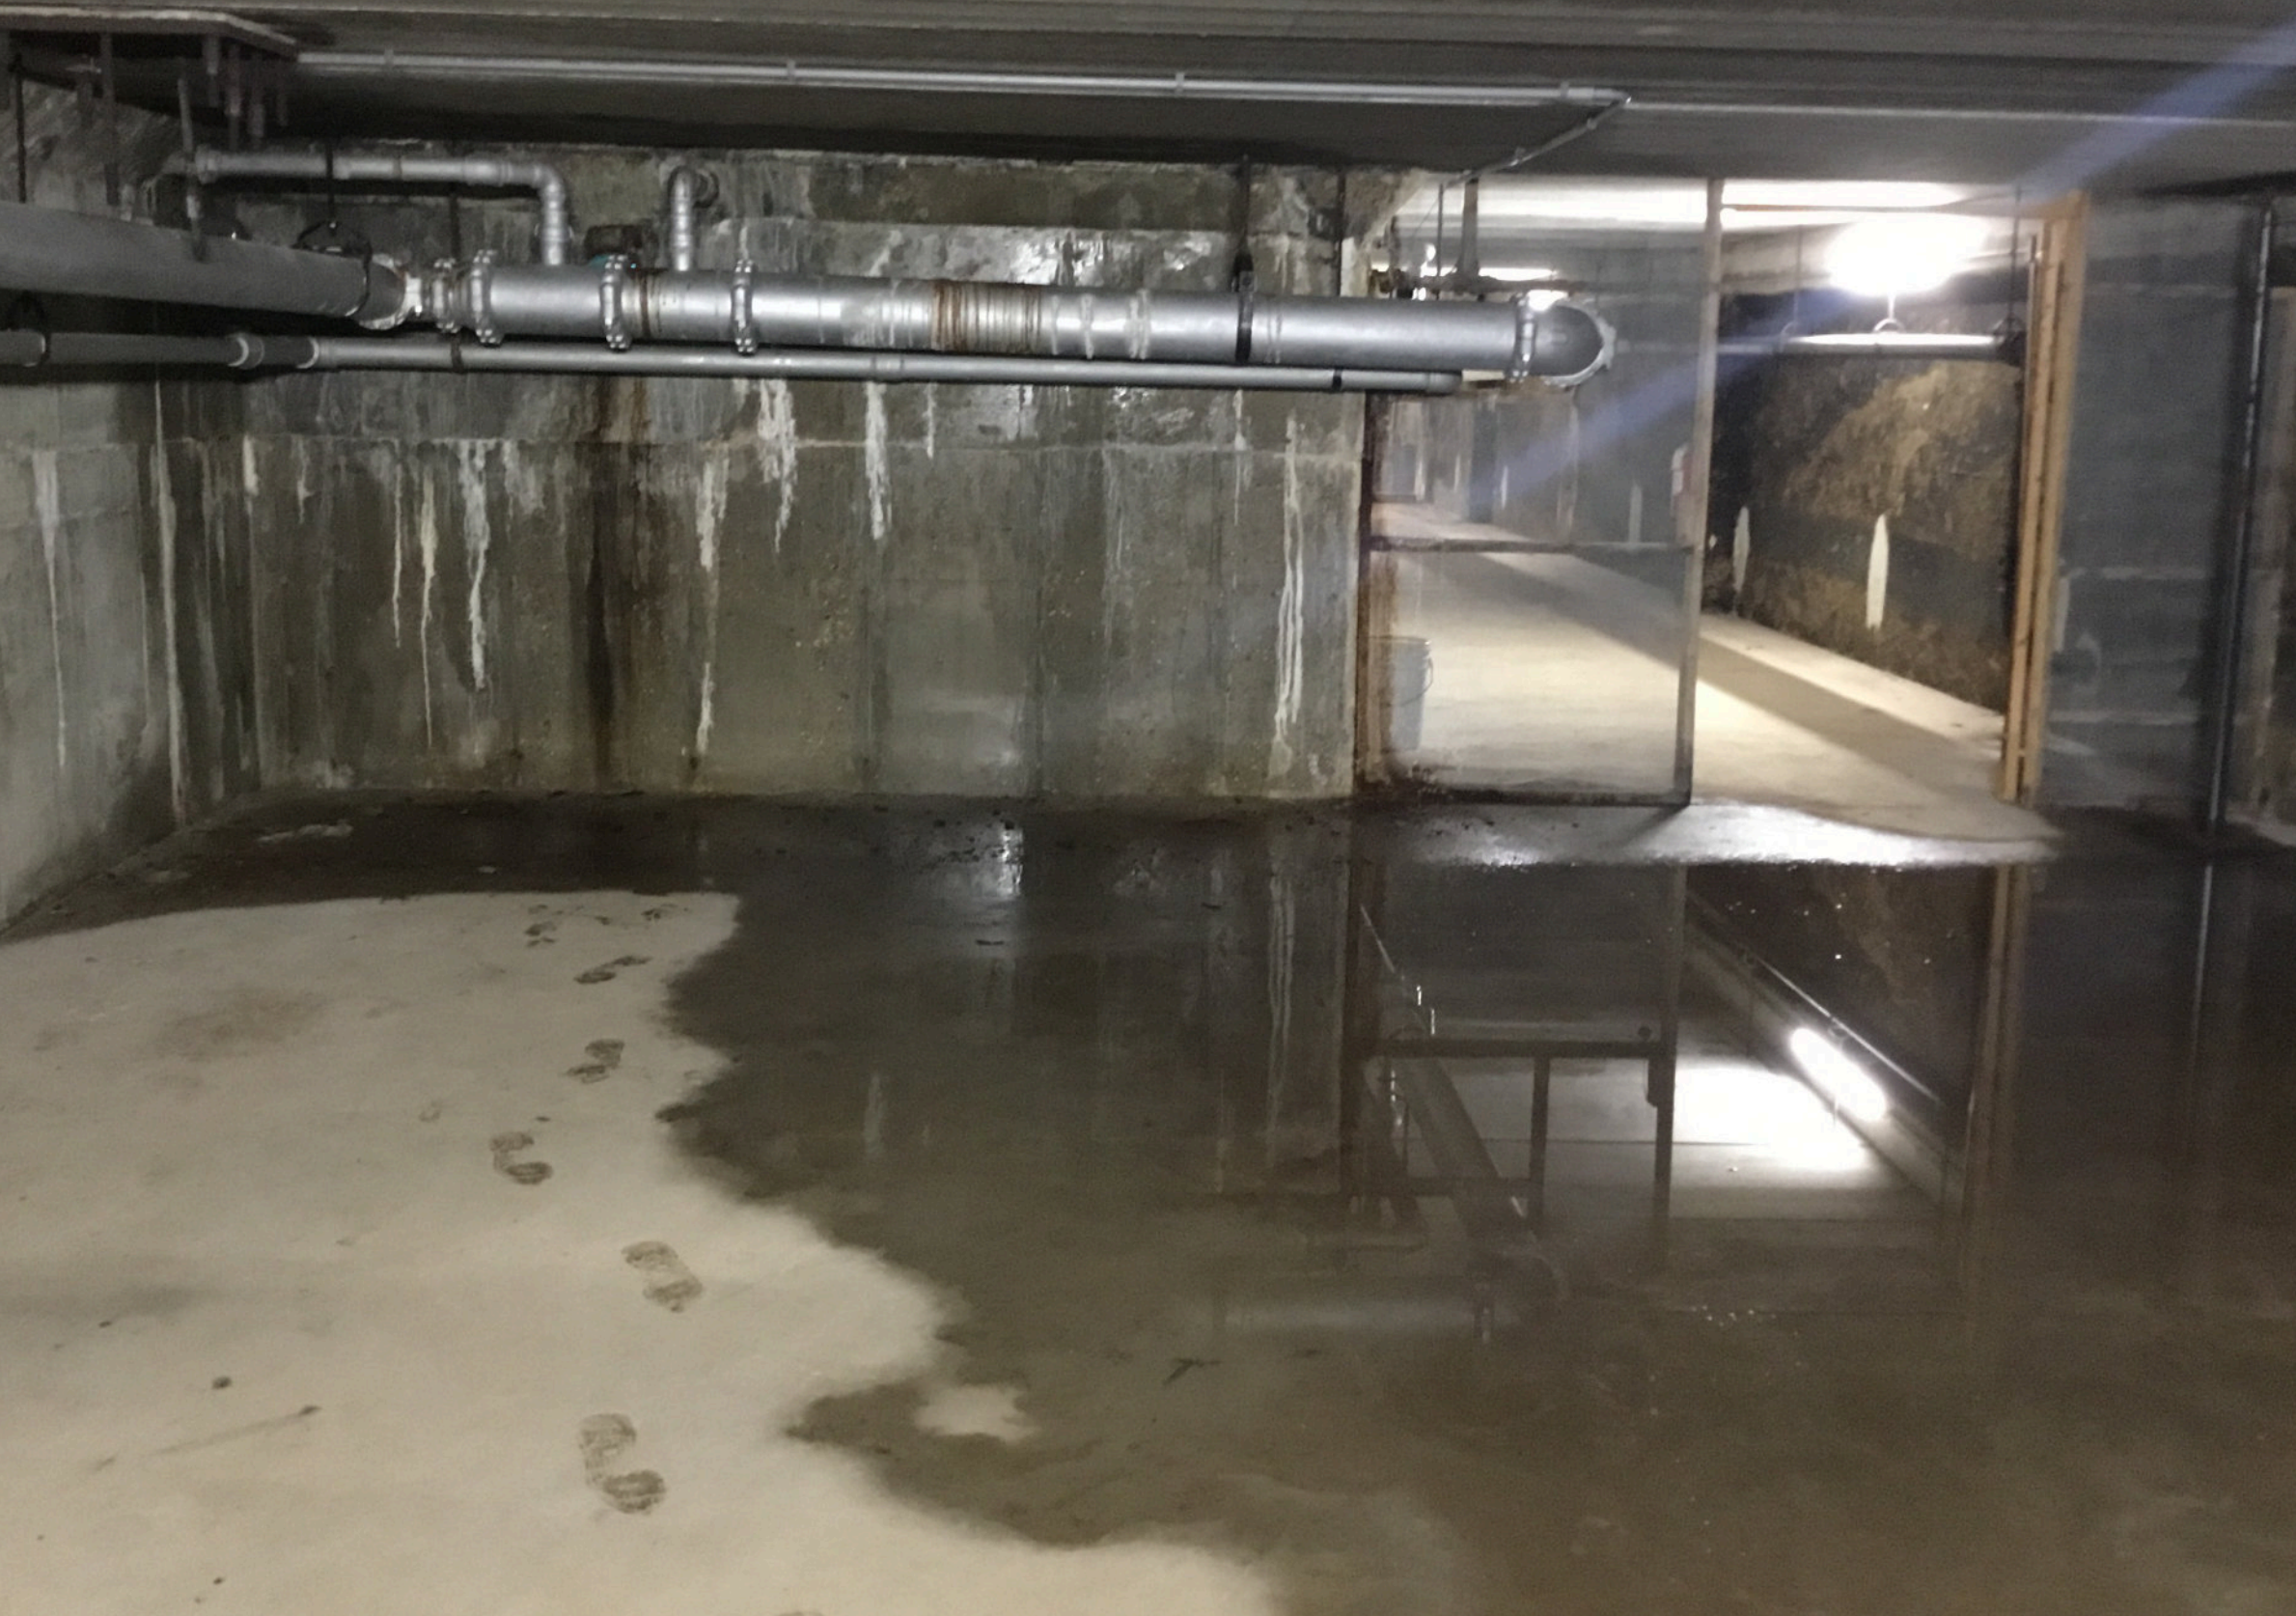
## WORN AND DETERIORATING PE SUPPORT SPACES

MANY OF THE LOCKER ROOMS' FINISHES APPEAR TO BE ORIGINAL TO CONSTRUCTION, AND ARE SHOWING SIGNS OF AGE OR FAILING. MANY OF THE LOCKER ROOM LOCKERS HAVE EXTENSIVE RUSTING.

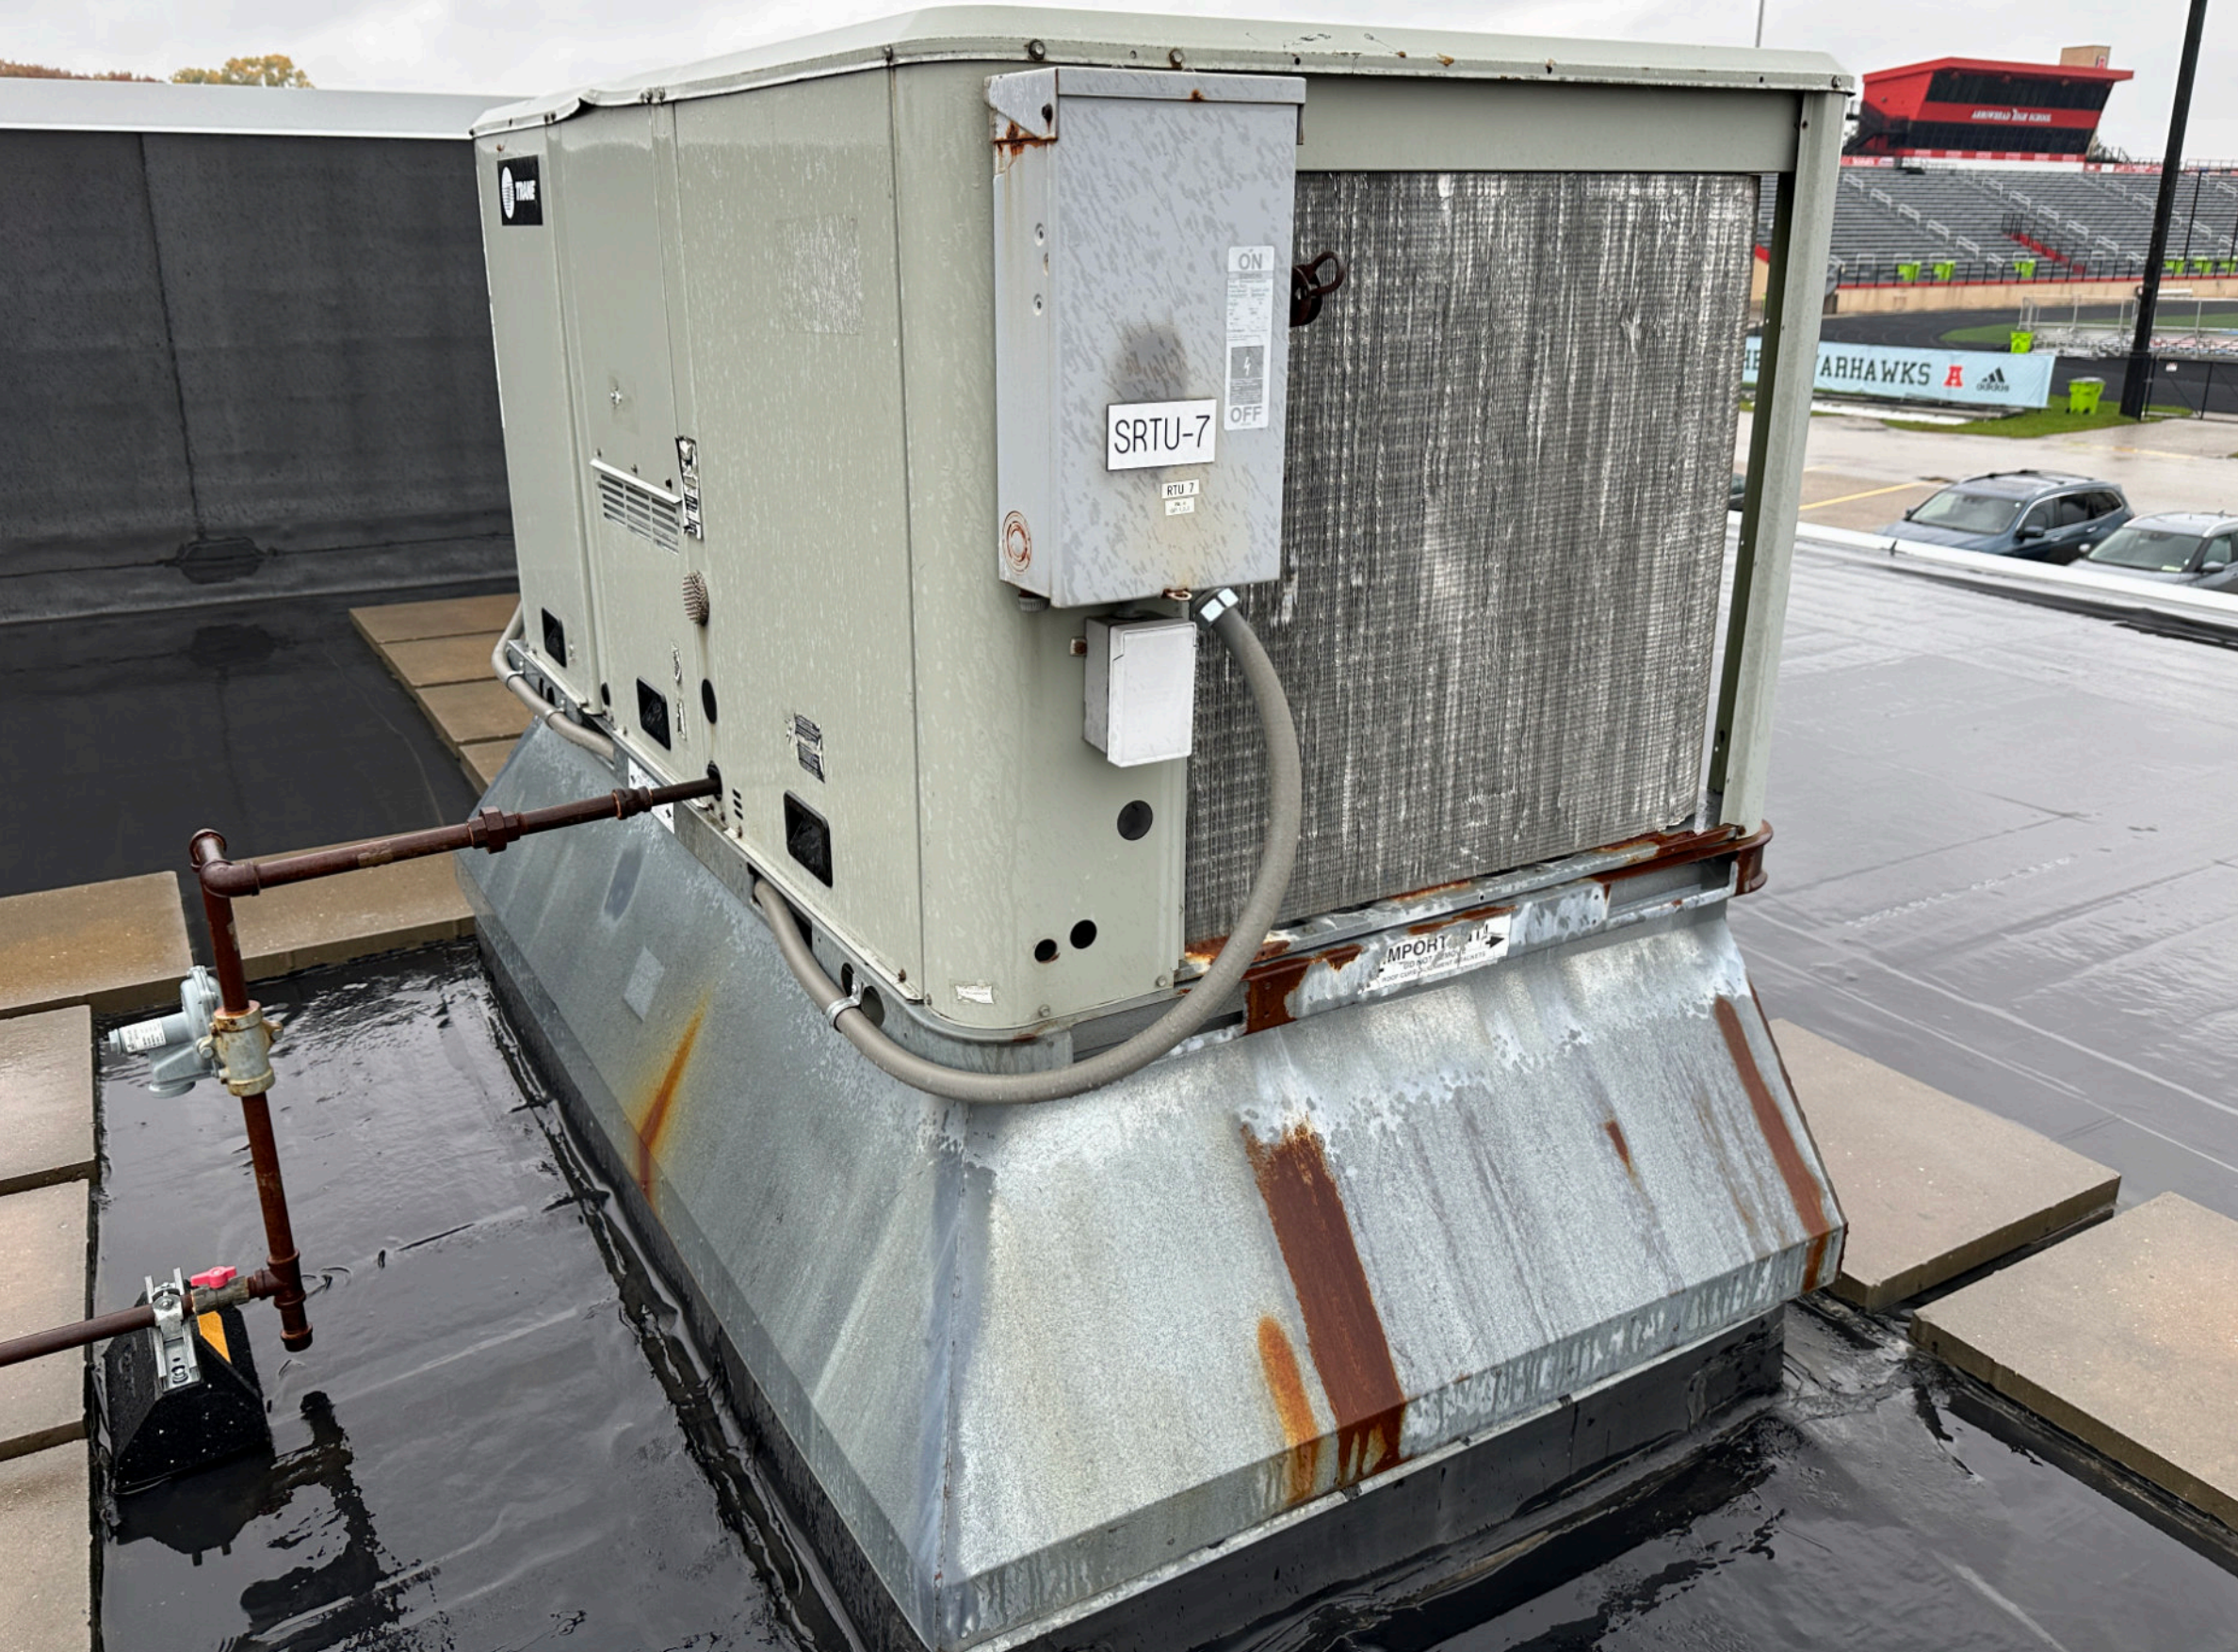
## **AGED ELECTRICAL SYSTEMS**

SOME ELECTRICAL DISTRIBUTION PANEL BOARDS ARE BEYOND THEIR USEFUL LIFE. SOME COMMUNICATIONS SYSTEM COMPONENTS IN THE BUILDING ARE NEARING THE END OF THEIR LIFE EXPECTANCY AND PROVIDE LIMITED FUNCTIONALITY.
