# FACILITIES ASSESSMENT BOARD PRESENTATION

ARROWHEAD UNION HIGH SCHOOL DISTRICT

#323398-01 | 12.13.2023

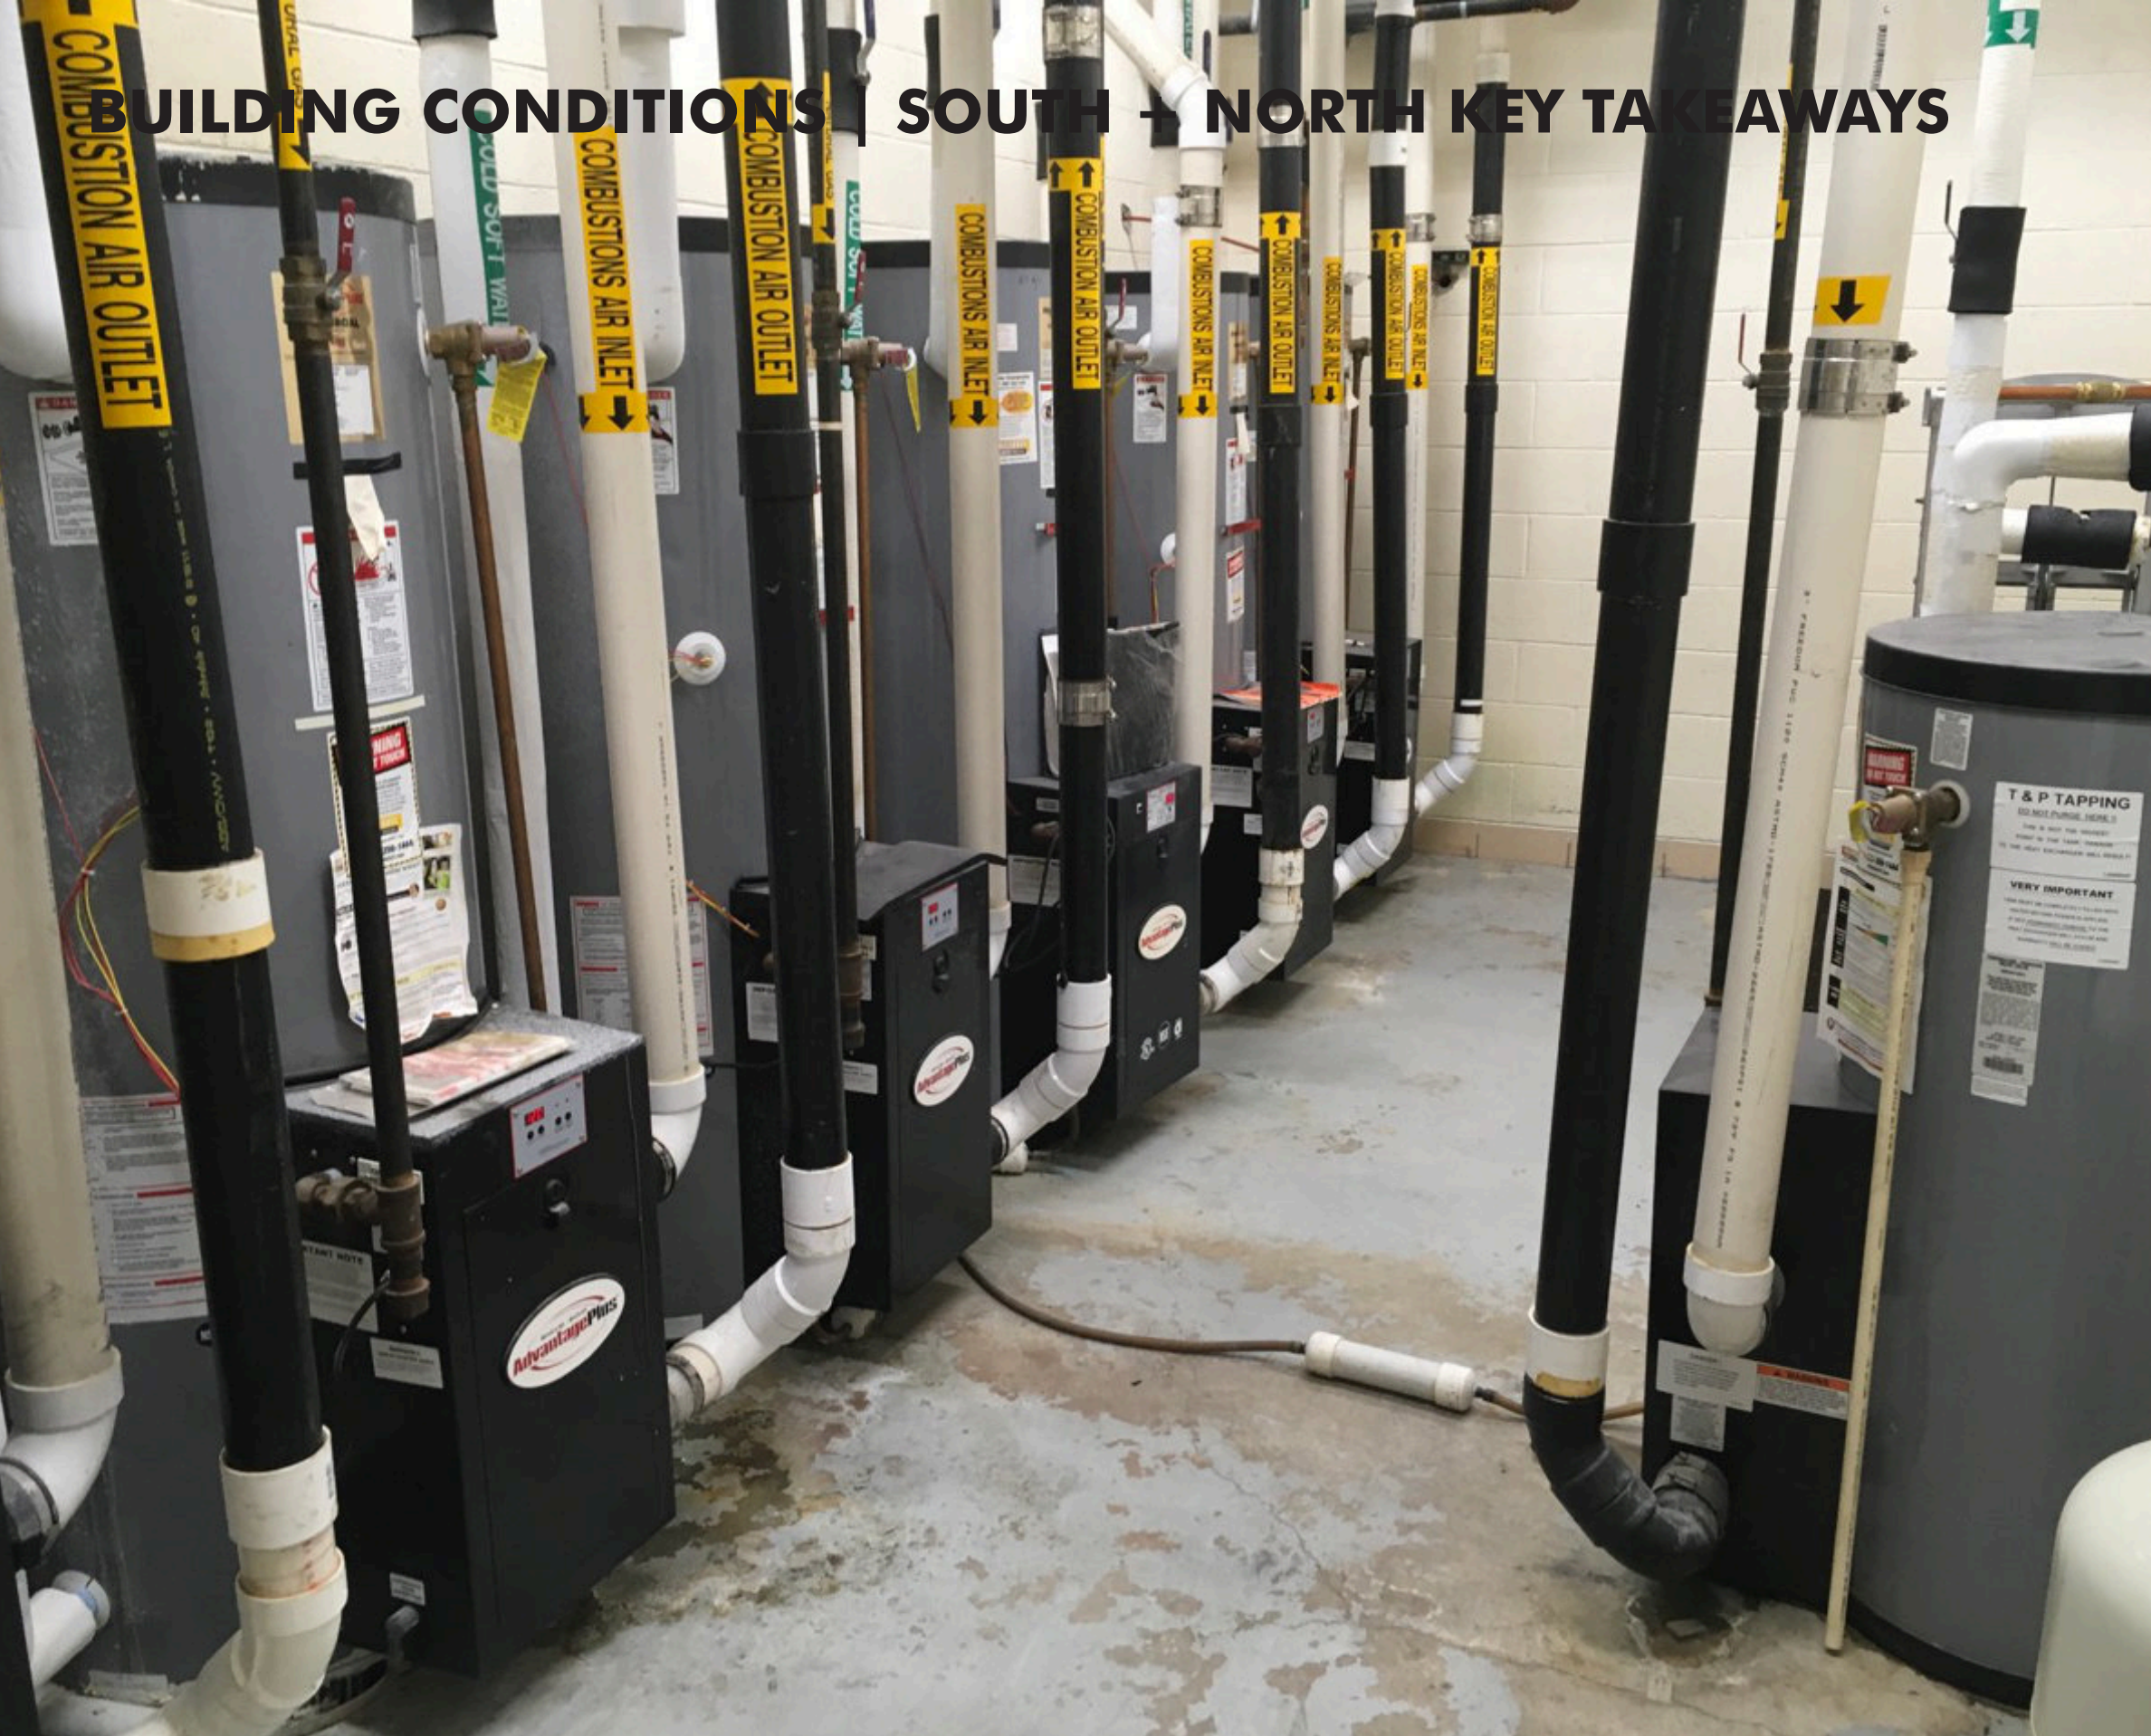
## WATER HEATING INEFFICIENCIES

DECENTRALIZED SYSTEM OF WATER HEATERS IS INEFFICIENT, MOST HEATERS STORE WATER AT LESS THAN RECOMMENDED MINIMUM TEMPERATURE.

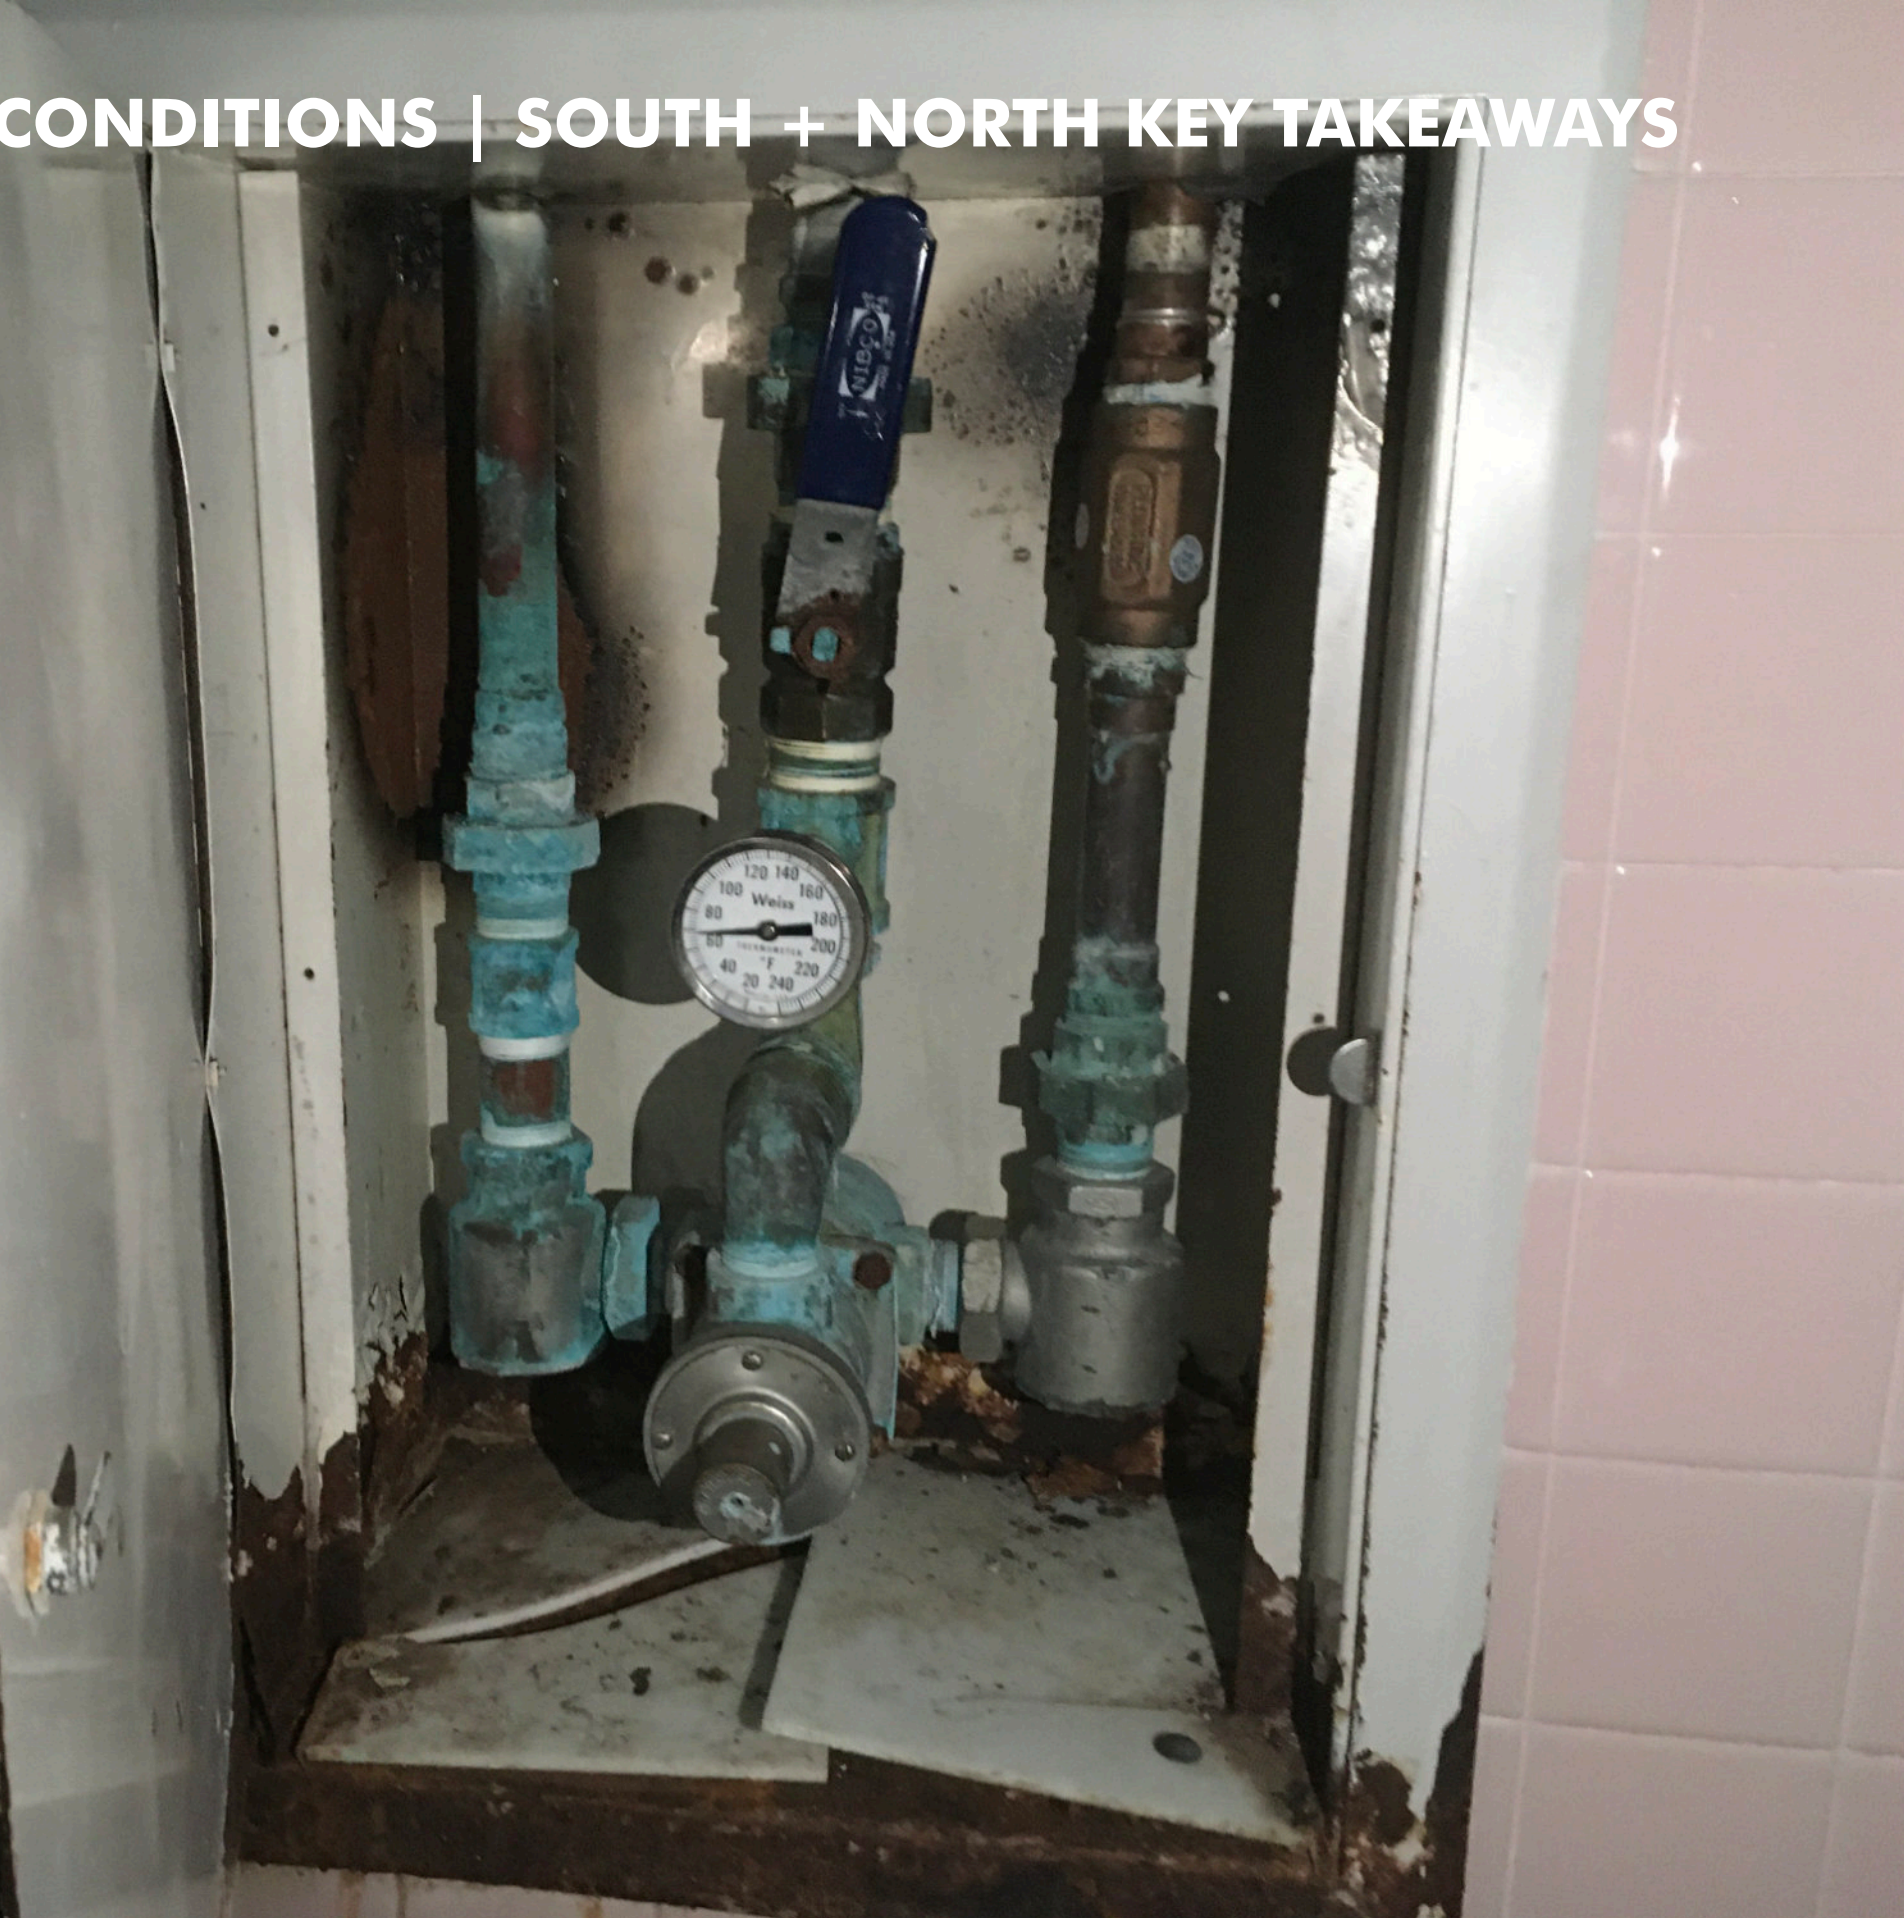
## OLD GALVANIZED PIPING

GALVANIZED PLUMBING PIPING IS BEYOND ITS LIFE EXPECTANCY.

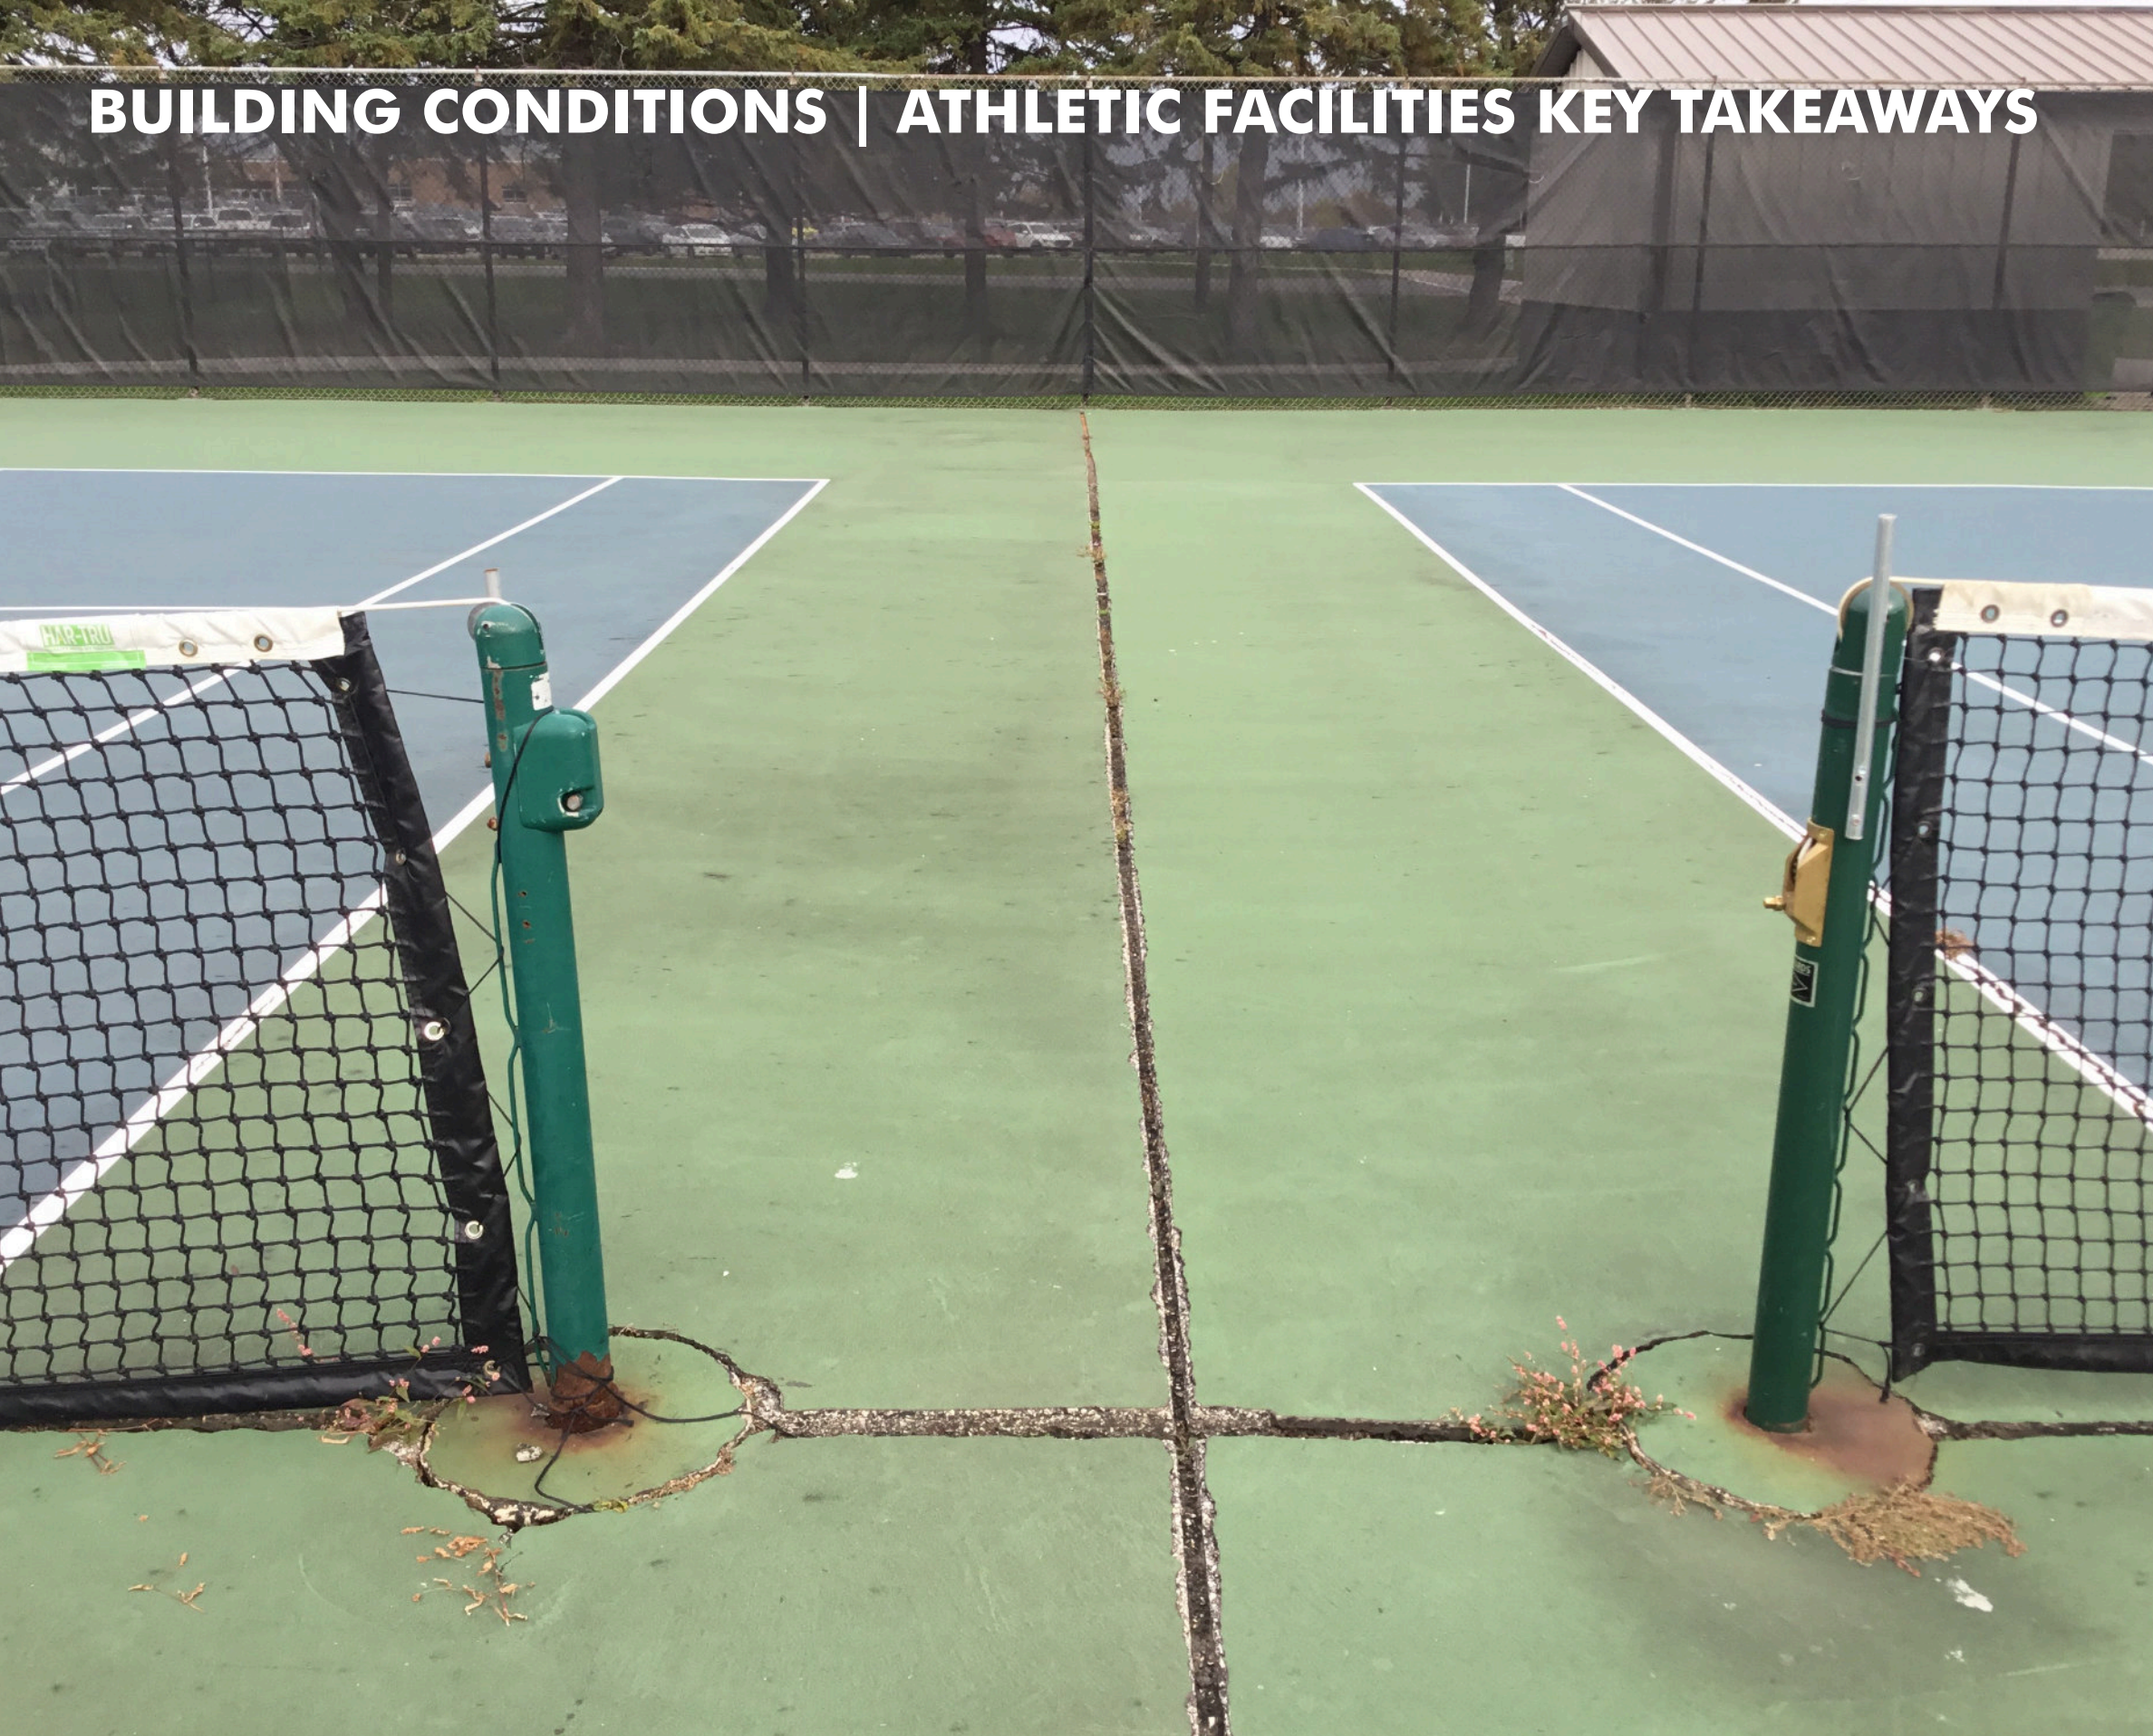
## WORN ATHLETIC SURFACES

MUCH OF THE TENNIS COURT PAVEMENT IS DETERIORATING AND IN POOR CONDITION. SOME WATER PONDING OCCURS ON ASPHALT NEAR THE FOOTBALL FIELD TICKET BOOTHS AFTER RAINFALL.

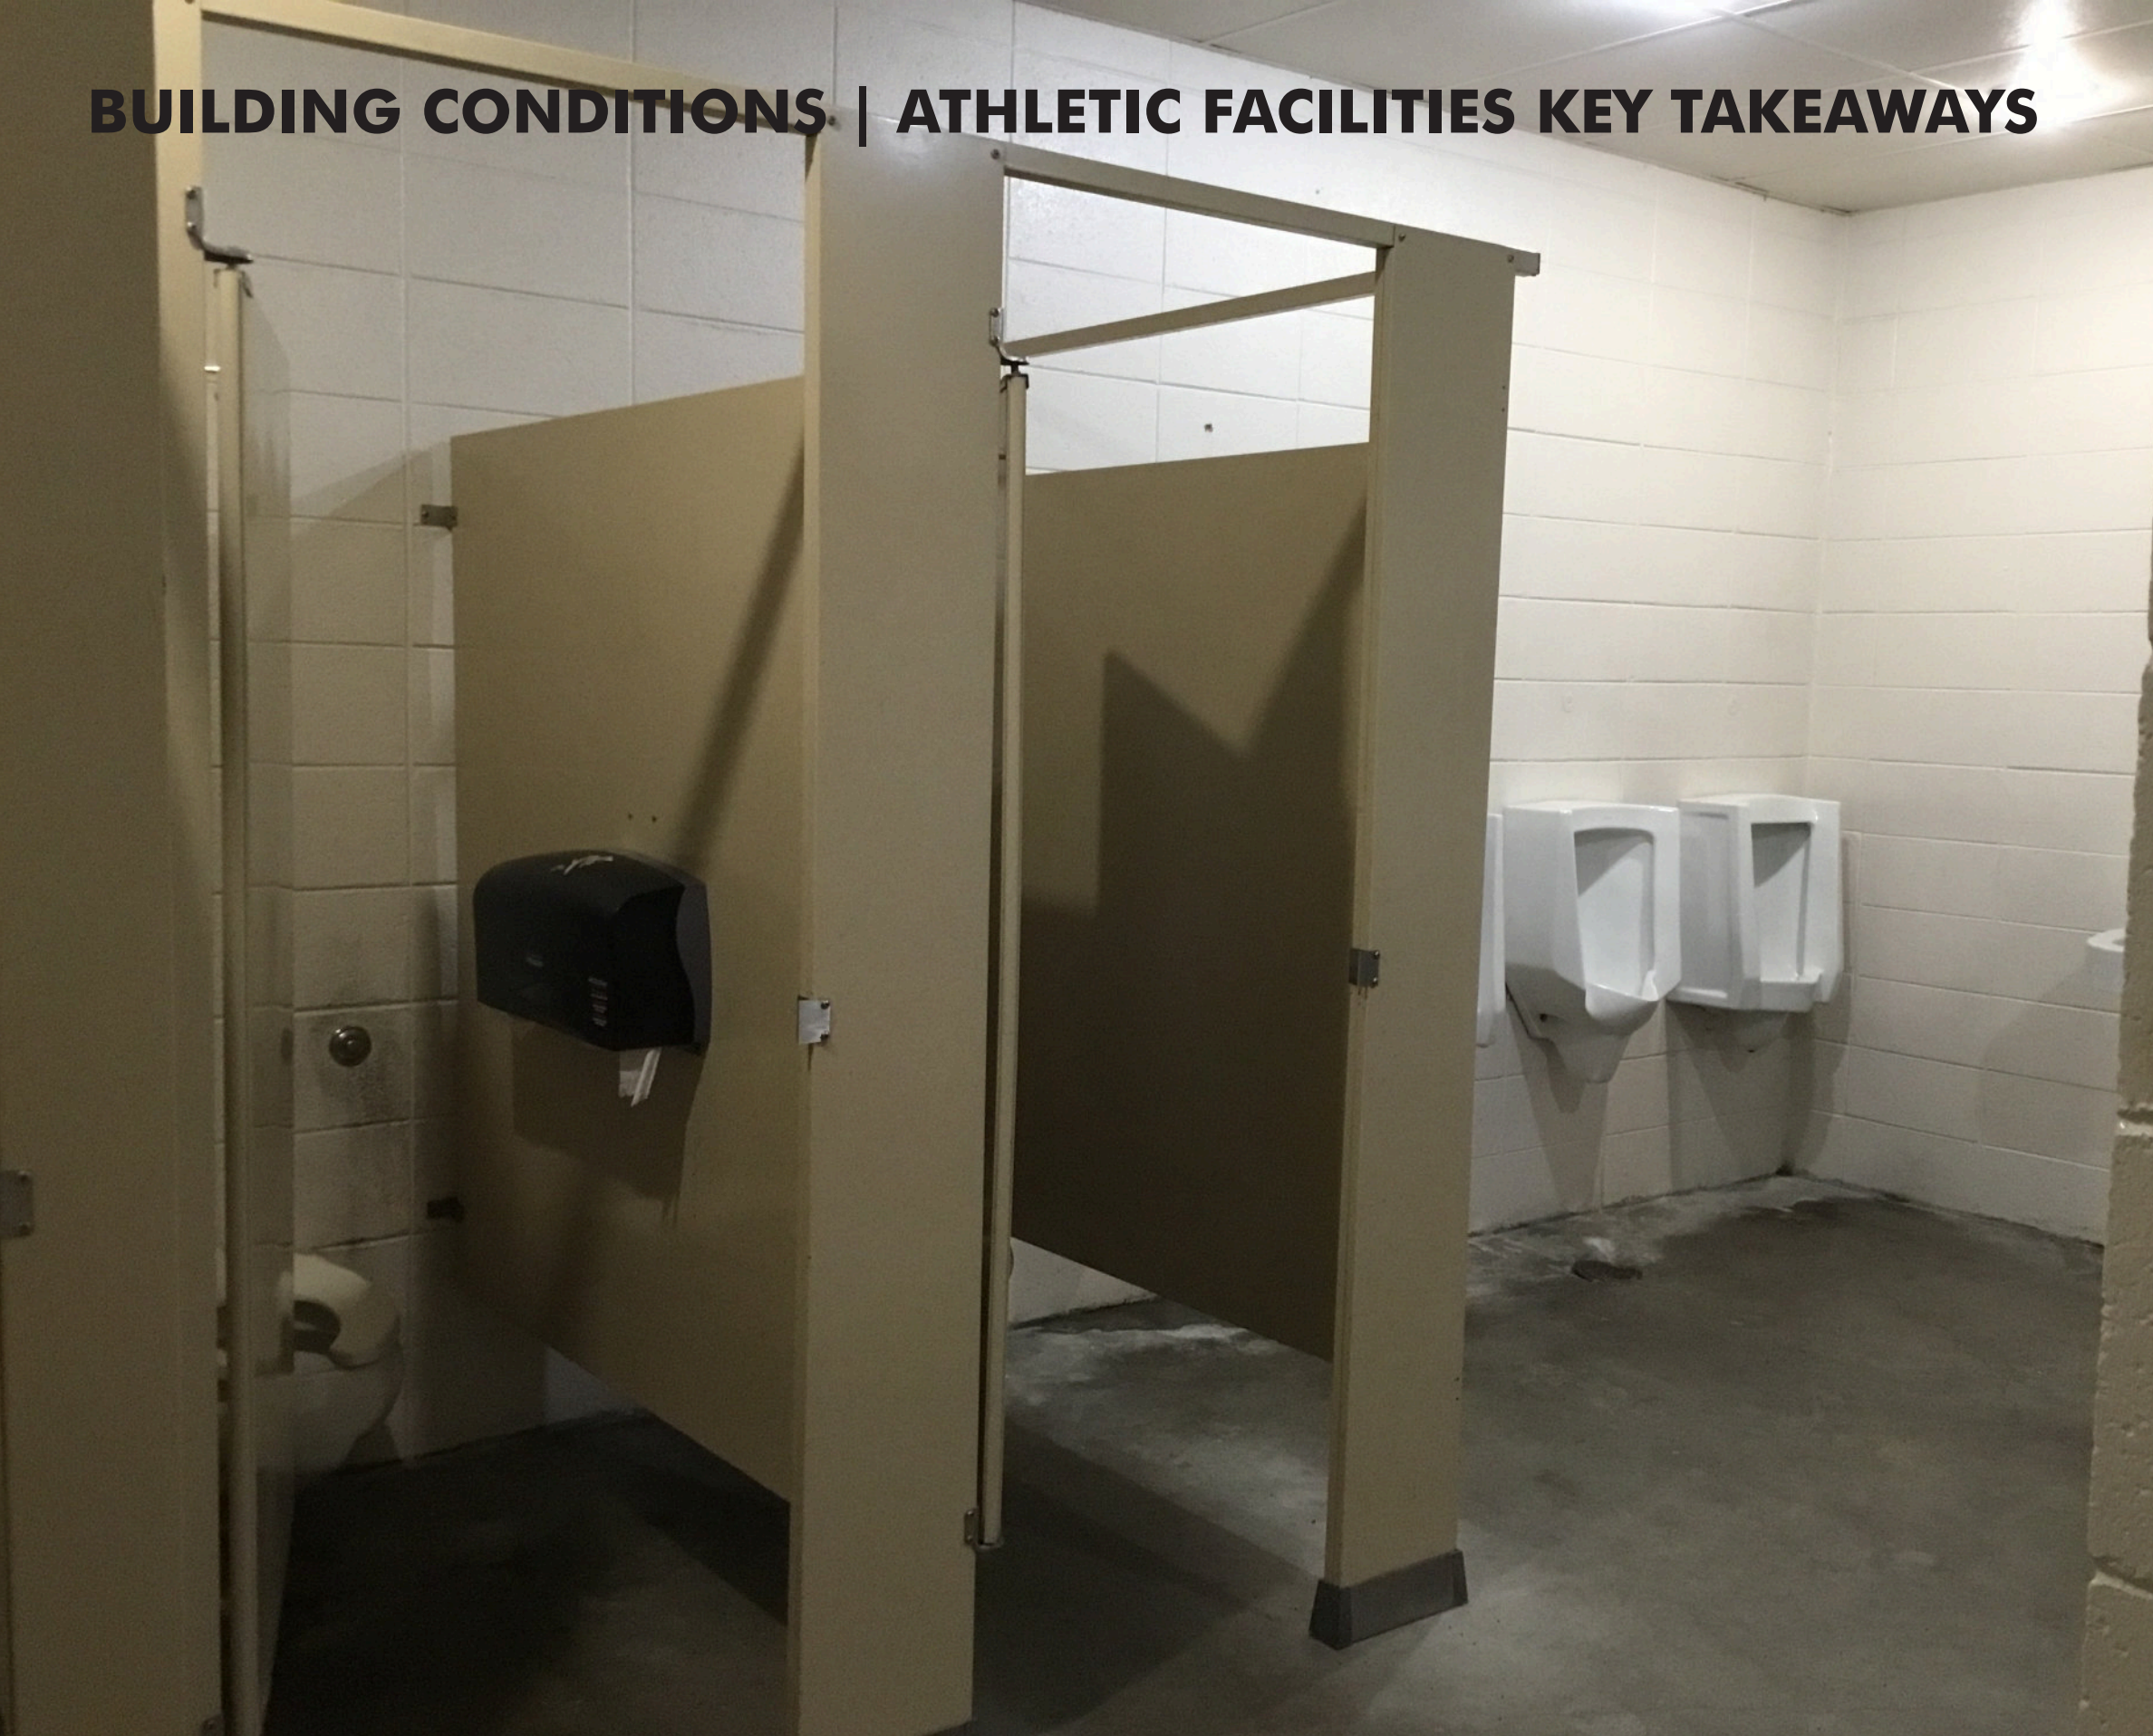
## ADA DEFICIENCIES

AT THE TOILET ROOM BUILDING, A NUMBER OF ADA DEFICIENCIES EXIST, INCLUDING INADEQUATE MANEUVERING CLEARANCES AT DOORS, A LARGE ELEVATION AT DOOR THRESHOLDS, AND LACK OF ACCESSIBLE TOILET STALLS. THE BLEACHERS AND PRESS BOX AT THE SOCCER STADIUM ARE ONLY REACHABLE BY STAIRS.

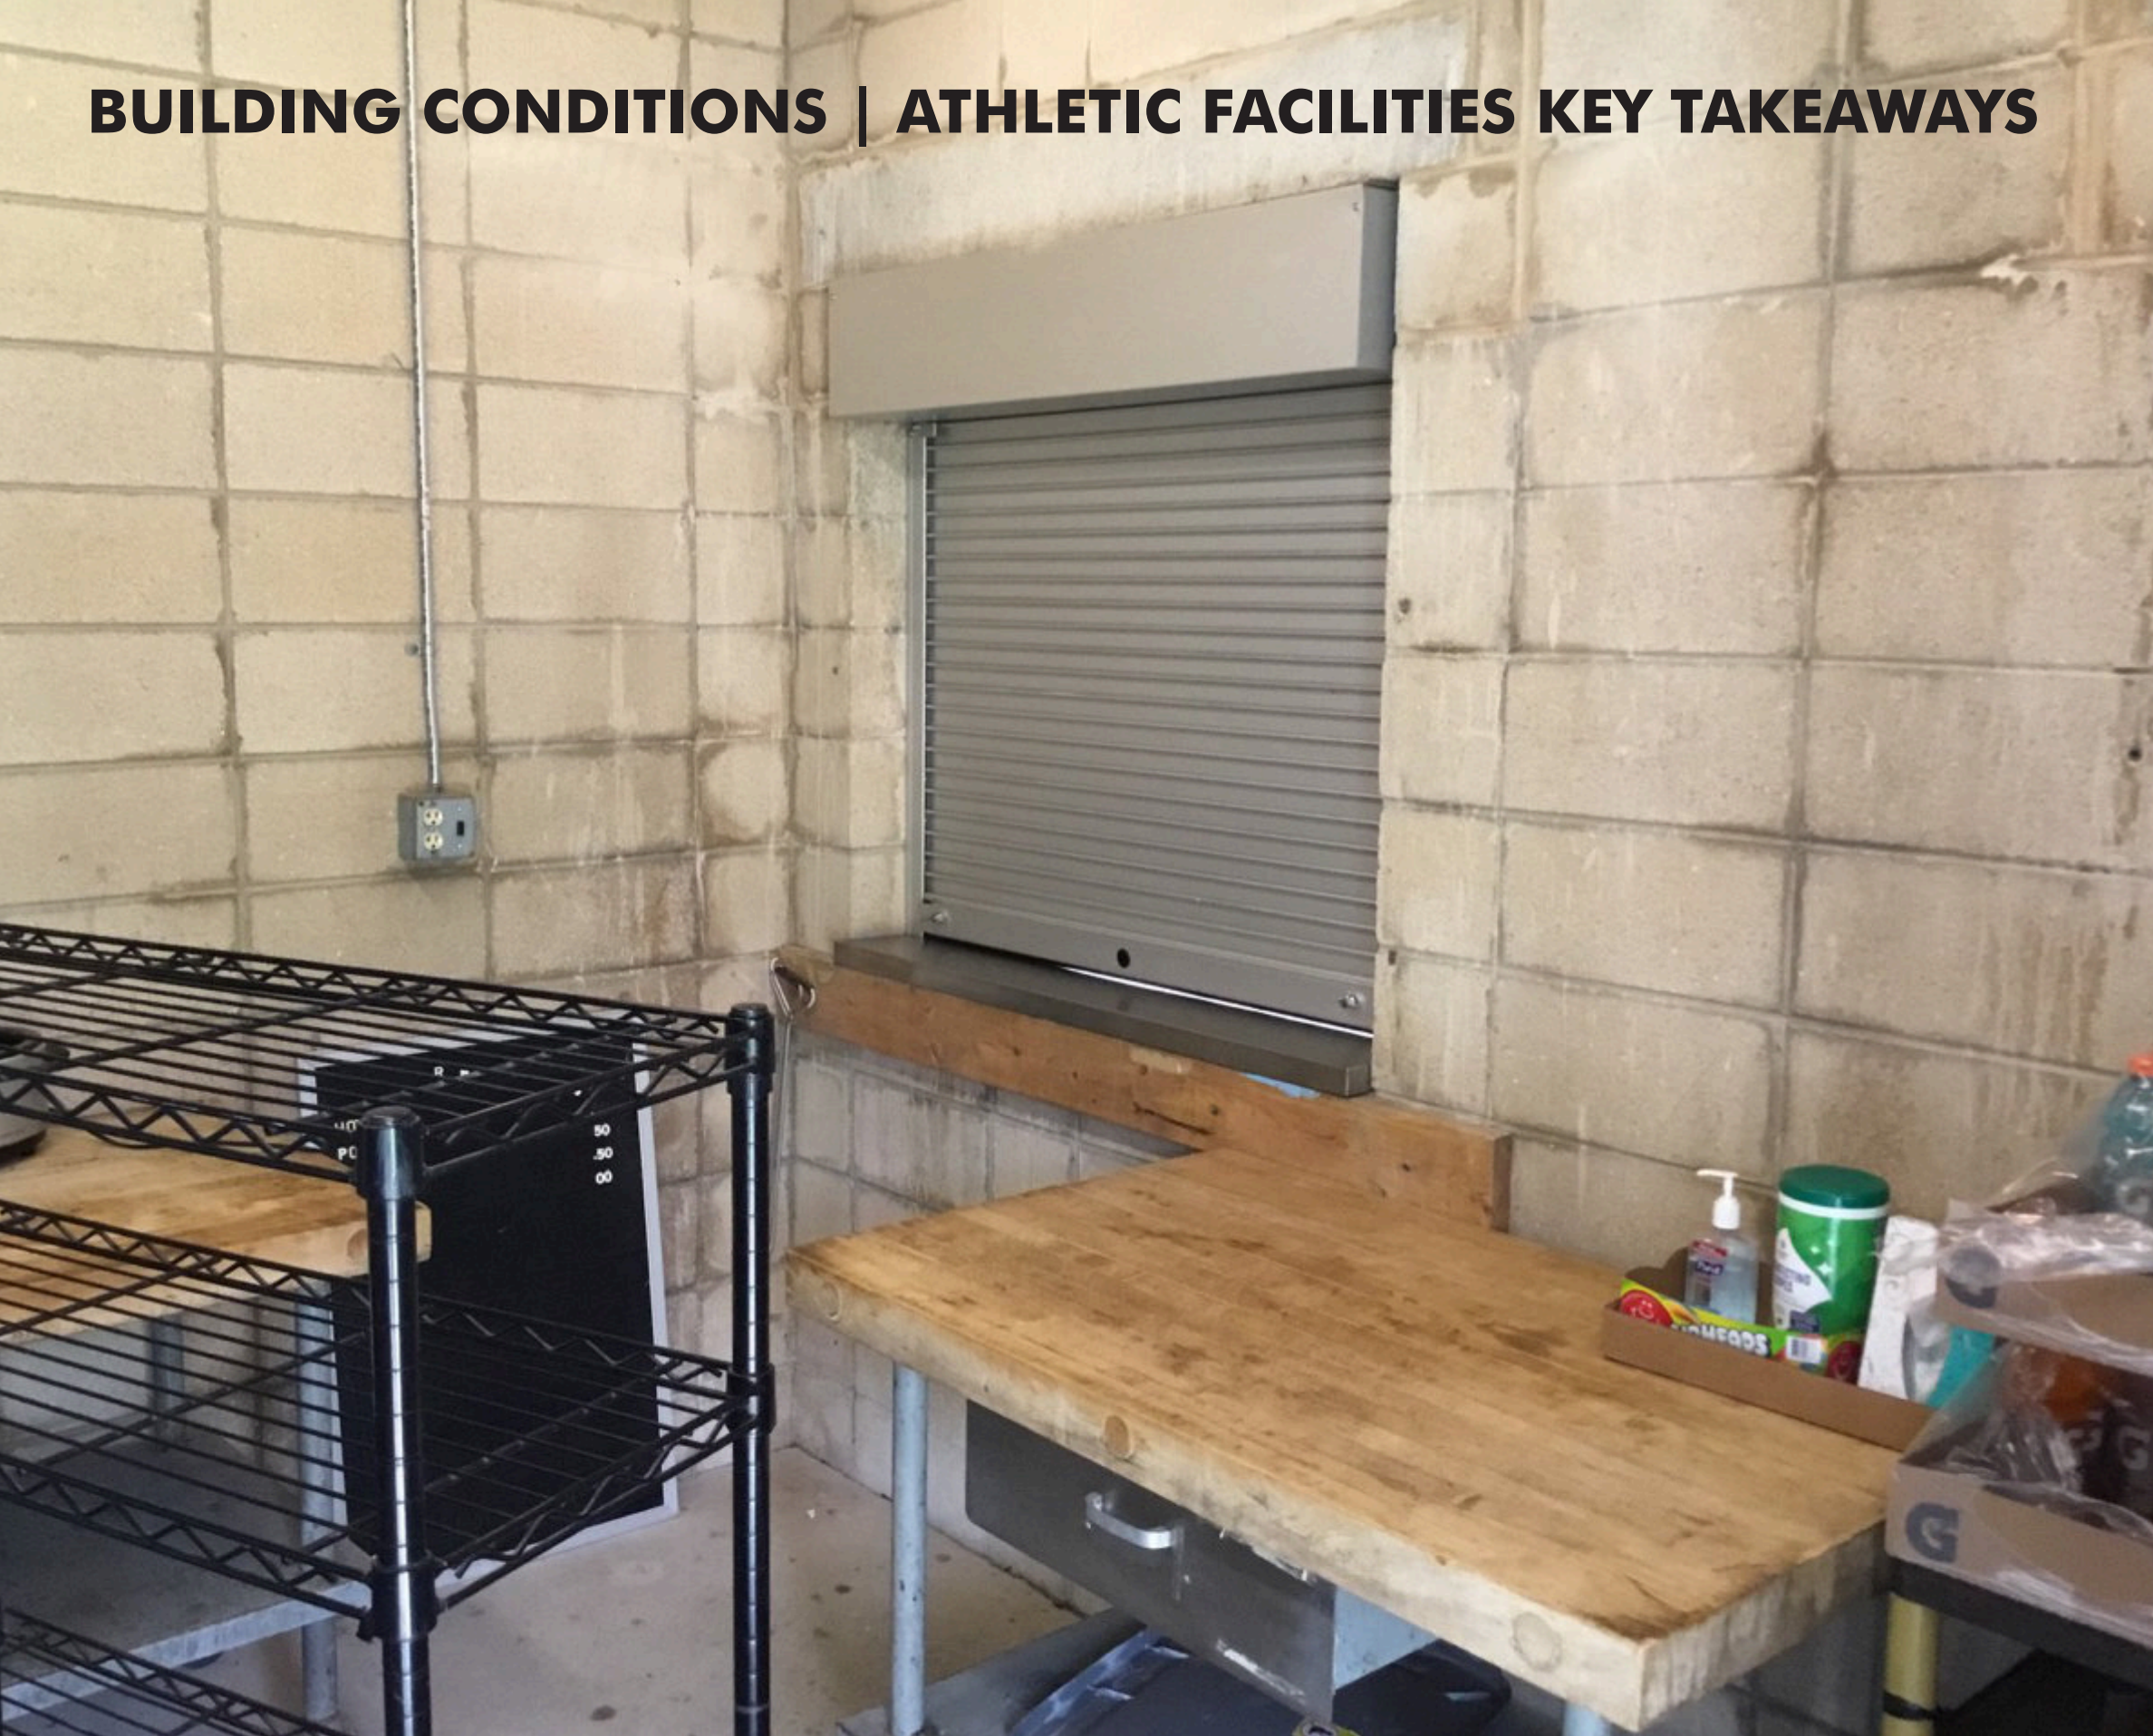
## WORN ATHLETIC FACILITY CONDITIONS

THE TOILET ROOM BUILDING AND CONCESSIONS BUILDINGS ARE SHOWING SOME SIGNS OF AGE, WITH SOME ITEMS LIKE COUNTER TOPS AND TOILET PARTITIONS NEARING THE END OF THEIR EXPECTED LIFE.

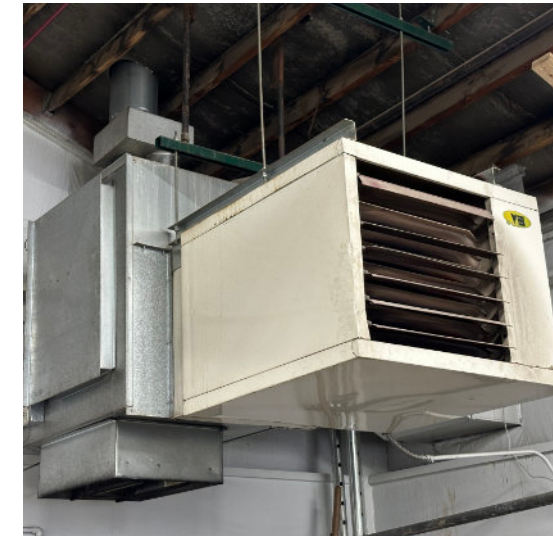
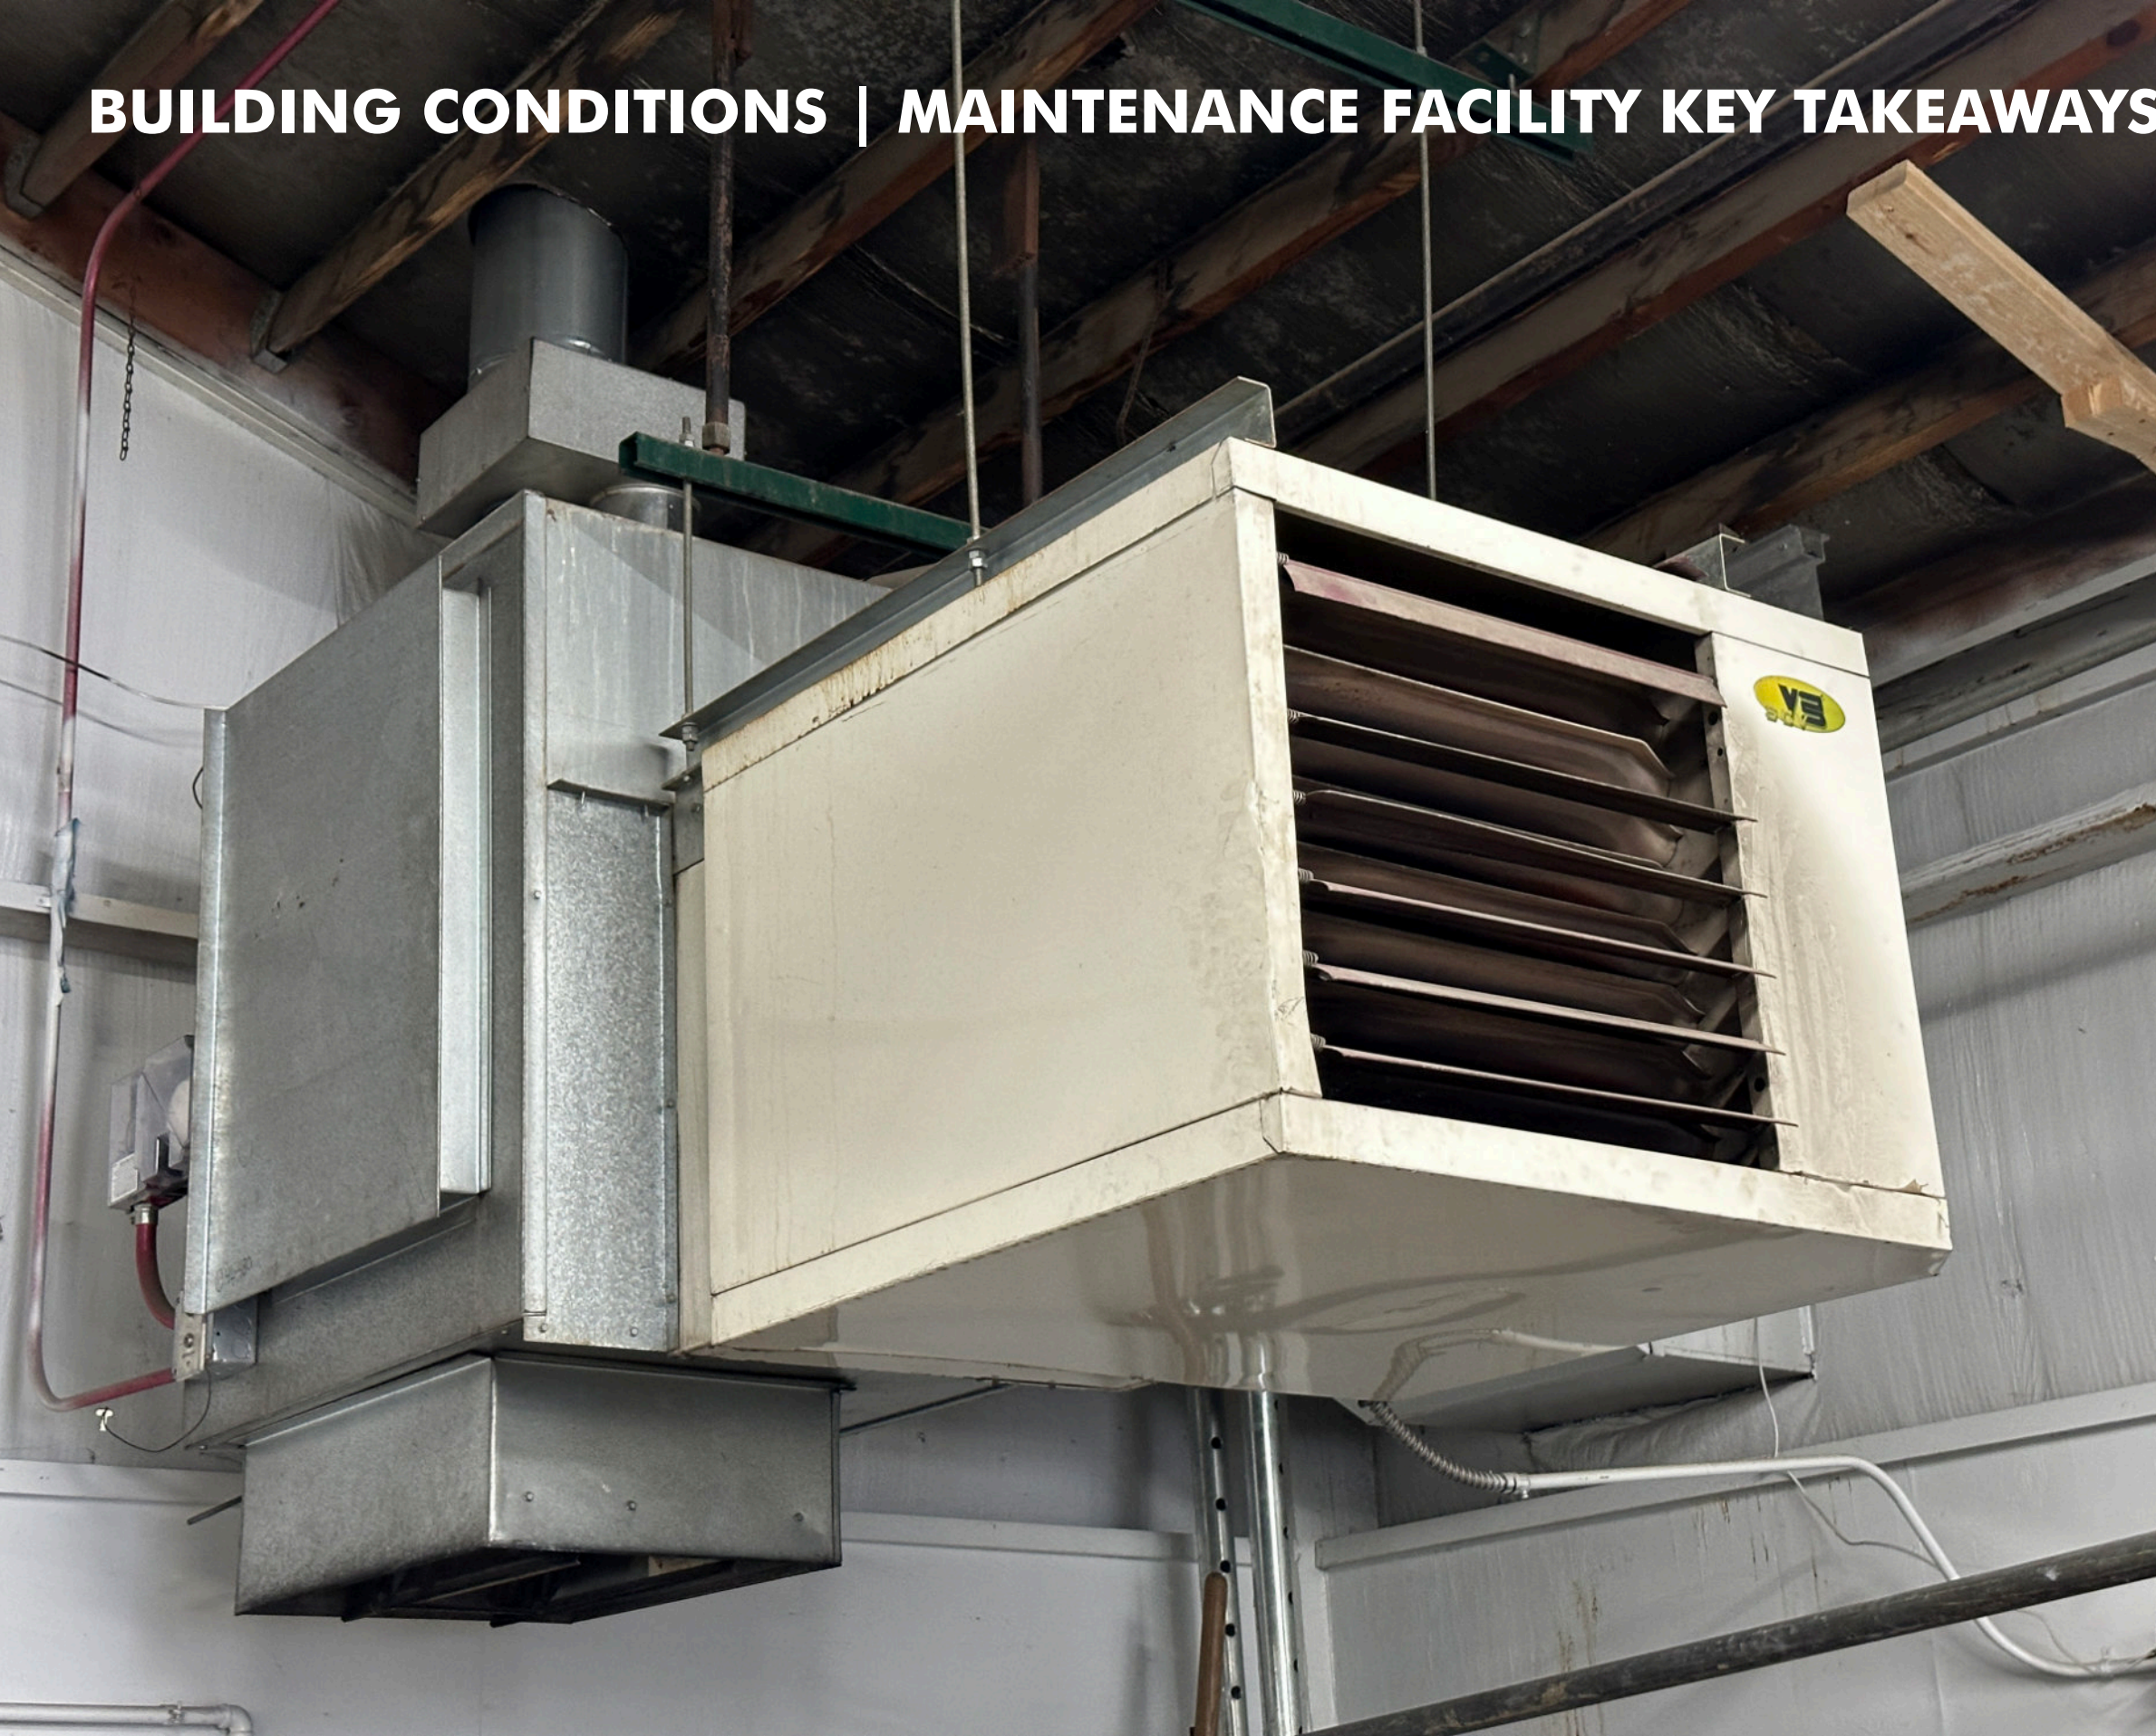
## AGED HVAC EQUIPMENT

MECHANICAL EQUIPMENT HAS EXCEEDED ITS LIFE EXPECTANCY, AND THE SERVICE AREAS ARE NOT PROPERLY VENTILATED.
