# FACILITIES ASSESSMENT BOARD PRESENTATION

ARROWHEAD UNION HIGH SCHOOL DISTRICT

#323398-01 | 12.13.2023

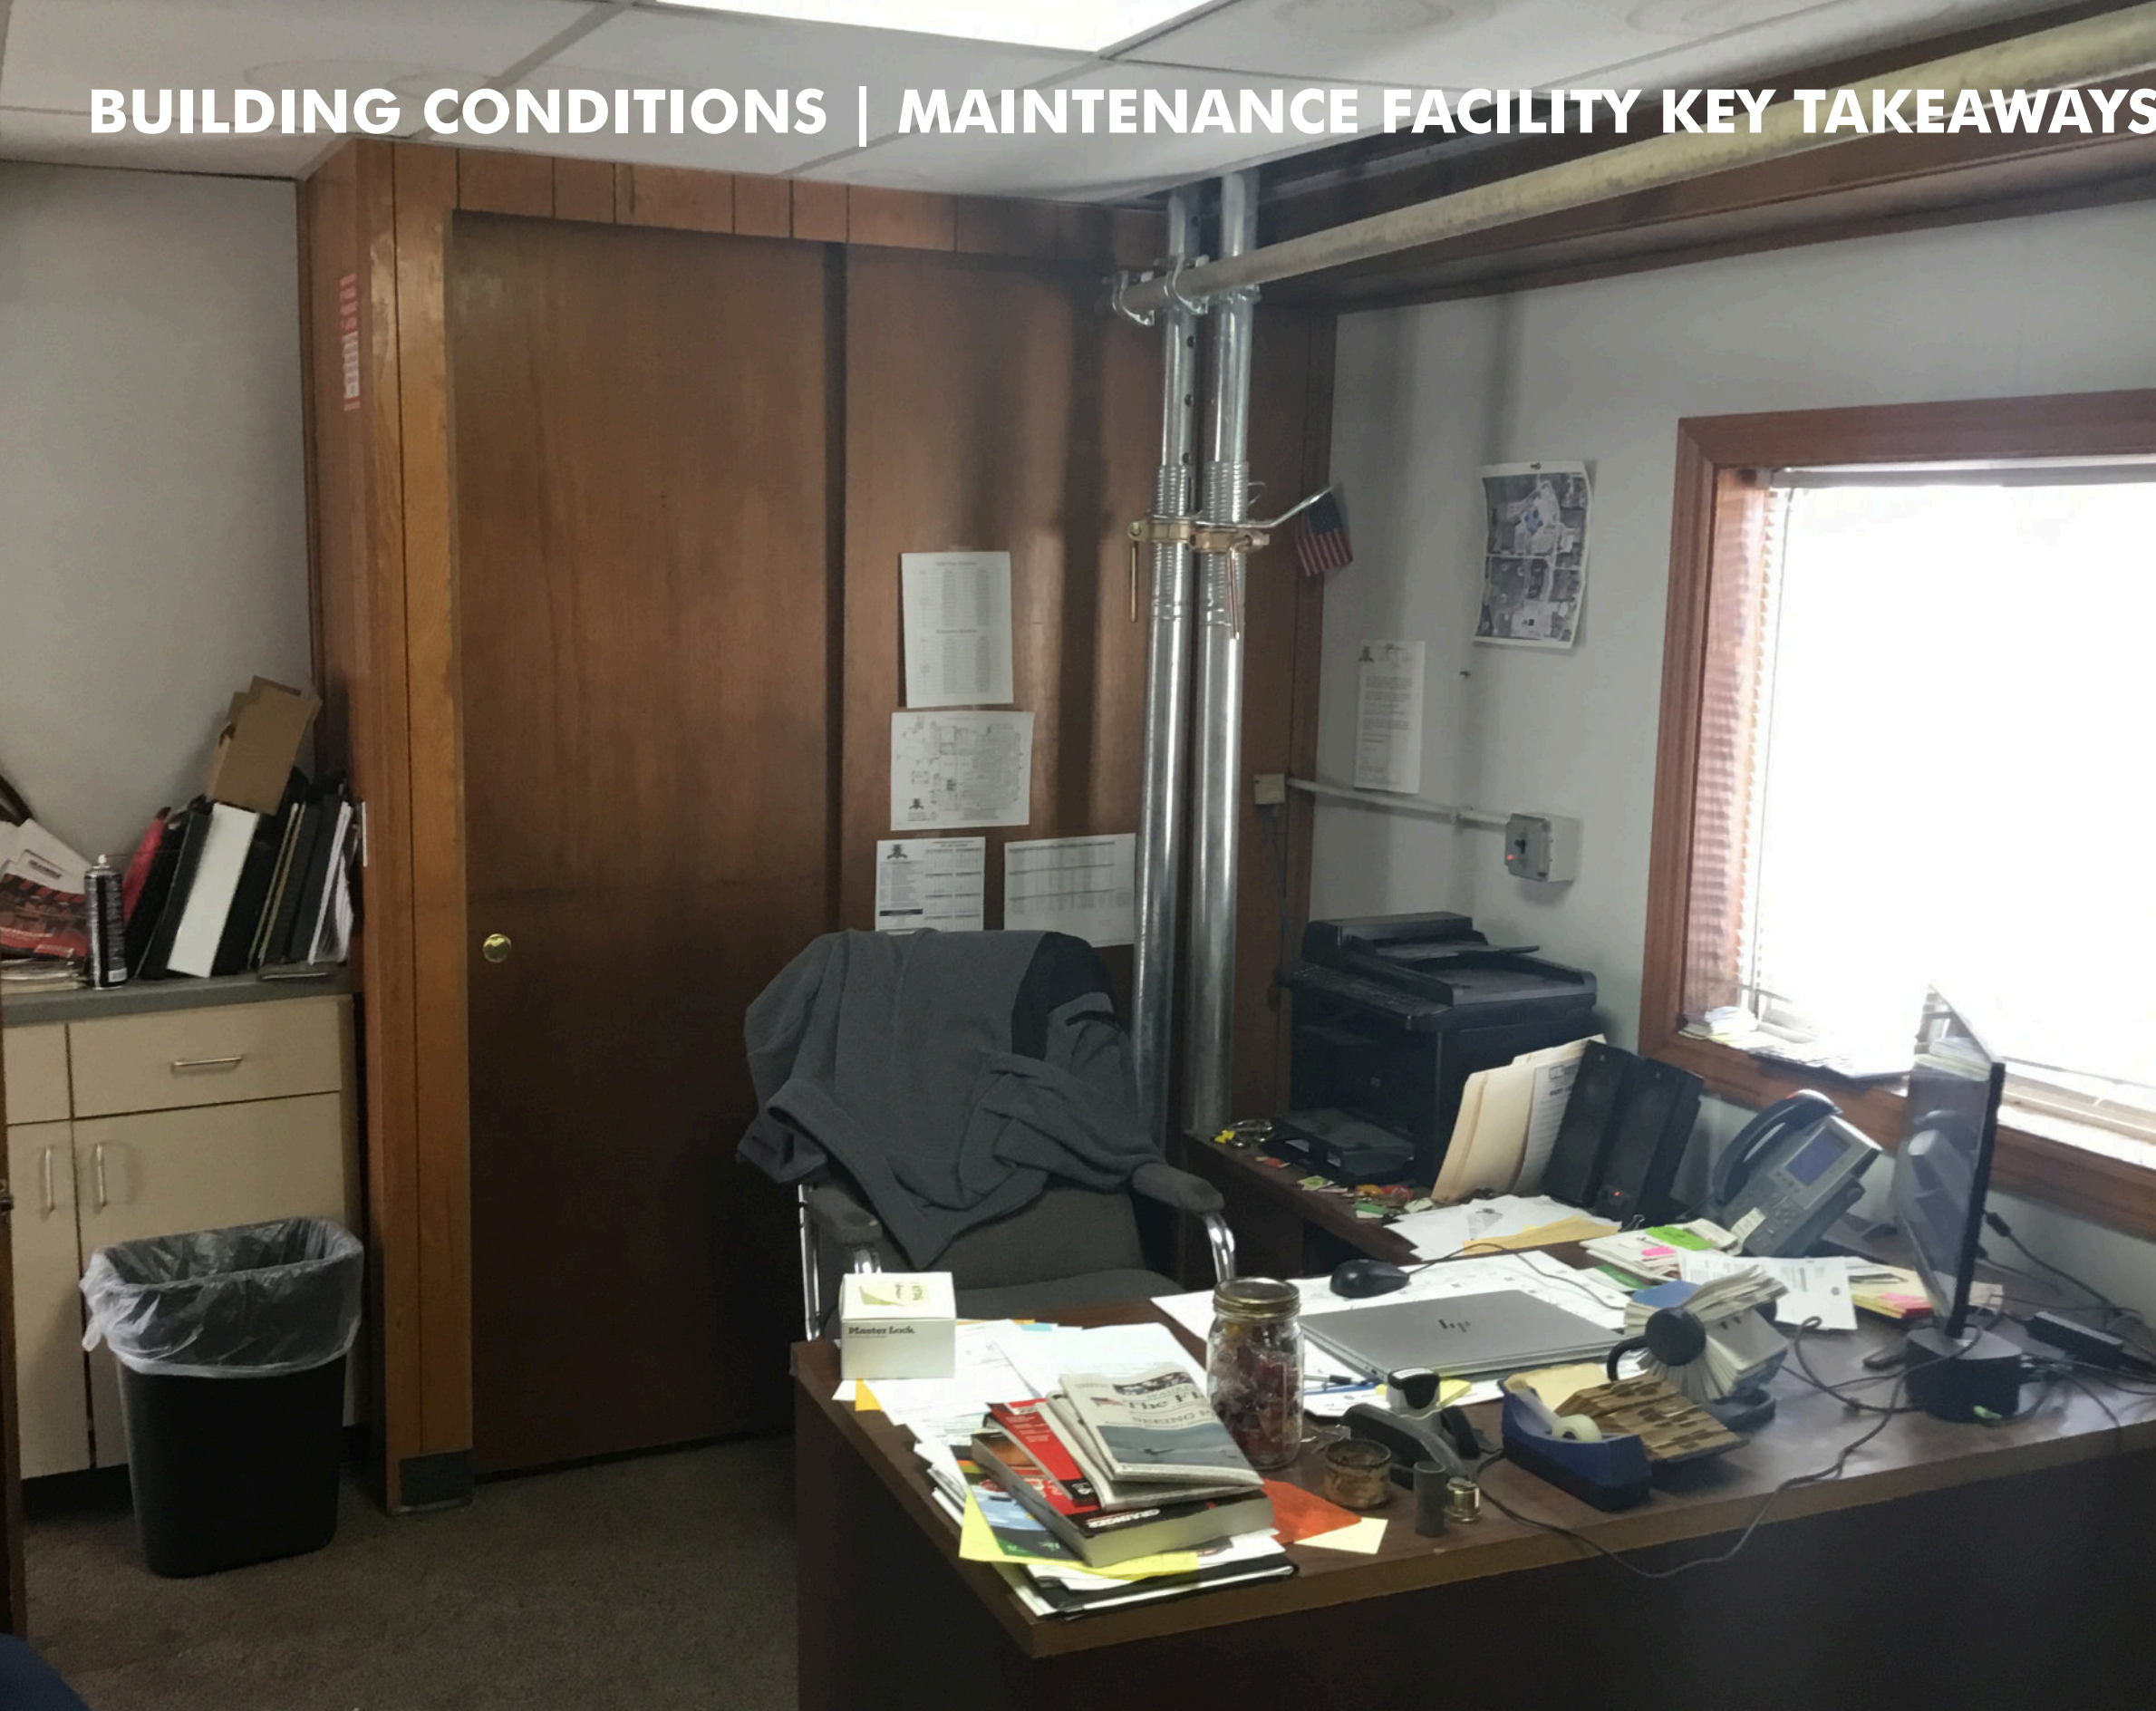
## STRUCTURAL DETERIORATION

SOME OF THE WOOD STRUCTURAL ELEMENTS ARE DETERIORATED. TEMPORARY STRUCTURAL SHORING HAS BEEN INSTALLED AT COLUMNS AS A SHORT-TERM MEASURE TO AVOID THE POSSIBILITY OF STRUCTURAL FAILURE.

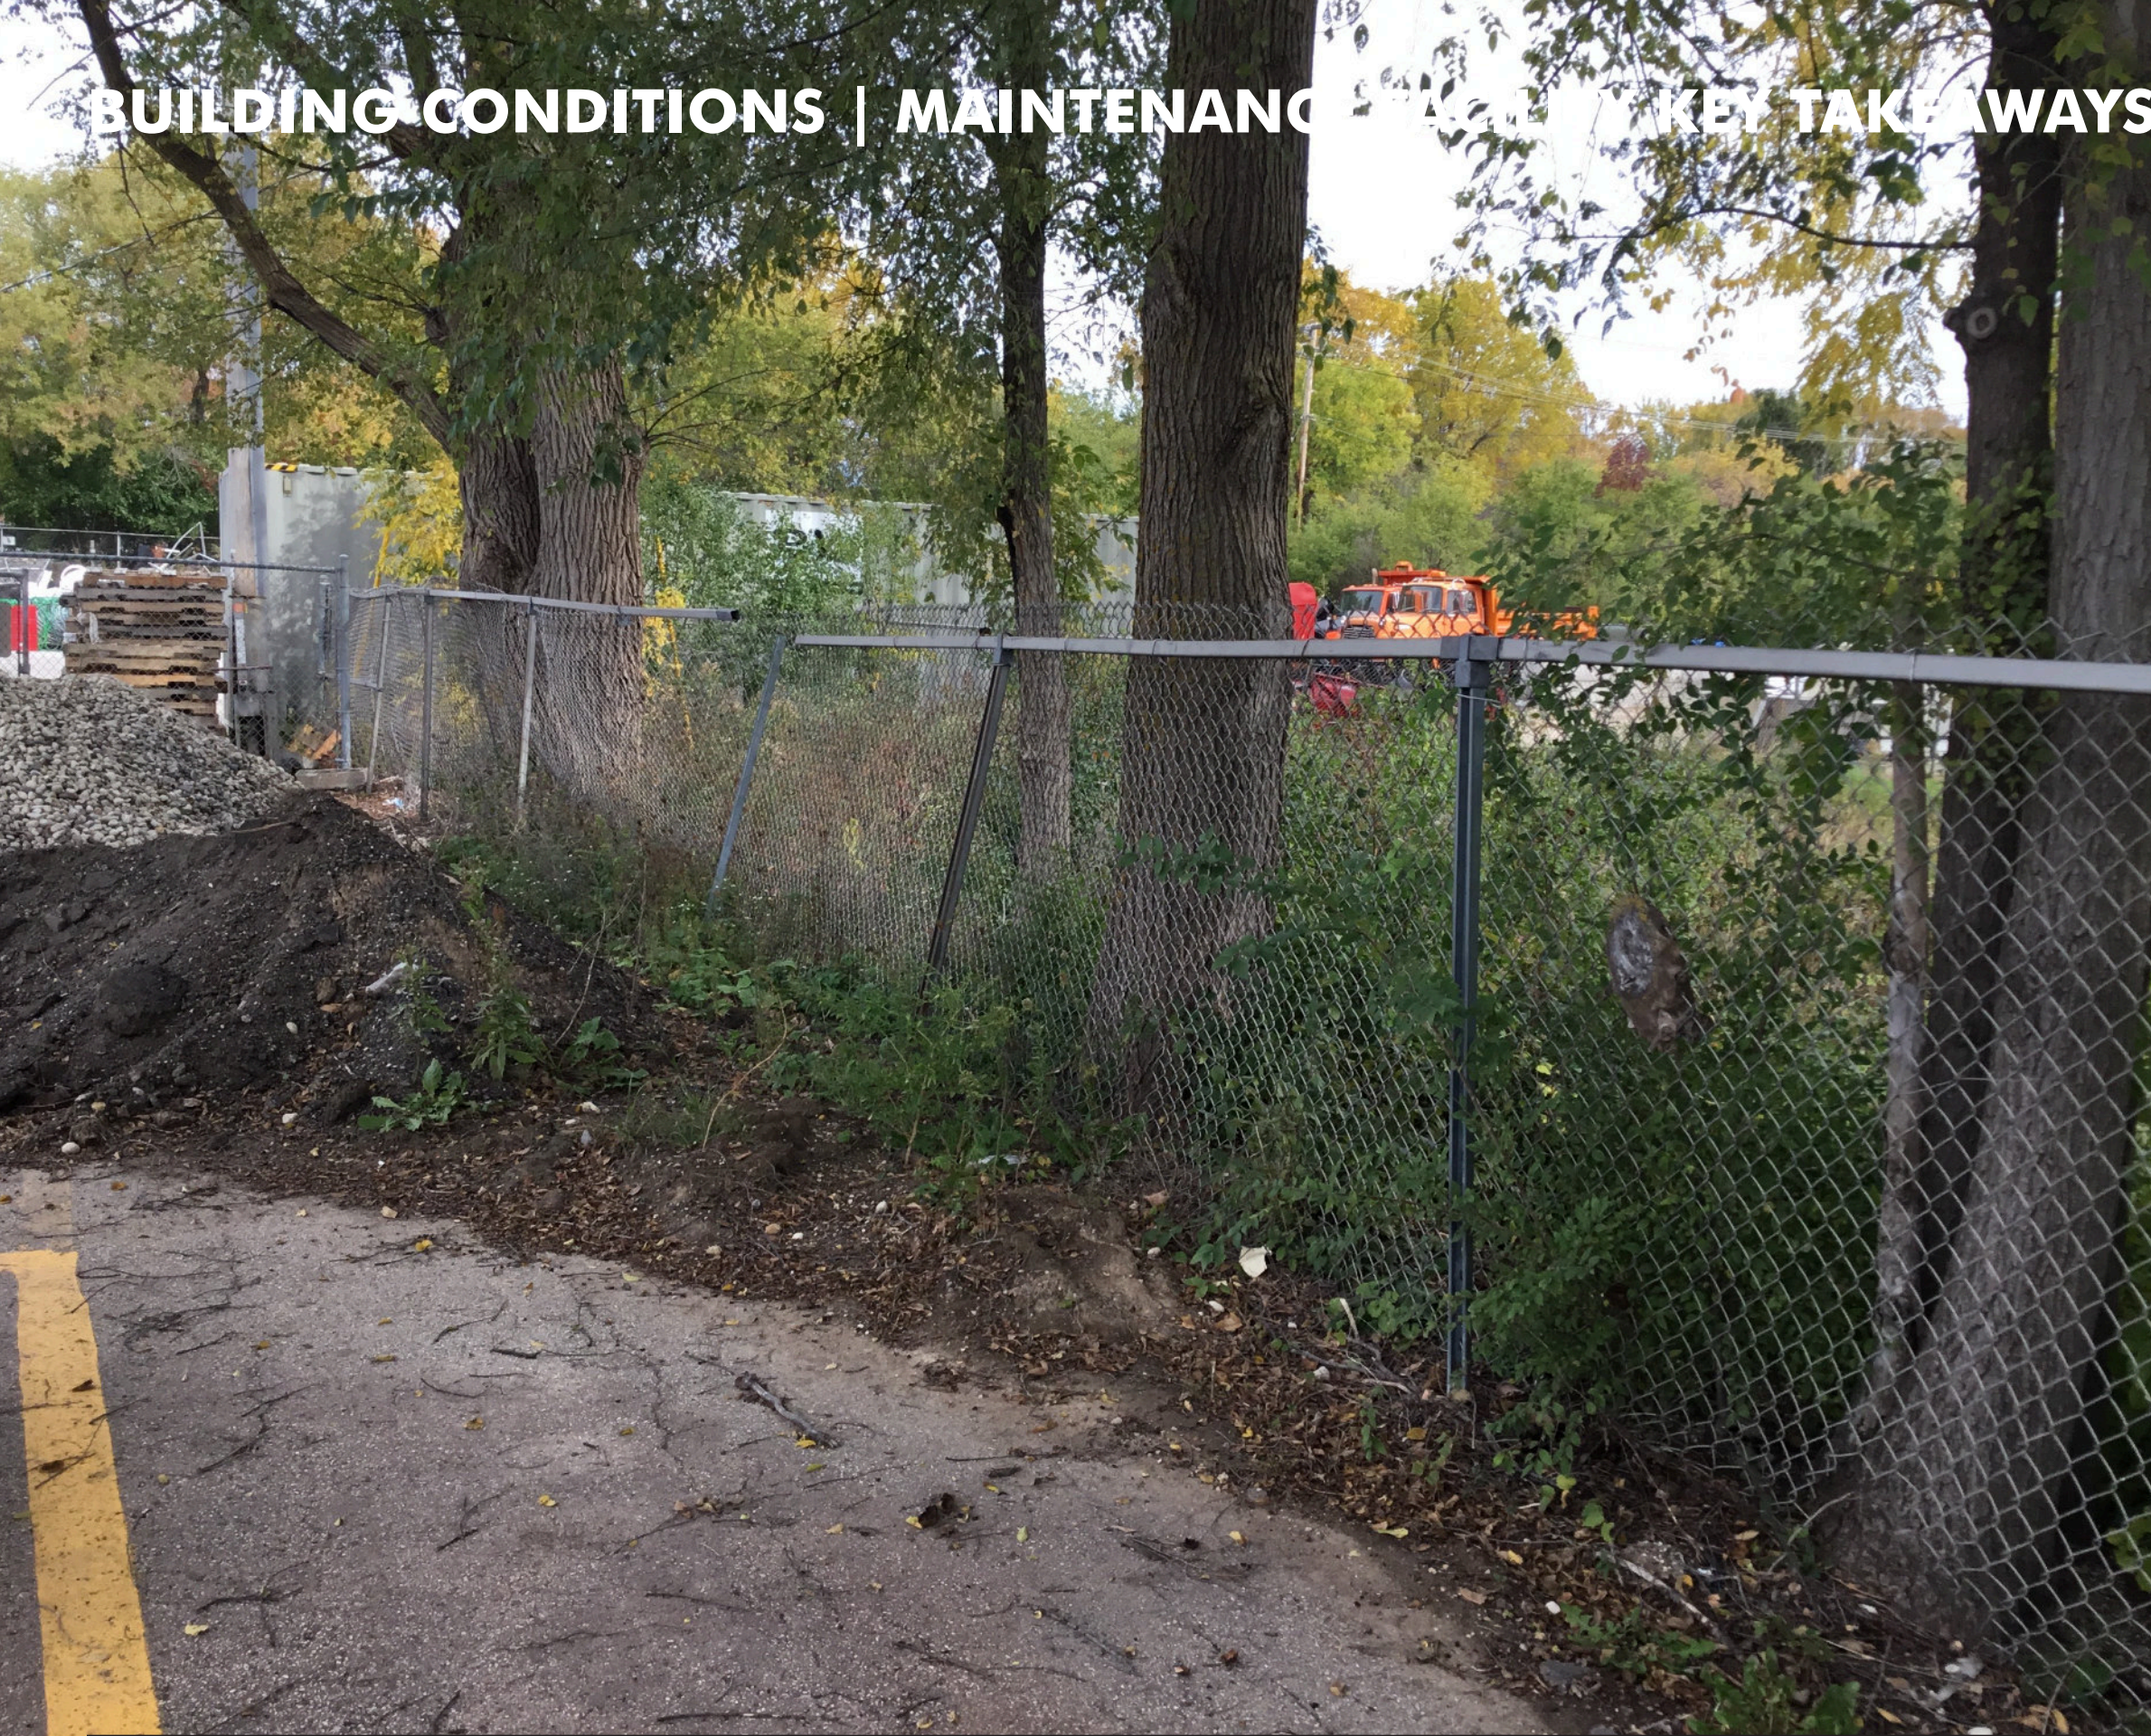
## DETERIORATING FENCE

CHAIN LINK FENCING AROUND PERIMETER OF SITE IS DAMAGED IN MANY AREAS AND DETERIORATING.

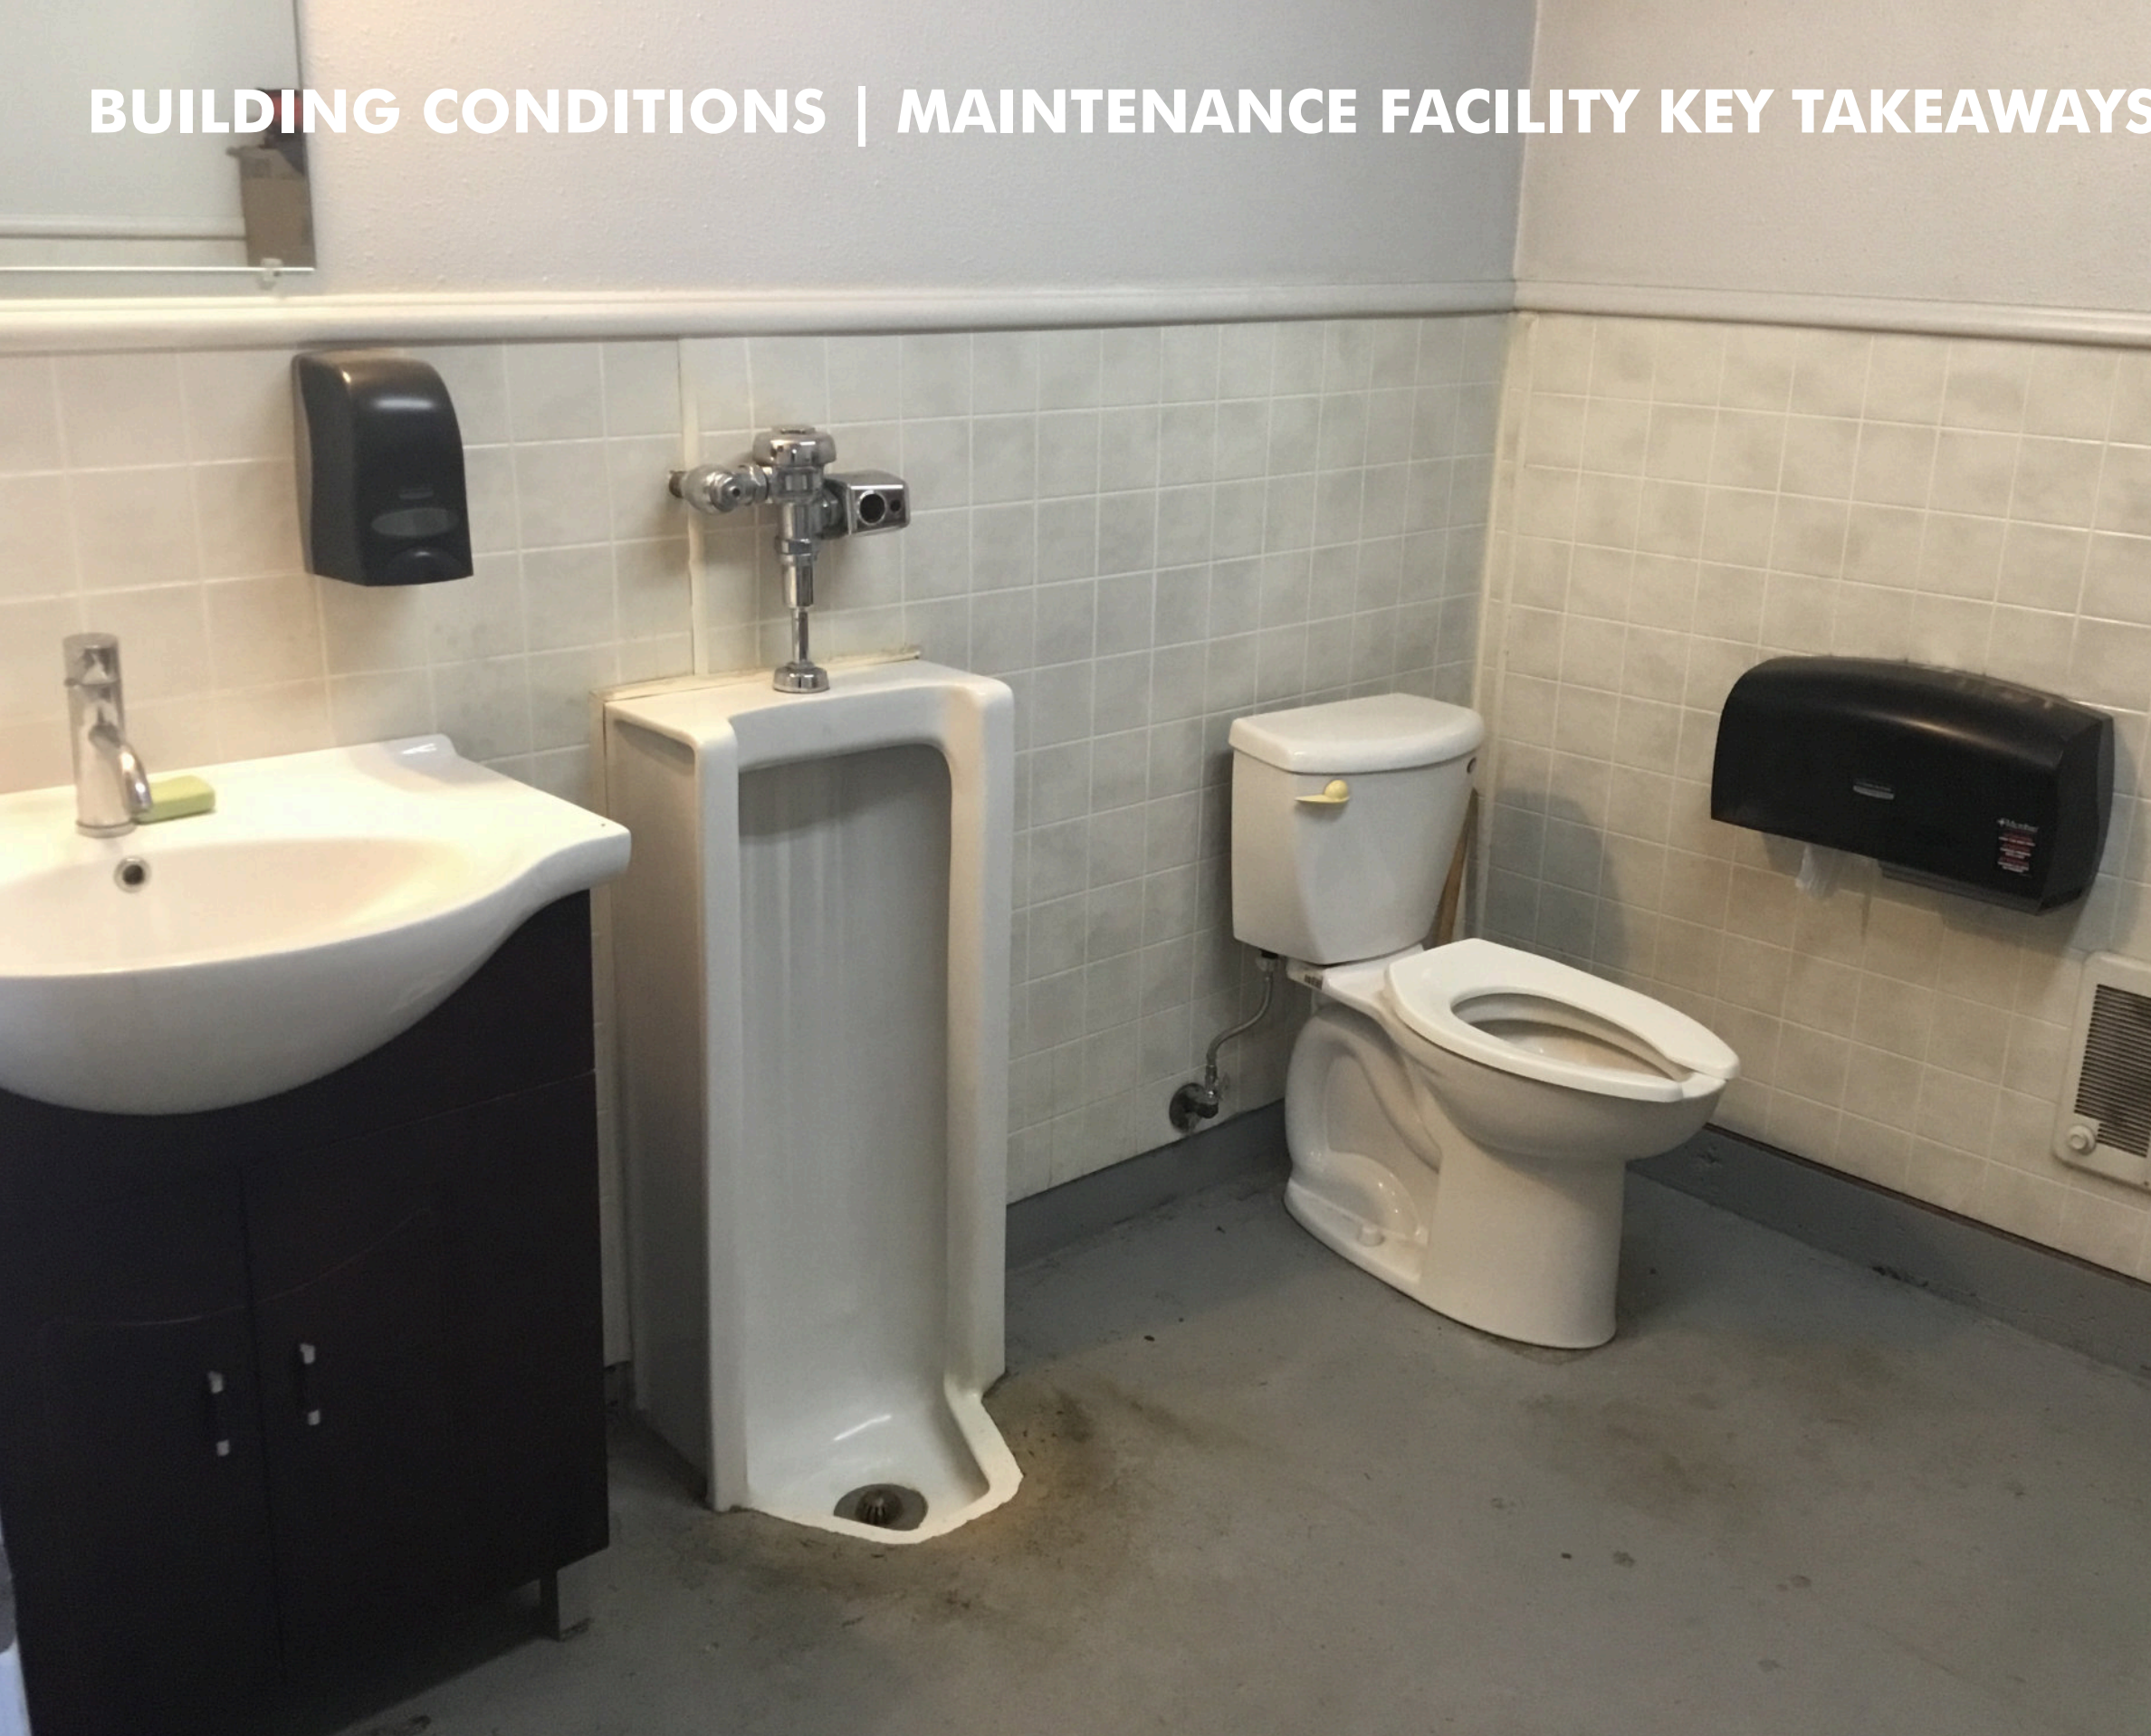
## ADA DEFICIENCIES

TOILET ROOMS IN THE BUILDING ARE NOT ACCESSIBLE.

TOILET ROOMS IN THE BUILDING  
ARE NOT ACCESSIBLE

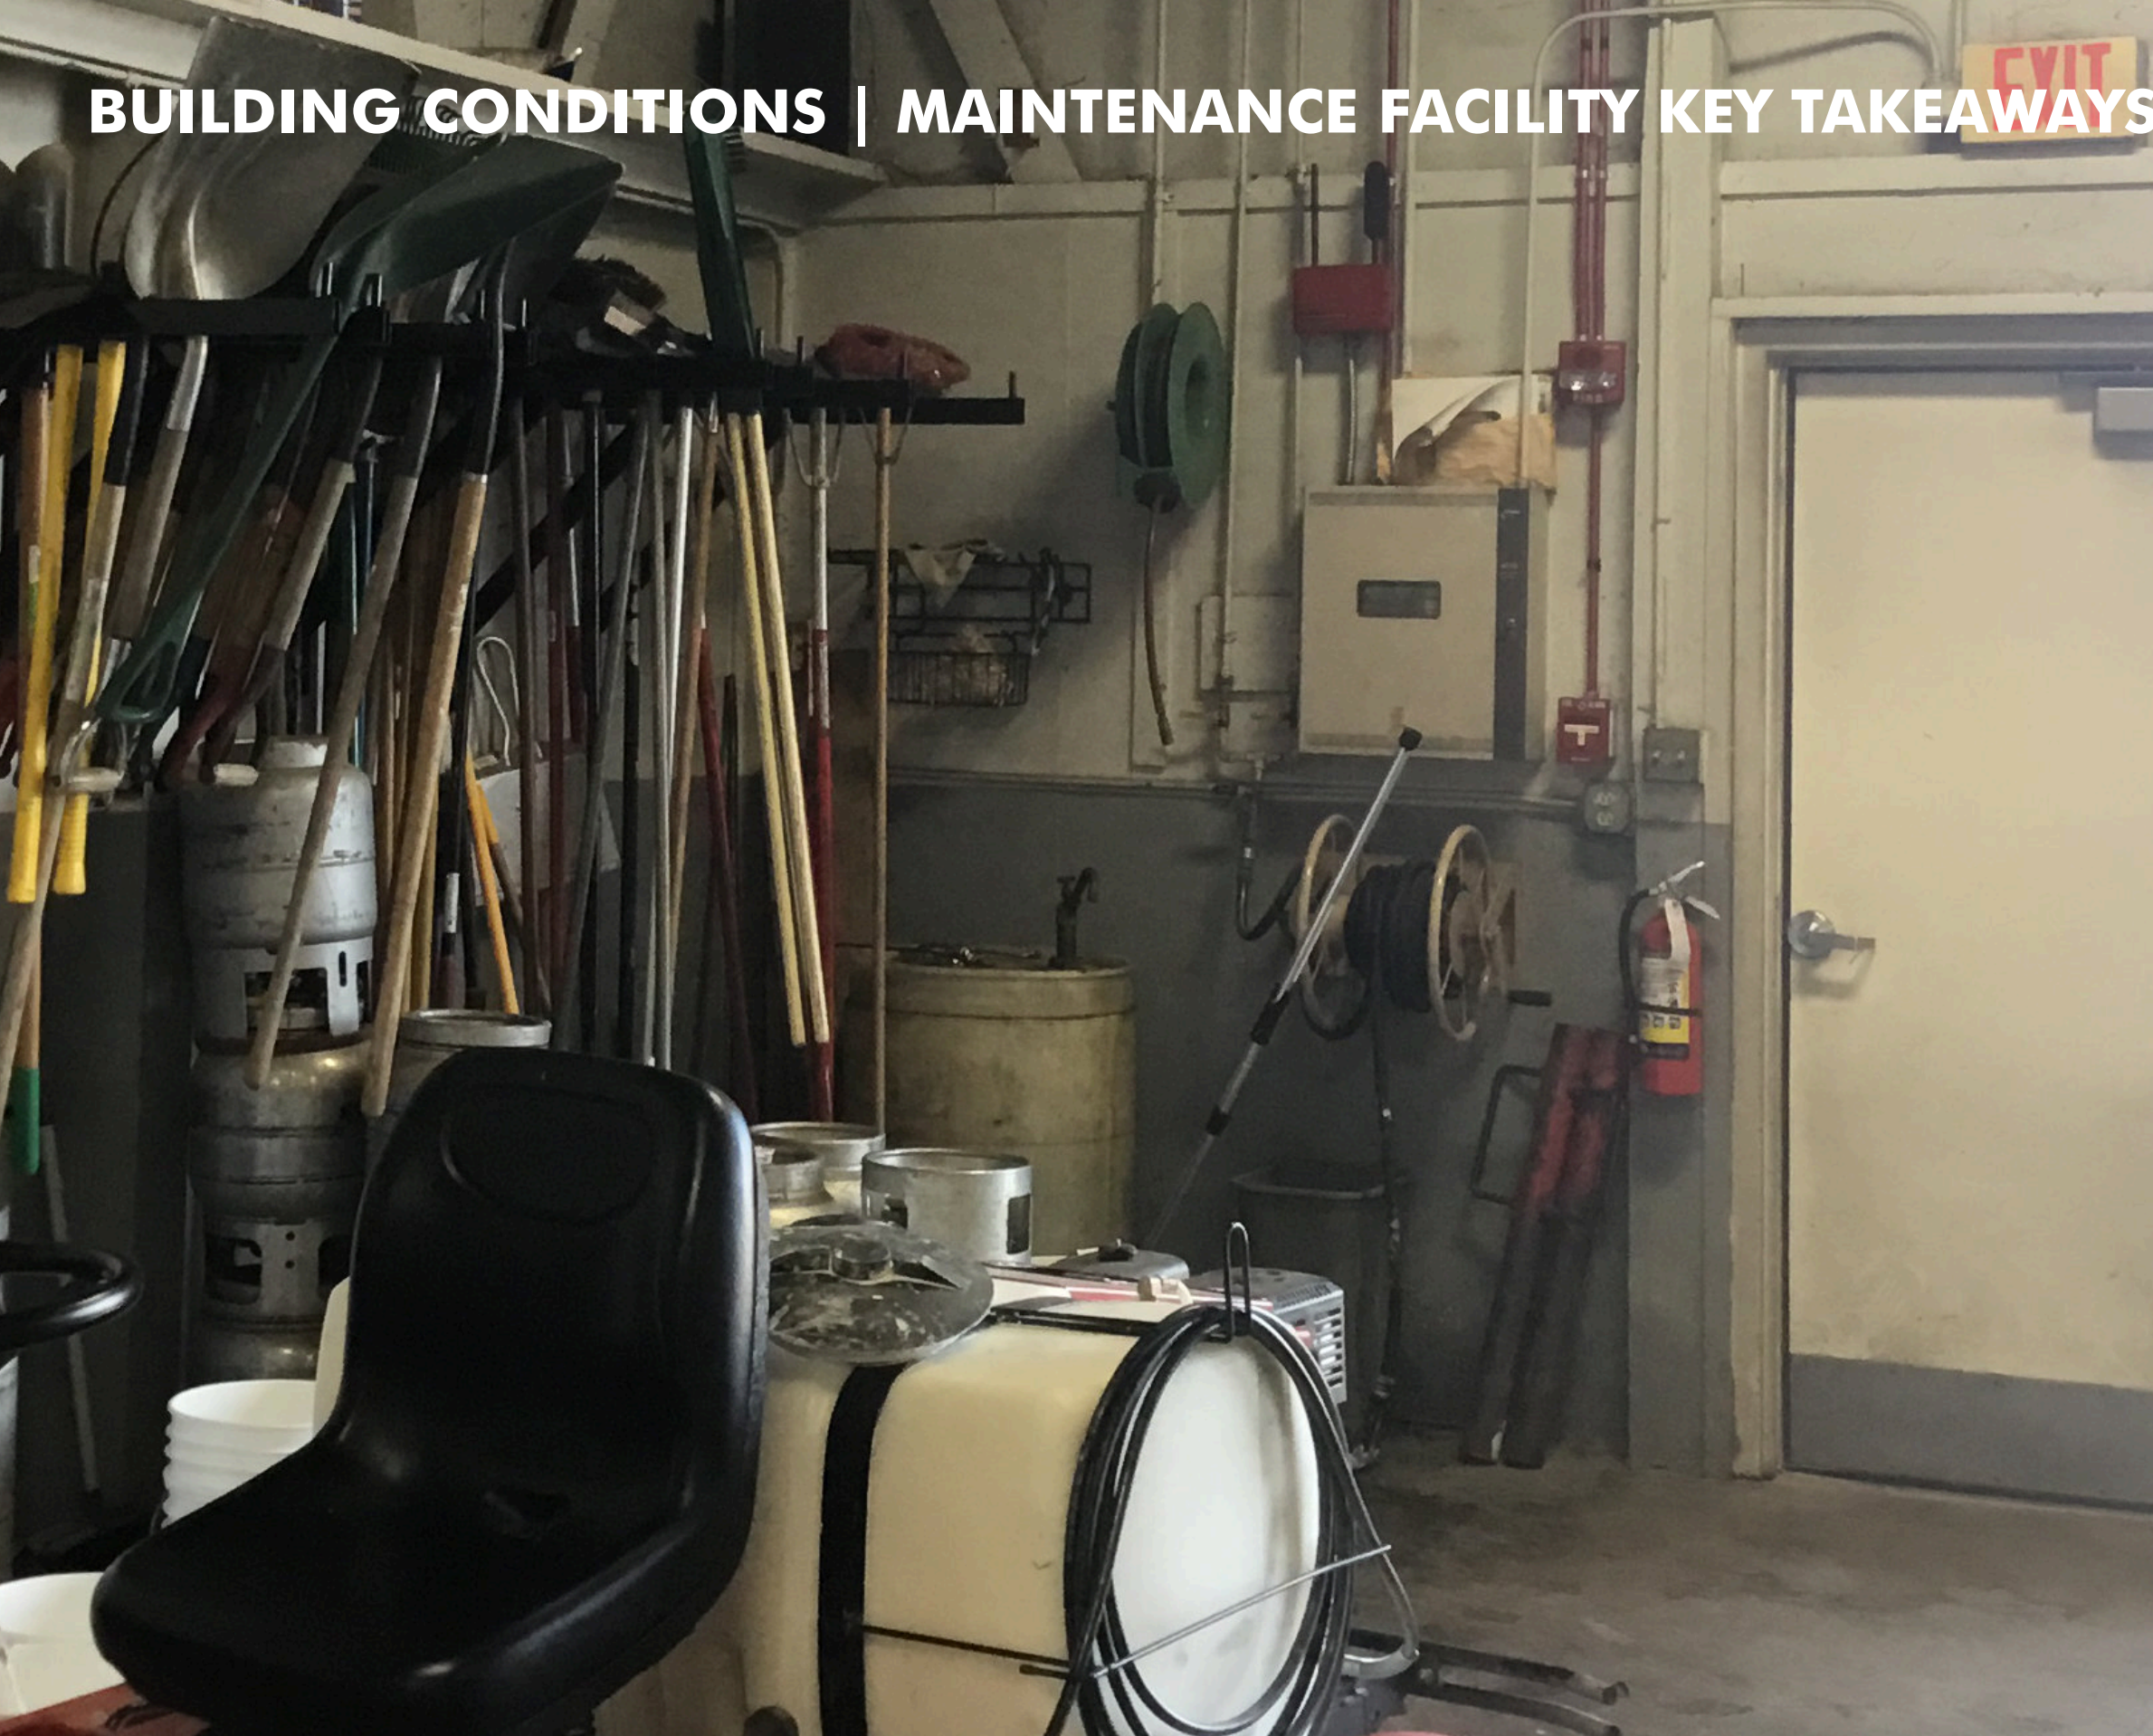
## AGED ELECTRICAL AND PLUMBING EQUIPMENT

MUCH OF THE ELECTRICAL AND PLUMBING EQUIPMENT IS NEARING OR HAS EXCEEDED THEIR USEFUL LIFE.

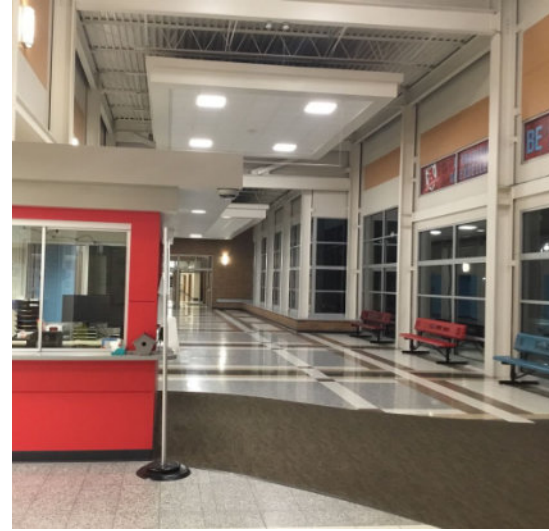
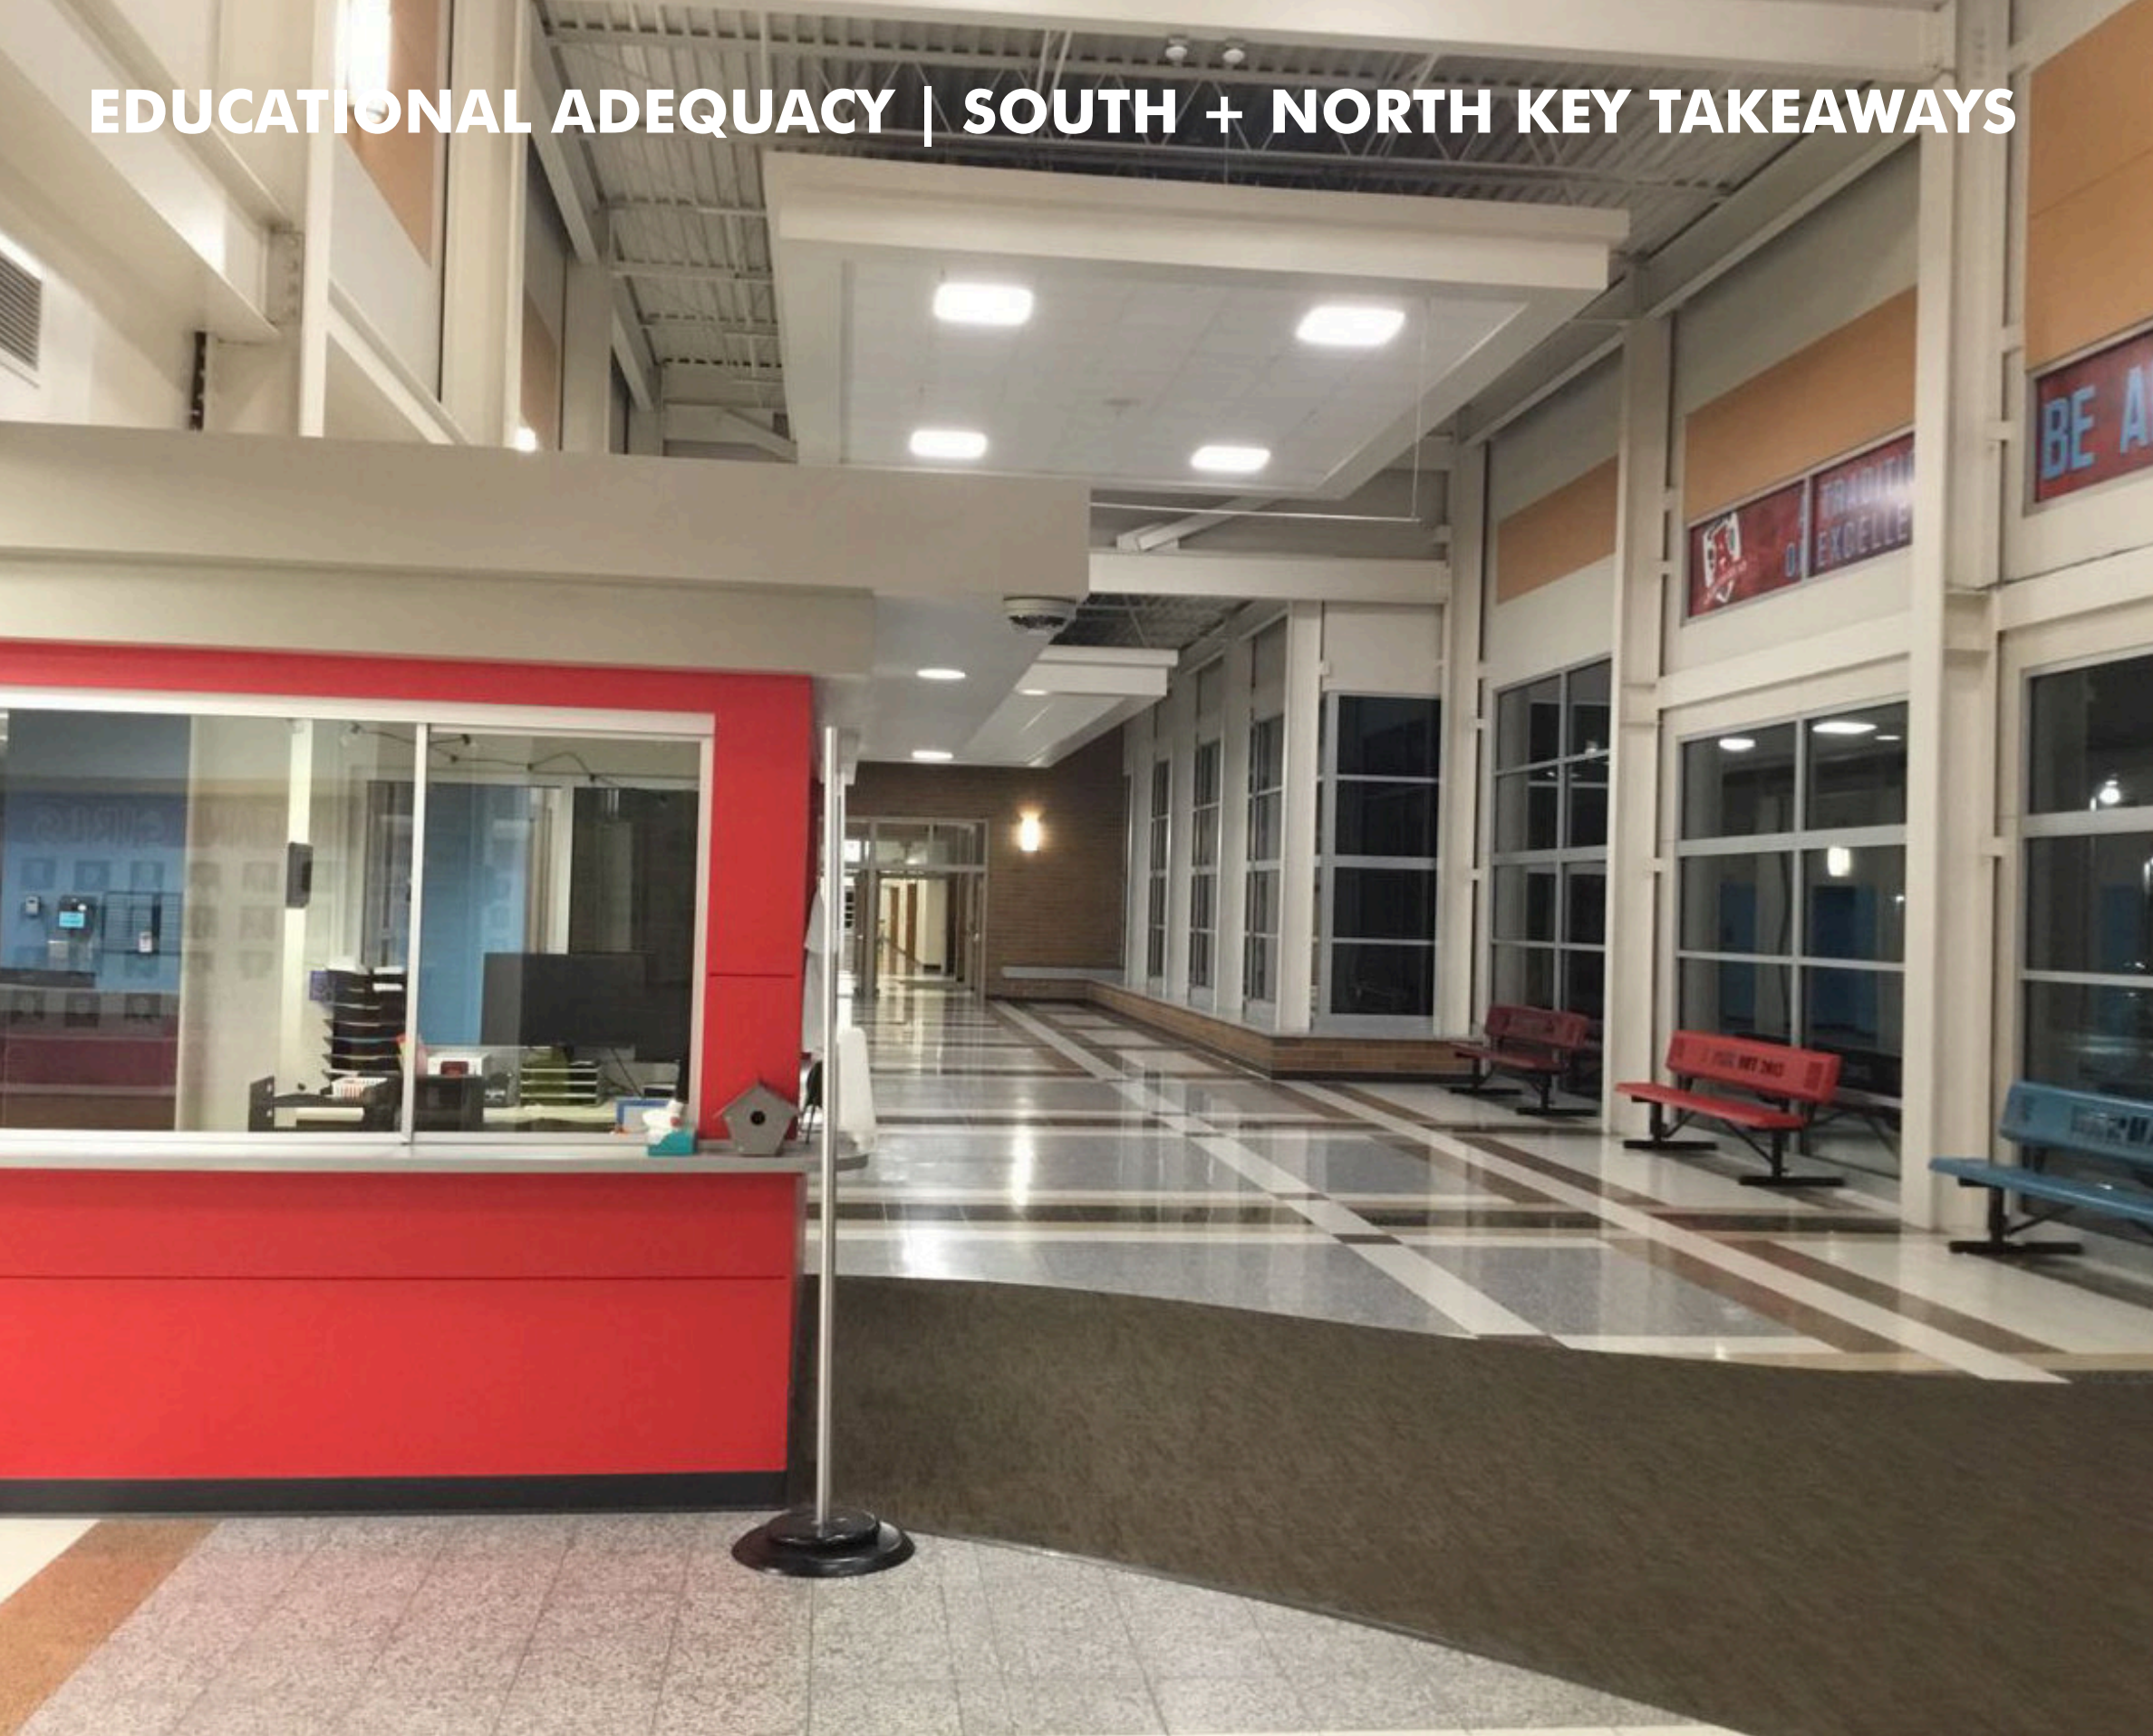
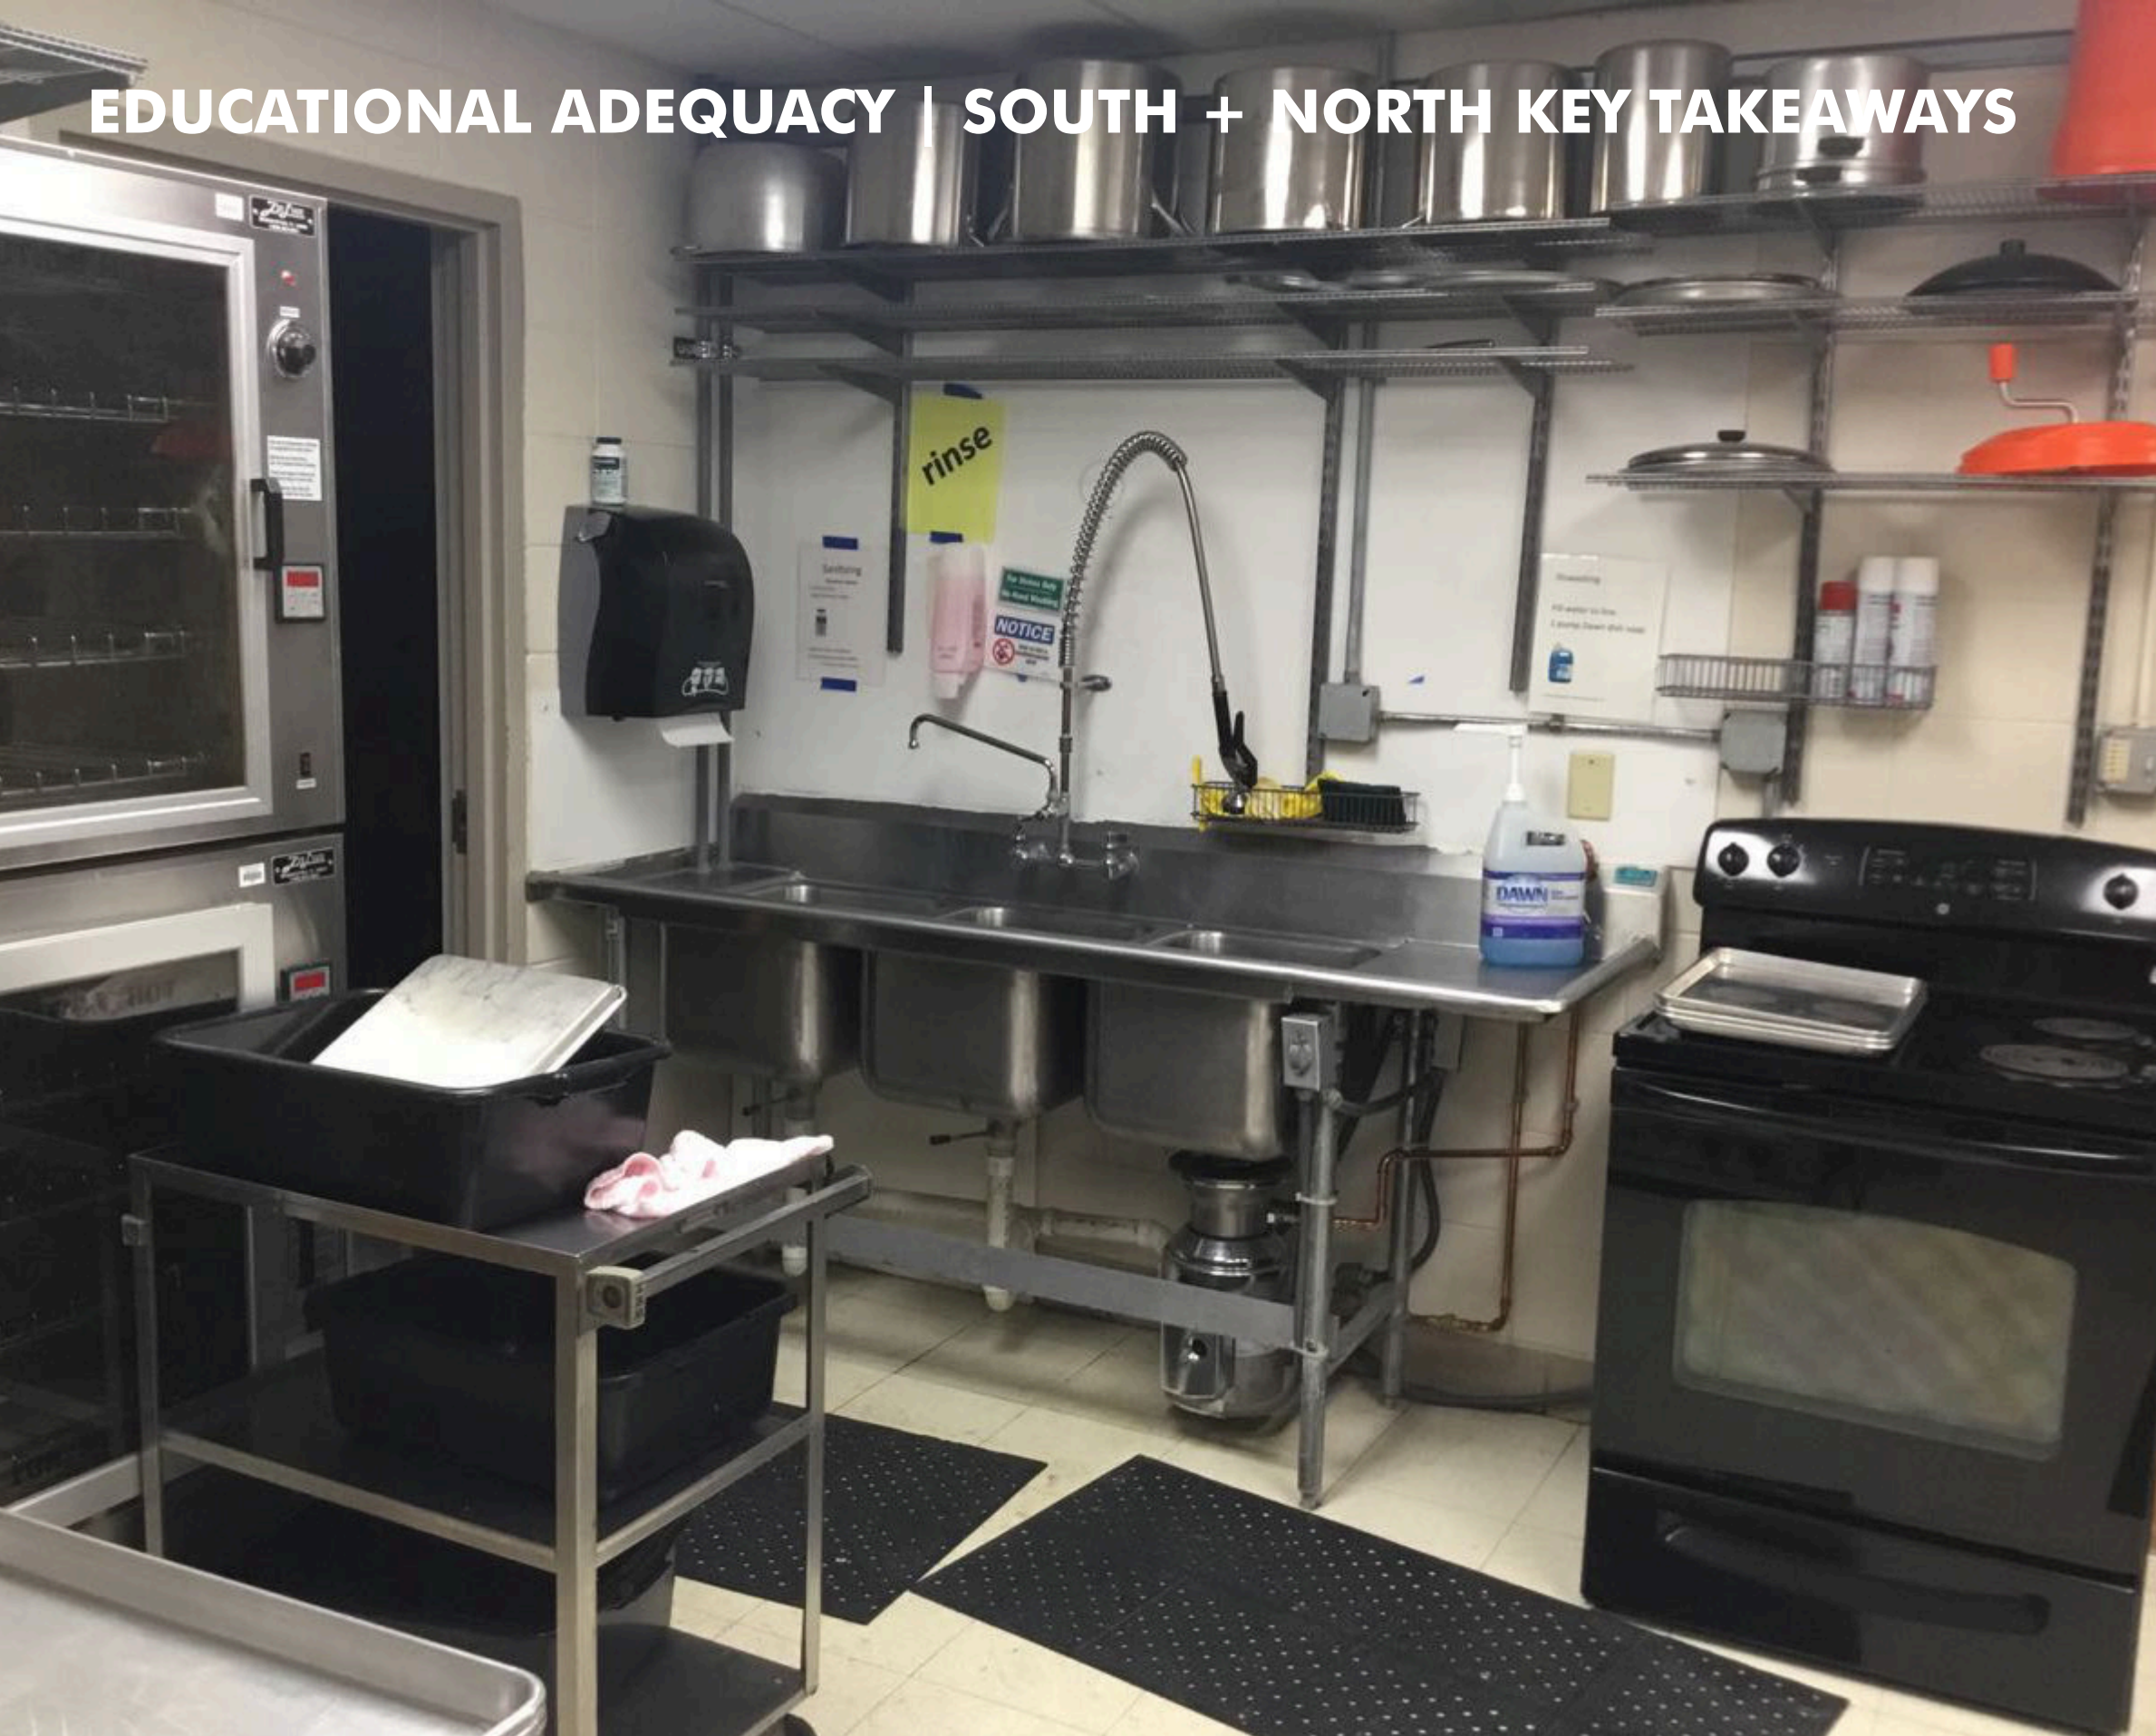
### LACK OF SECURE ENTRIES

BUILDING ACCESS COULD BE IMPROVED AT BOTH CAMPUSES WITH THE CREATION OF SECURE, CONTROLLED MAIN ENTRANCES THAT BRING VISITORS DIRECTLY INTO THE MAIN OFFICE PRIOR TO ACCESSING THE SCHOOL. (2016)
