# FACILITIES ASSESSMENT BOARD PRESENTATION

ARROWHEAD UNION HIGH SCHOOL DISTRICT

#323398-01 | 12.13.2023

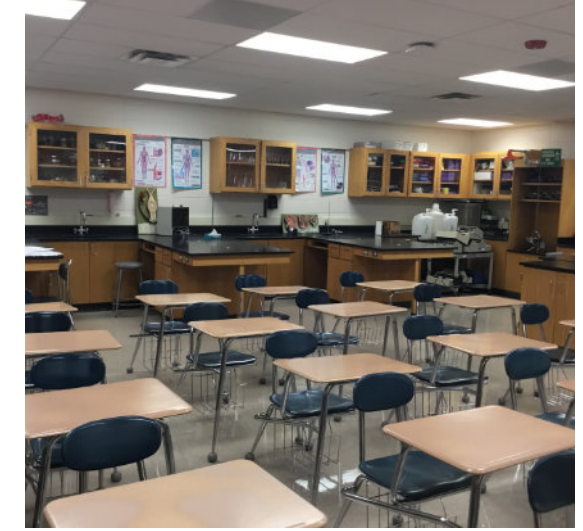
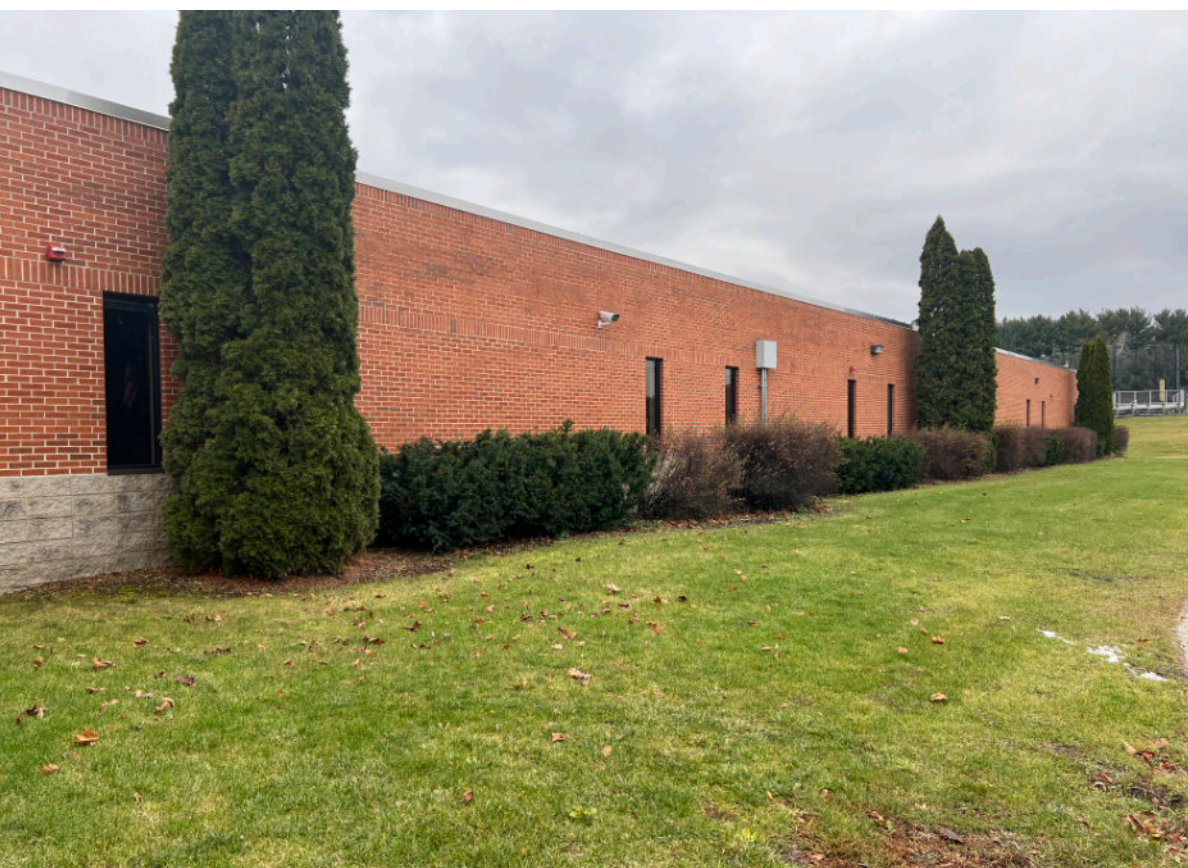
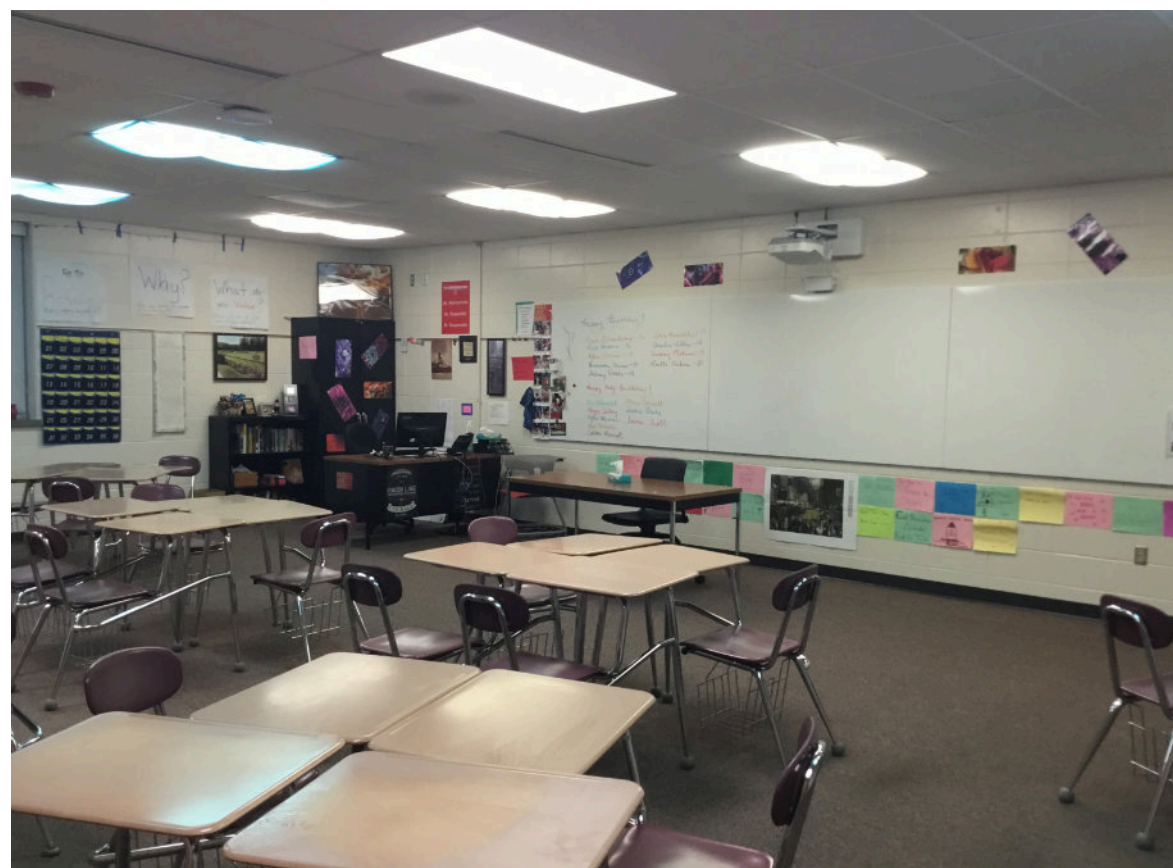
### LACK OF NATURAL LIGHT

COMPACT BUILDING FOOTPRINTS RESULT IN MANY INBOARD CLASSROOMS AND SPECIALTY SPACES WITHOUT ACCESS TO DAYLIGHT OR VIEWS.

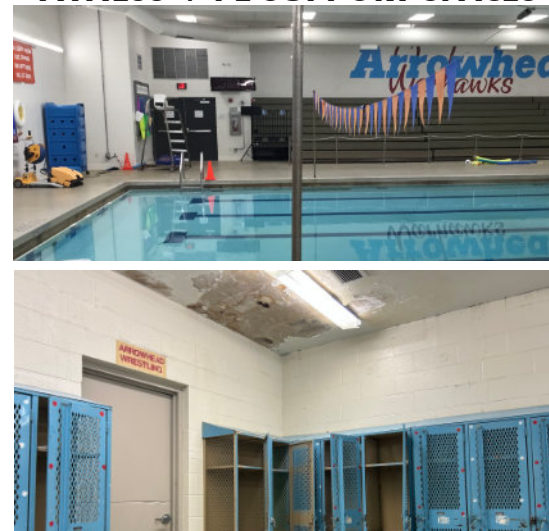
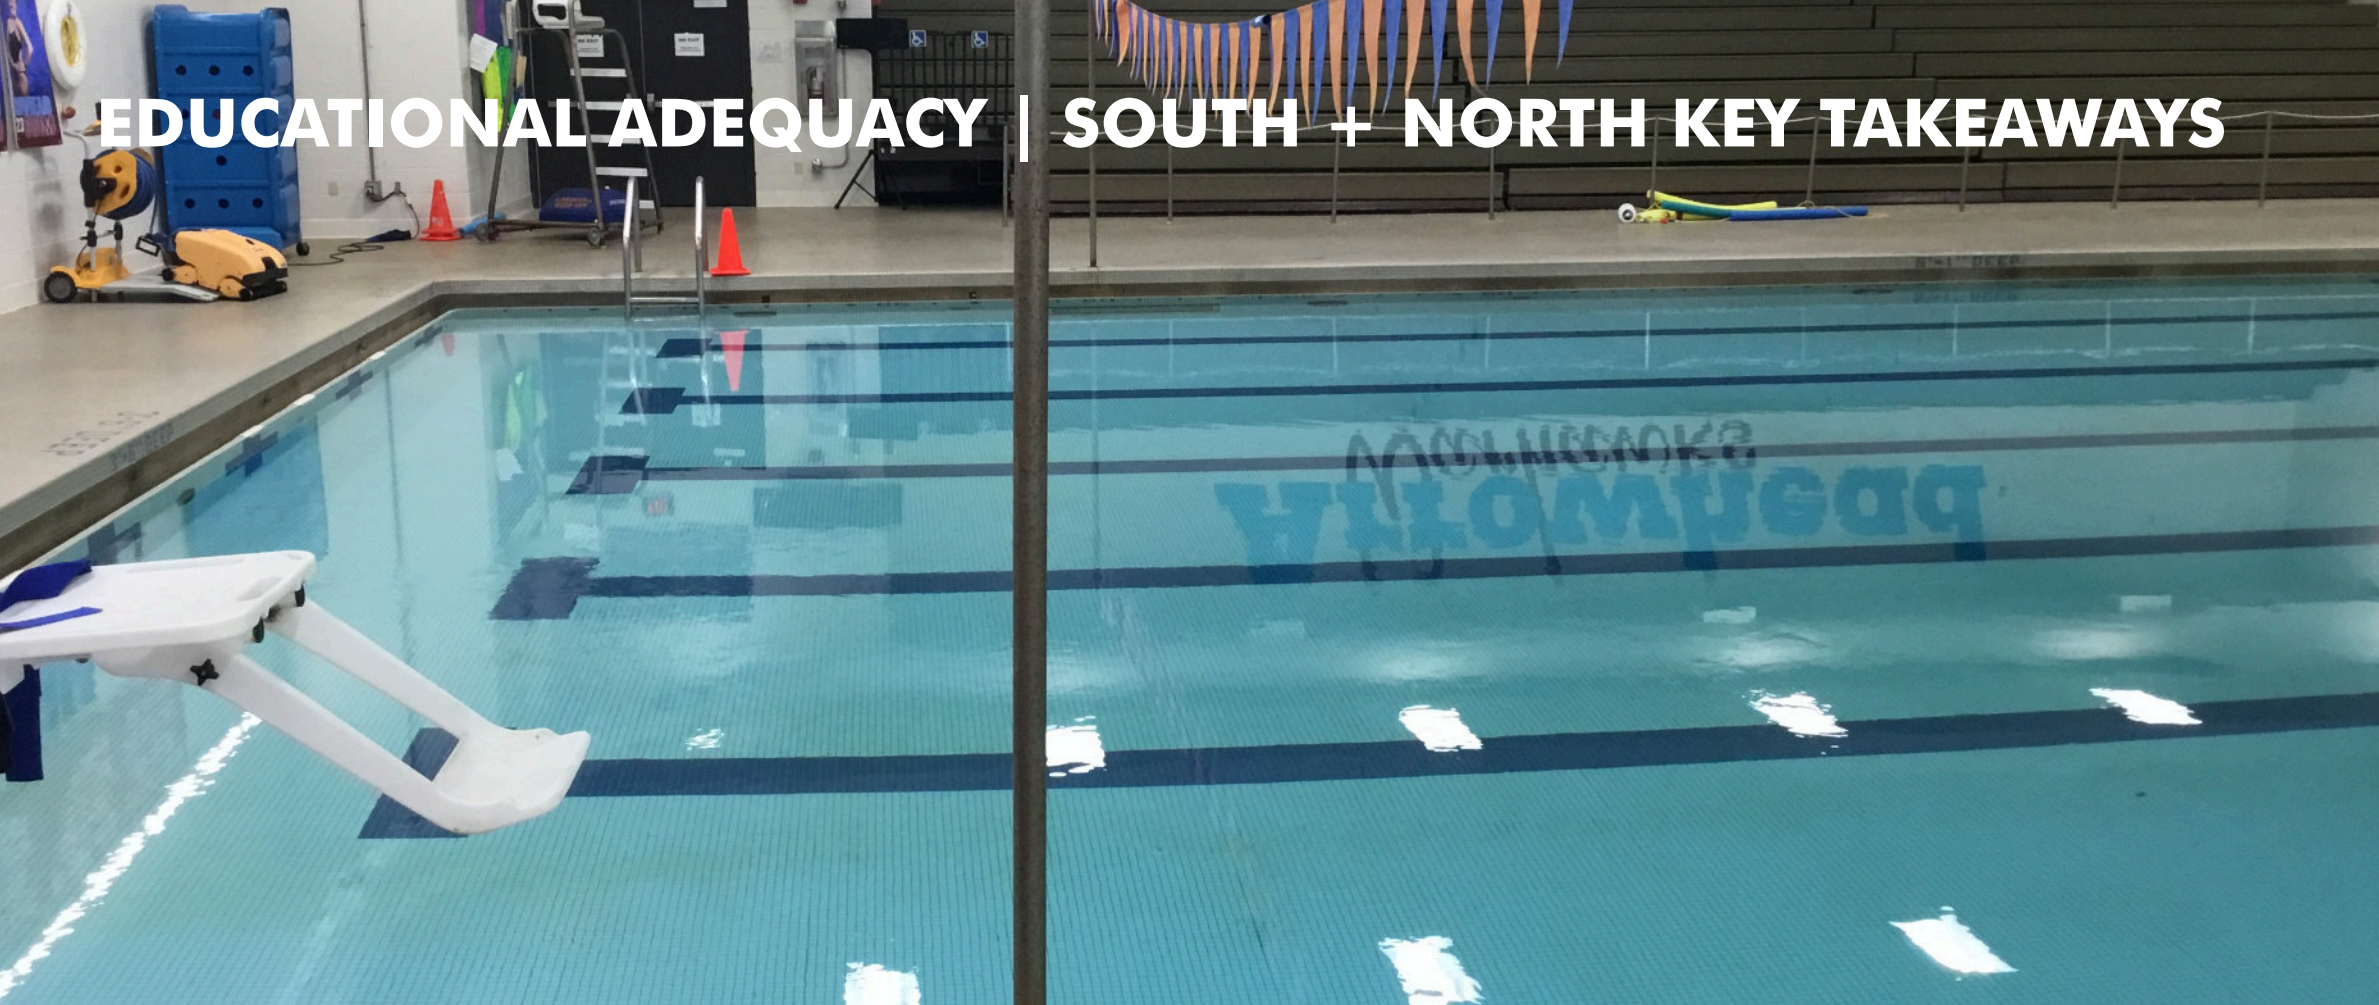
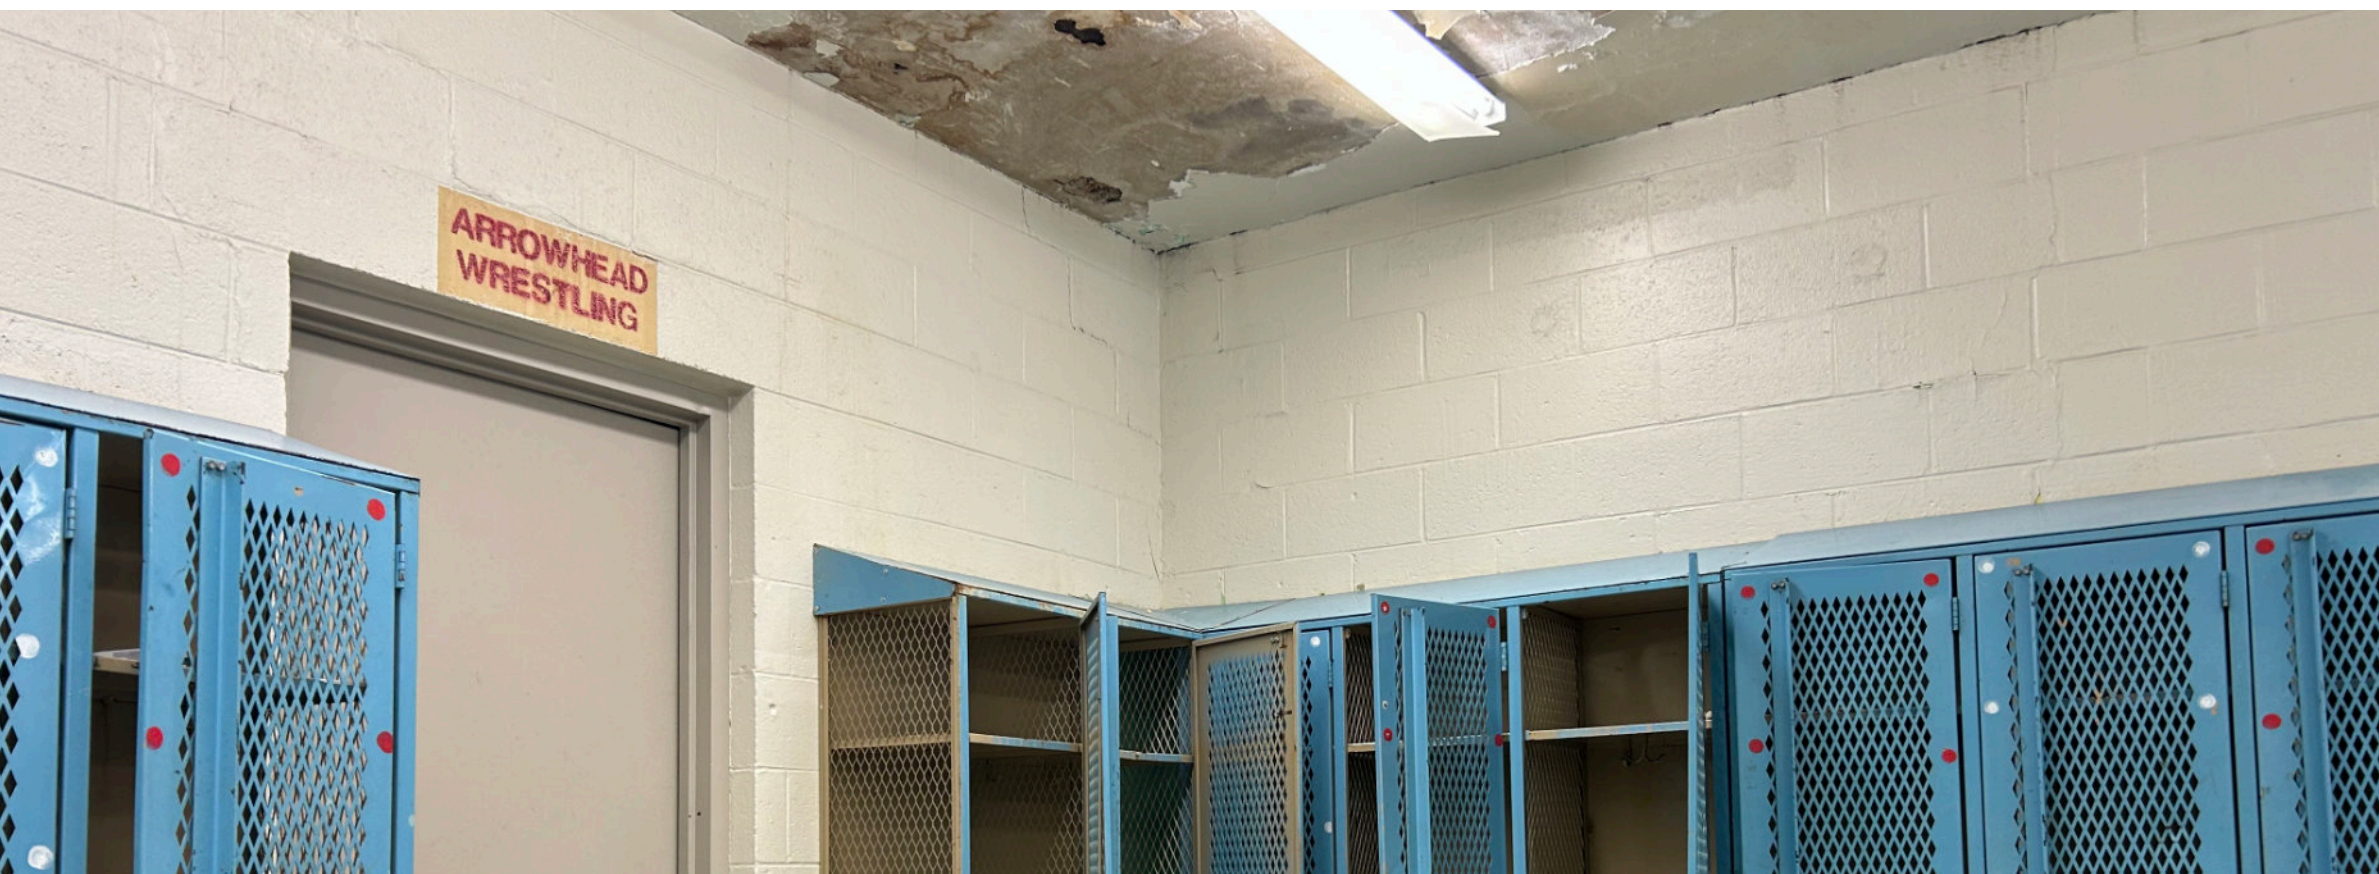
### UNDERSIZED CAFETERIA, POOL, GYM, FITNESS + PE SUPPORT SPACES

THE BUILDING'S LARGE SPECIALTY SPACES ARE GROSSLY UNDERSIZED AND INADEQUATELY DESIGNED. THEREFORE, THESE SPACES ARE UNDERUTILIZED BOTH FOR SCHOOL AND COMMUNITY FUNCTIONS.

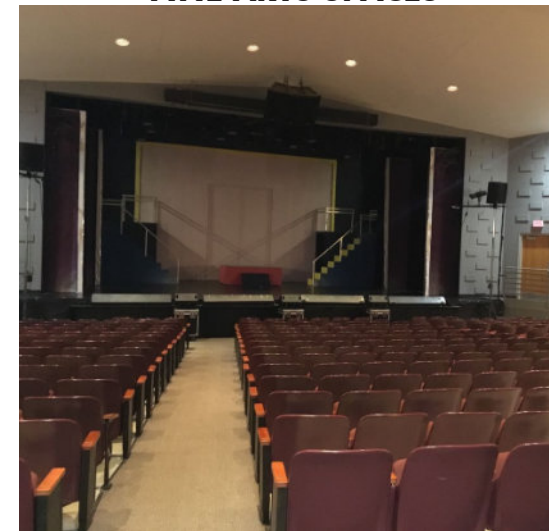
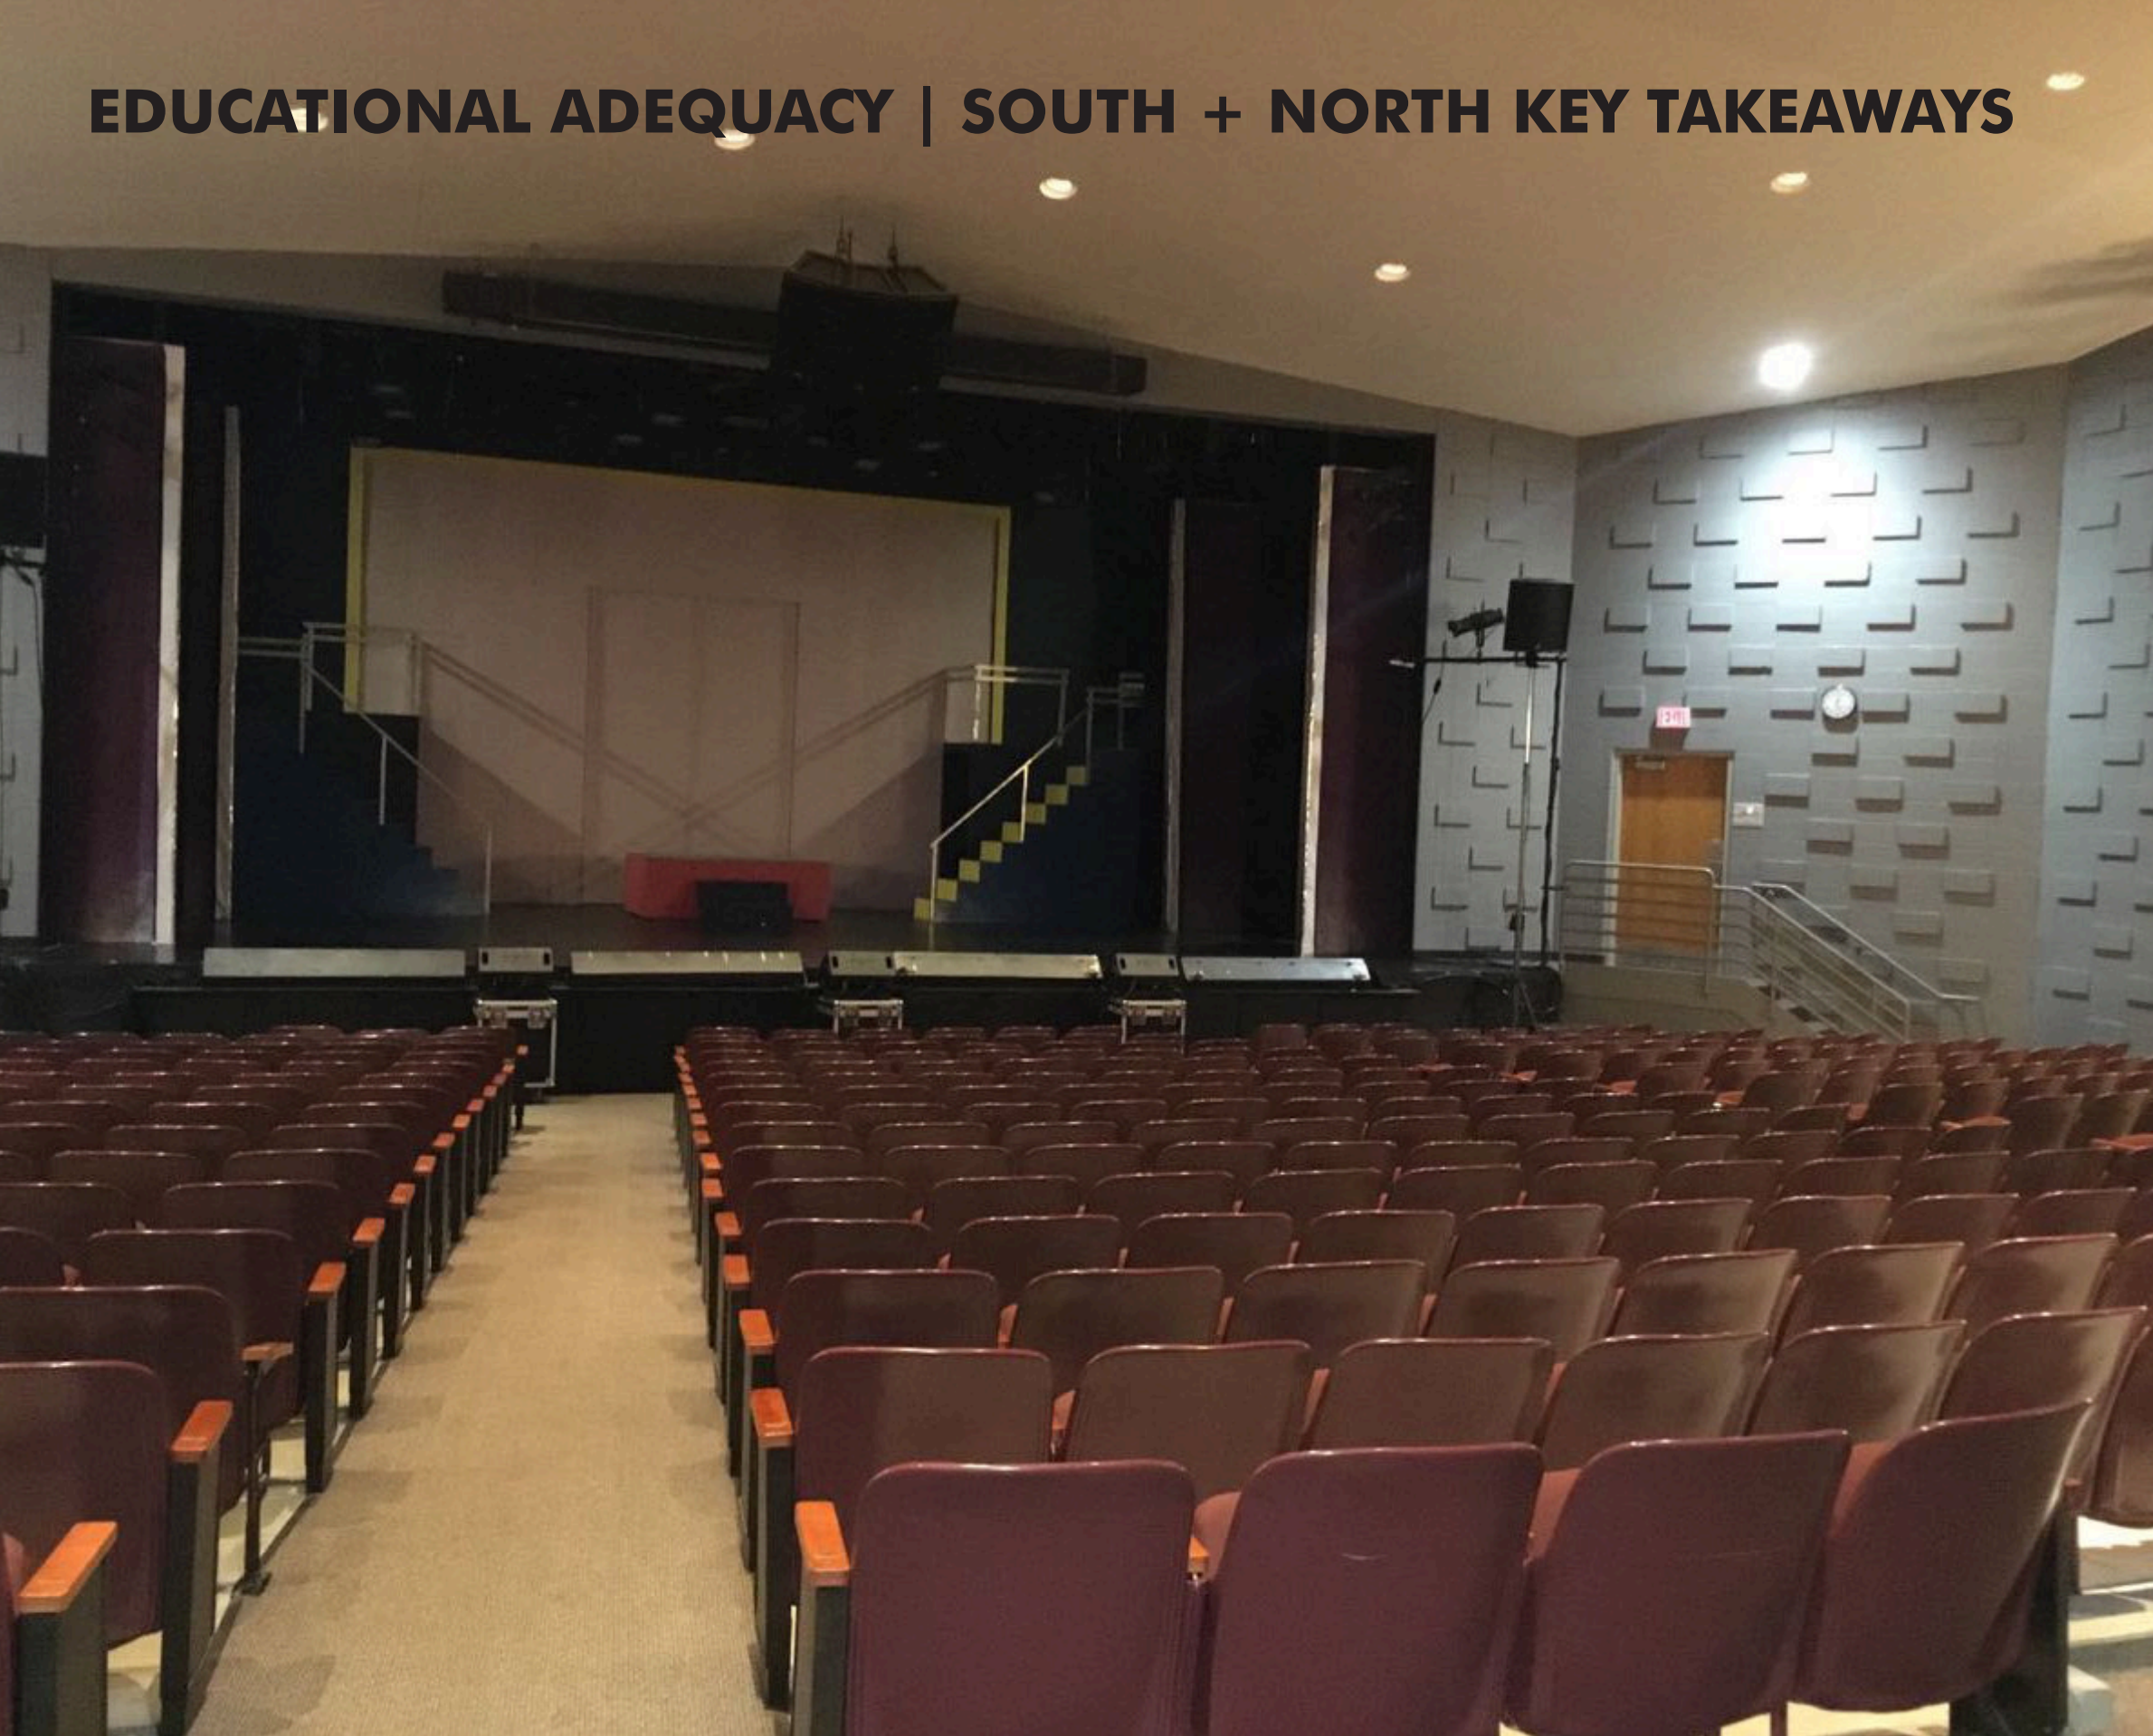
### UNDERSIZED AUDITORIUM + FINE ARTS SPACES

THE FINE ARTS PROGRAM SPACE (THEATER AND MUSIC) IS UNDERSIZED, OUTDATED AND LACKS PRACTICE ROOMS, STORAGE, LARGE PERFORMANCE SPACE, AND STUDENT DISPLAY AREAS. (2016)

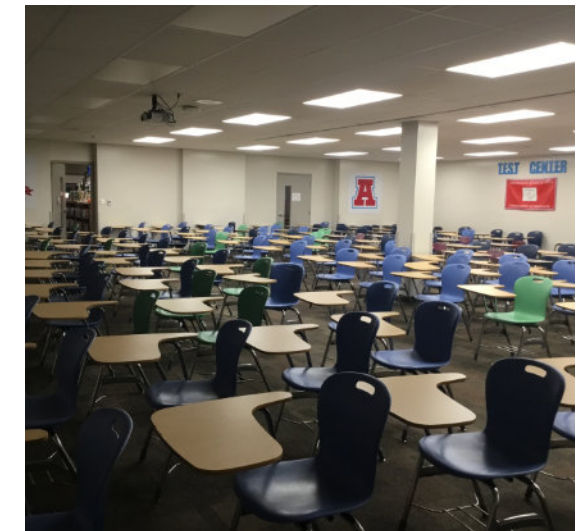
### OUTDATED FURNITURE

FURNITURE IS OUTDATED AND DOES NOT PROVIDE THE NEEDED LEVEL OF FLEXIBILITY TO ACCOMMODATE STUDENT-CENTERED LEARNING.

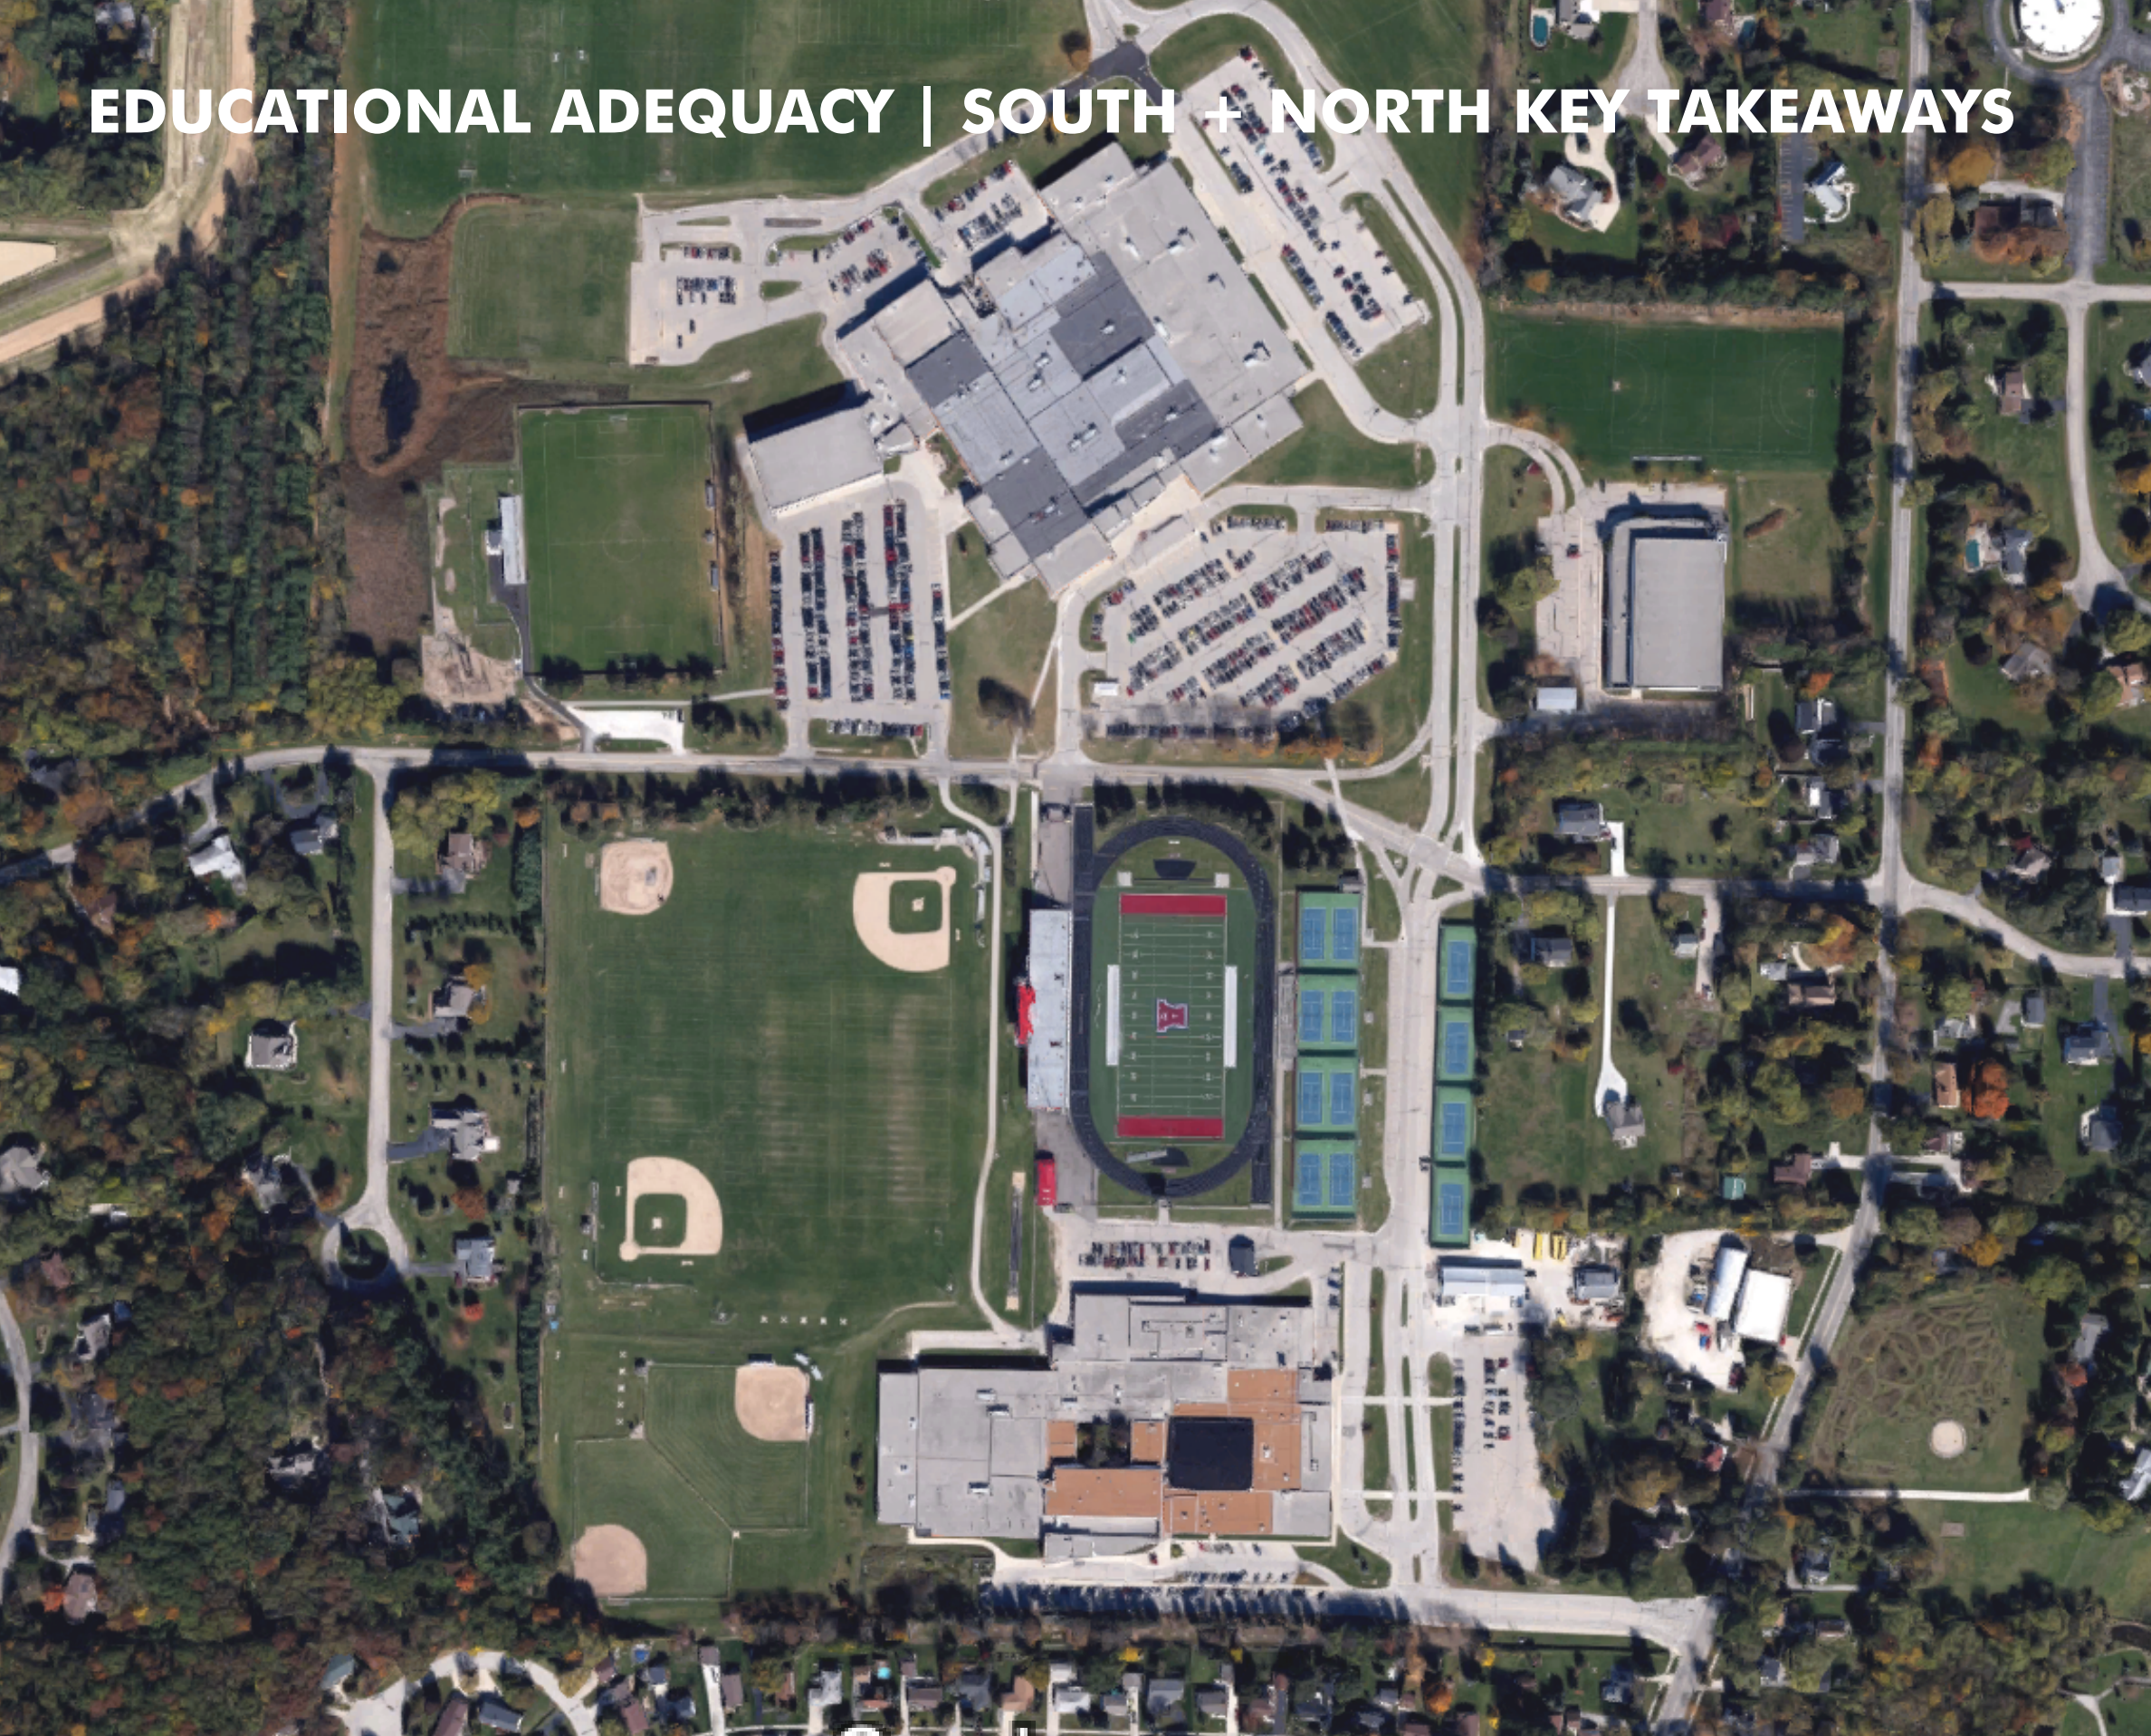
## TWO SEPARATE BUILDINGS

SEPARATE CAMPUSES RESULT IN DUPLICATION OF SPACES AND INEFFICIENCIES IN THE CURRENT FACILITIES.

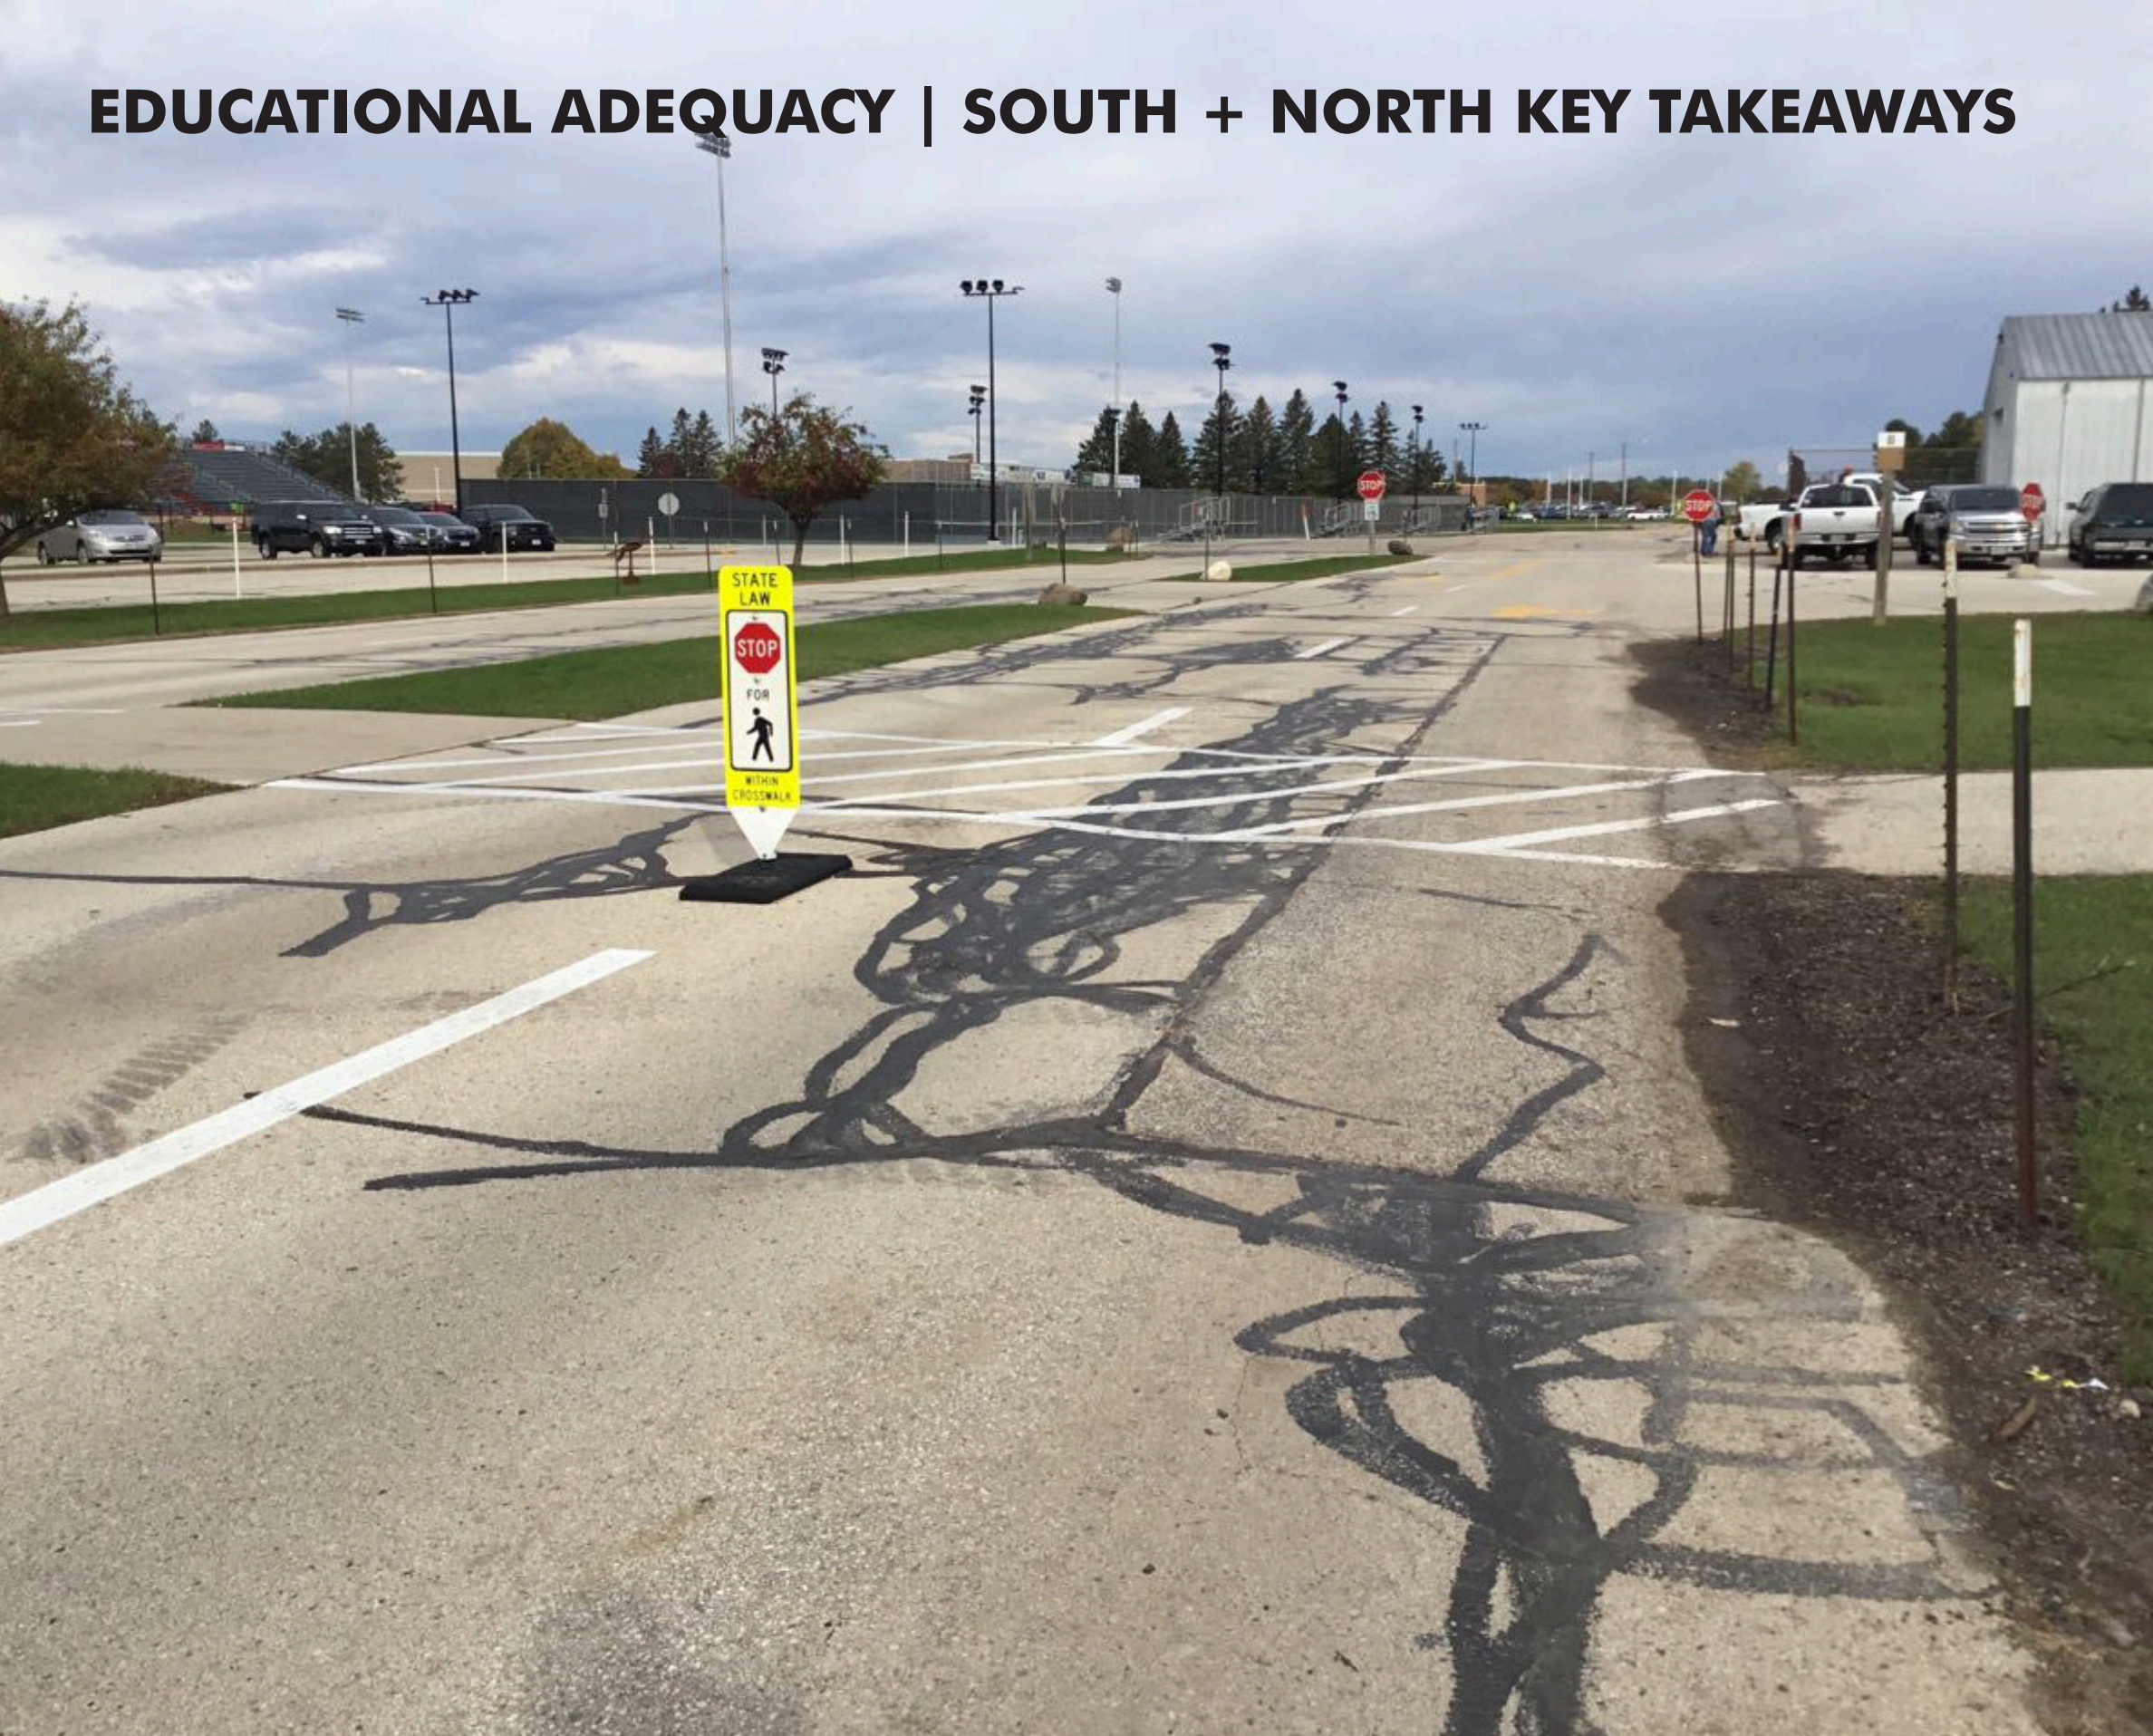
## PICK-UP/DROP-OFF CONCERNS

GENERAL CIRCULATION  
CONGESTION ISSUES RELATED  
TO TRAFFIC FLOW OF VARIOUS  
MODES OF TRANSPORTATION.

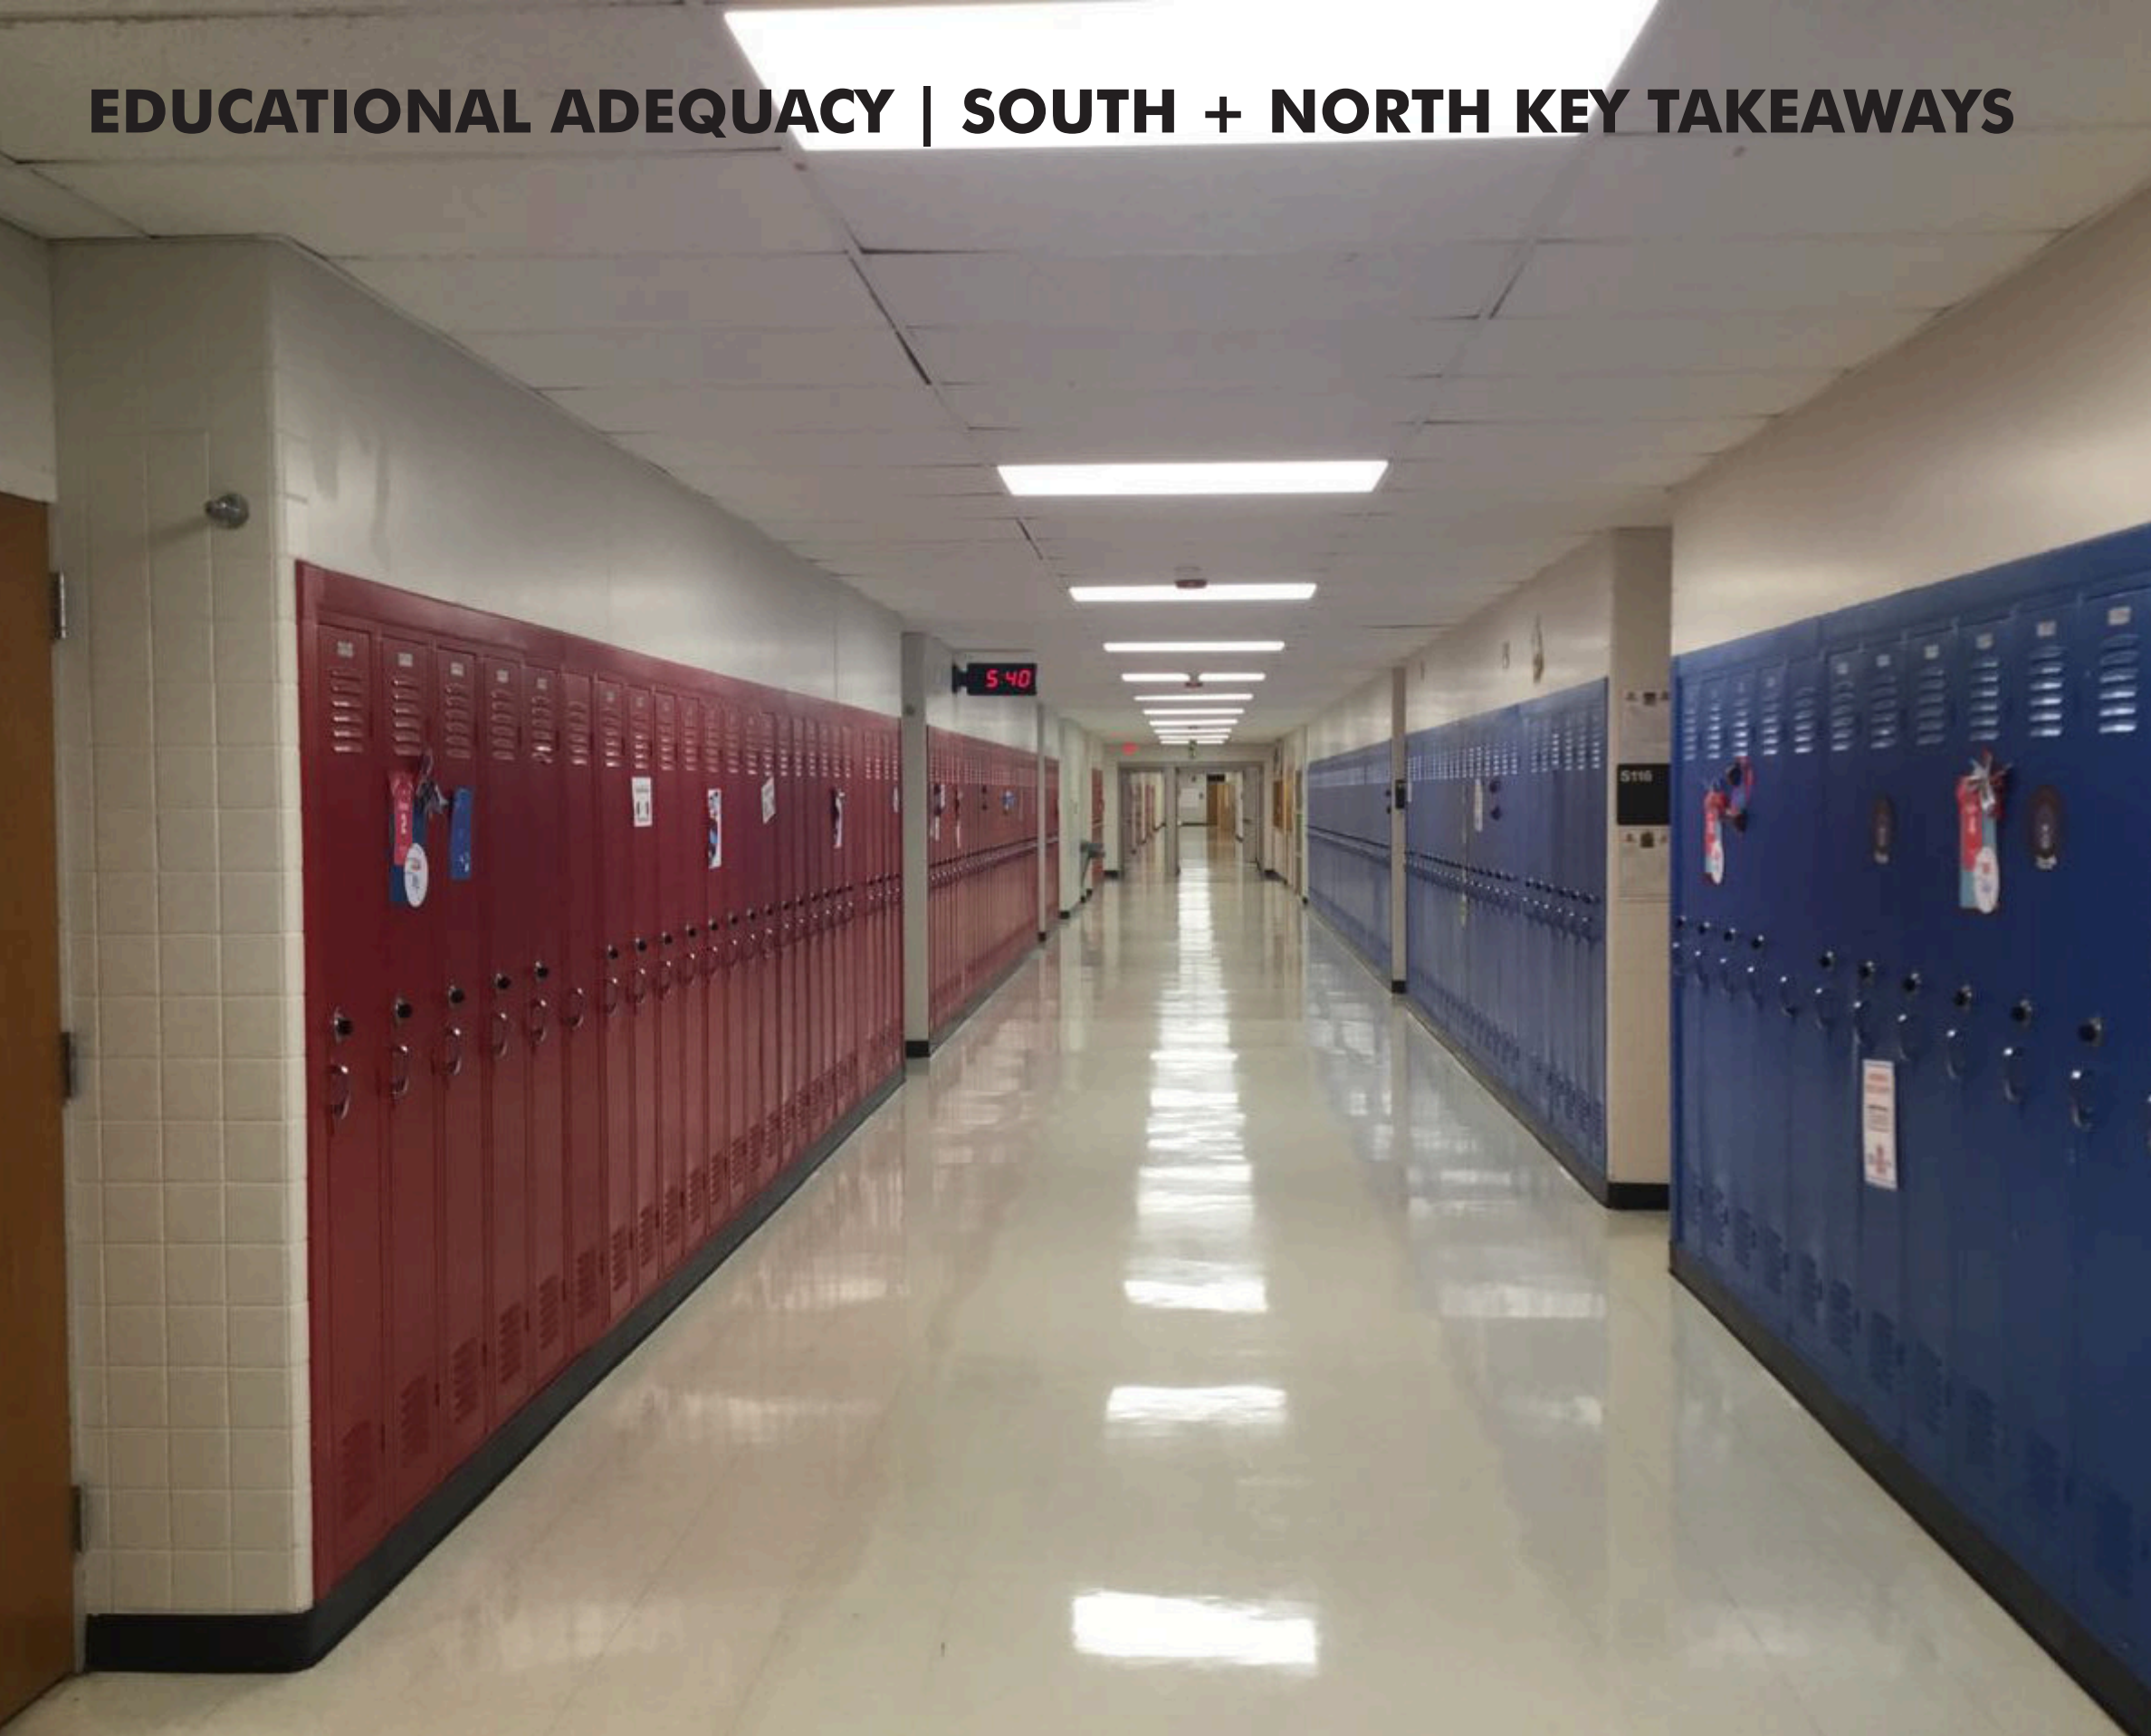
### LACK OF BREAKOUT/ COLLABORATION

TEACHING METHODOLOGIES ARE LIMITED DUE TO LACK OF SUPERVISABLE BREAKOUT SPACE TO ALLOW FOR GROUP WORK OUTSIDE, YET ADJACENT TO THE CLASSROOM.
