# FACILITIES ASSESSMENT BOARD PRESENTATION

ARROWHEAD UNION HIGH SCHOOL DISTRICT

#323398-01 | 12.13.2023

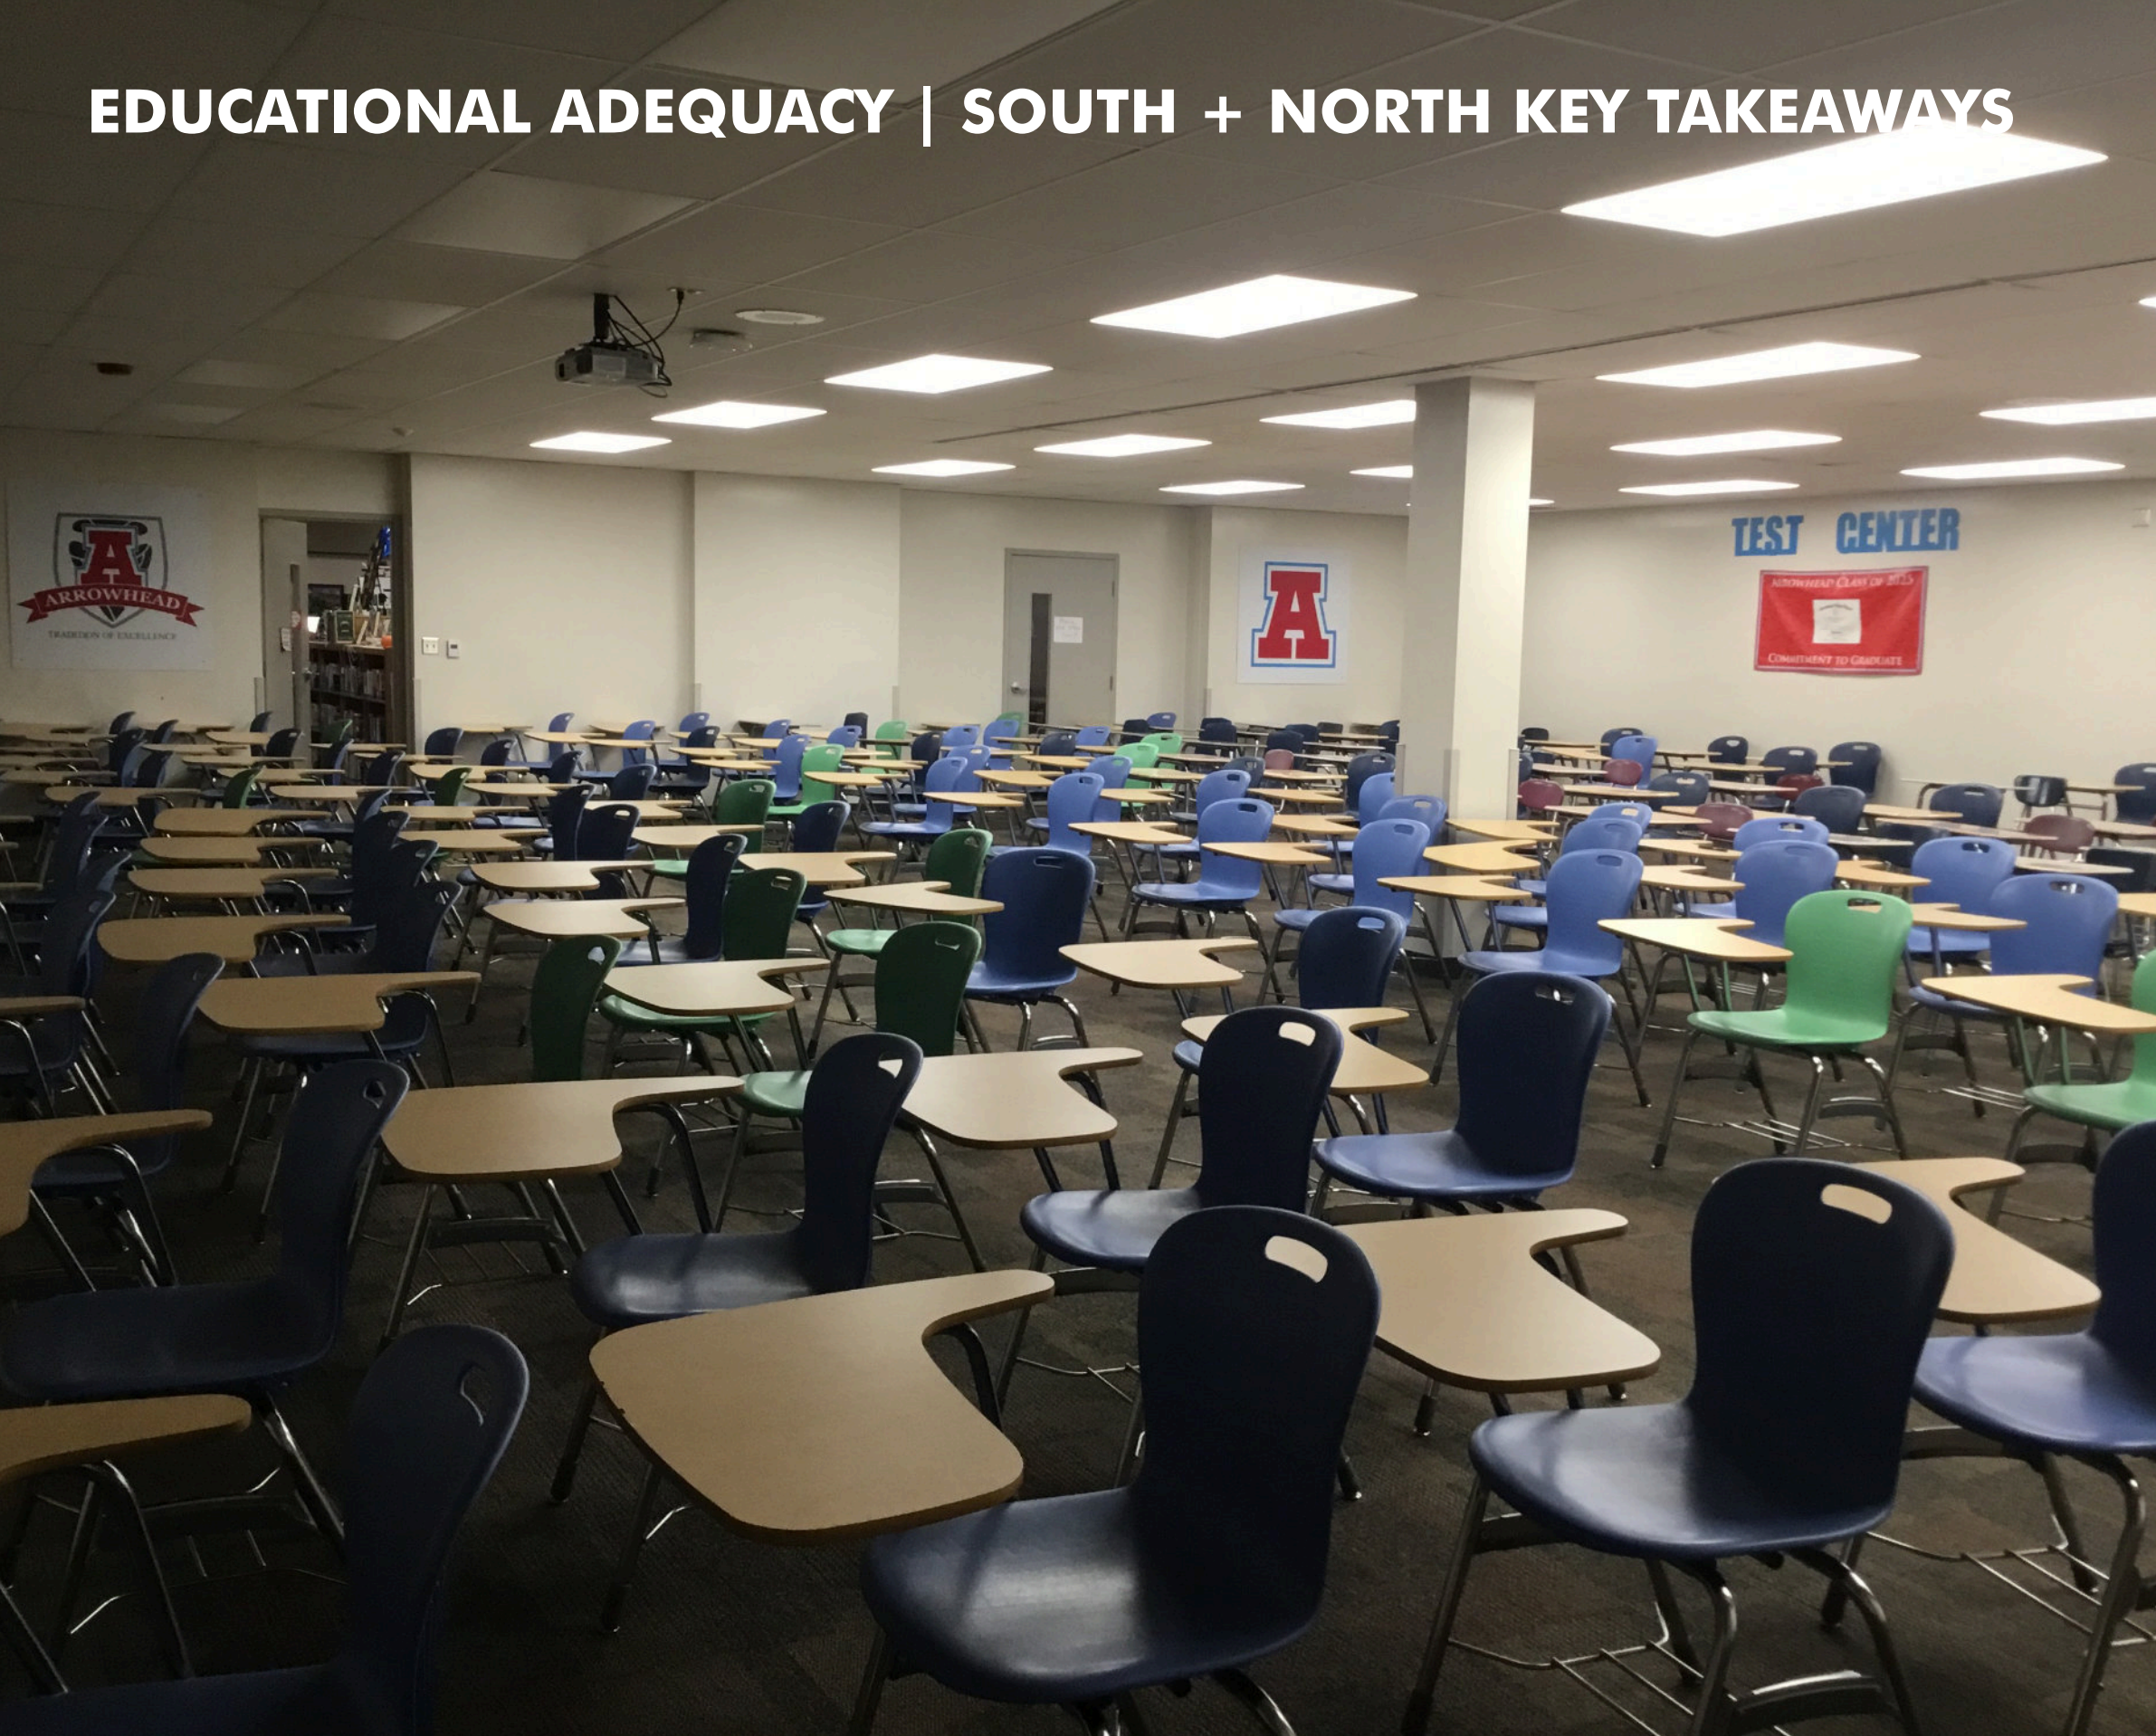
## OUTDATED FURNITURE

FURNITURE IS OUTDATED AND DOES NOT PROVIDE THE NEEDED LEVEL OF FLEXIBILITY TO ACCOMMODATE STUDENT-CENTERED LEARNING.
