FACILITIES ASSESSMENT SUMMARY REPORT

ARROWHEAD UNION HIGH SCHOOL DISTRICT

#323398-00 | 12.13.2023

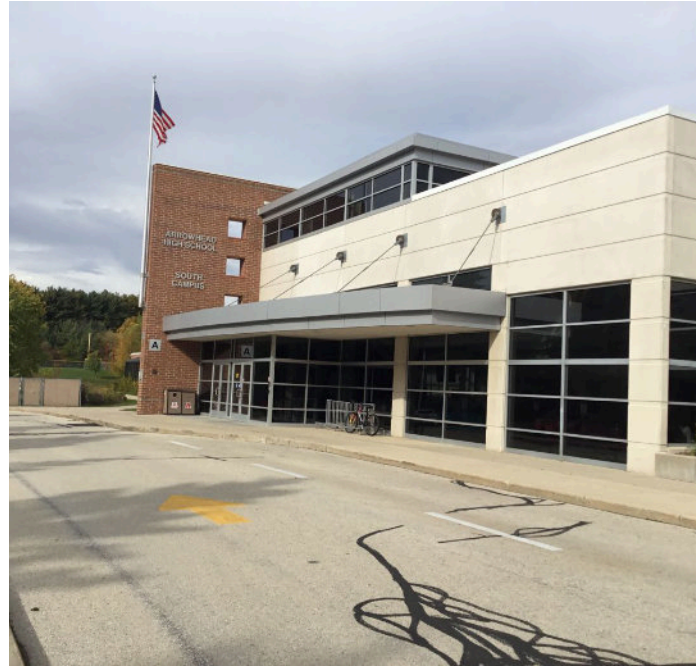
SOUTH CAMPUS

GRADES	9-10	CONDITIONS	3.27
SITE (ACRES)	112	EAA	2.21
BUILDING SF	220,057	ENROLLMENT	2037
YEAR BUILT	1955	CAPACITY	2158
ADDITIONS / RENO	1961, 1985, 1993, 2000	UTILIZATION	58%

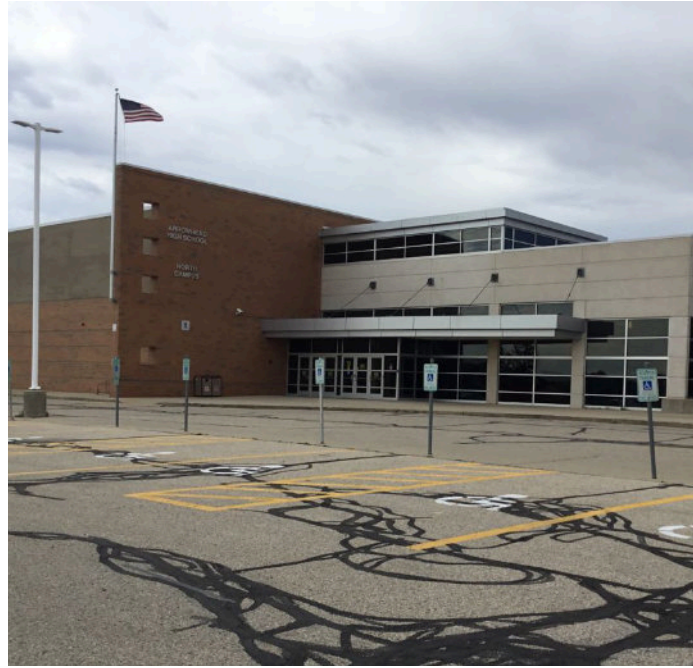
NORTH CAMPUS

GRADES	11-12	CONDITIONS	3.34
SITE (ACRES)	112	EAA	2.10
BUILDING SF	265,519	ENROLLMENT	2037
YEAR BUILT	1969	CAPACITY	2158
ADDITIONS / RENO	1974, 1988, 1992, 2000	UTILIZATION	58%

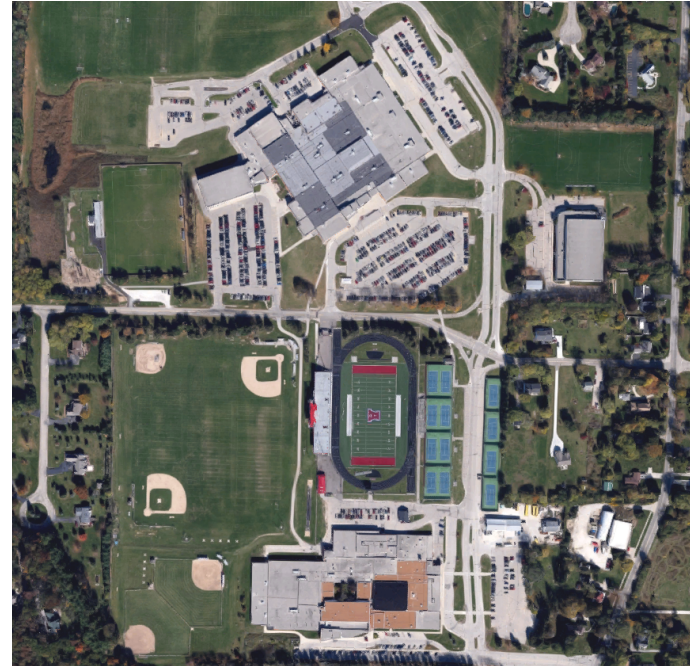
ATHLETIC FACILITIES

GRADES	-	CONDITIONS	3.08
SITE (ACRES)	112	EAA	-
BUILDING SF	-	ENROLLMENT	-
YEAR BUILT	-	CAPACITY	-
ADDITIONS / RENO	-	UTILIZATION	-

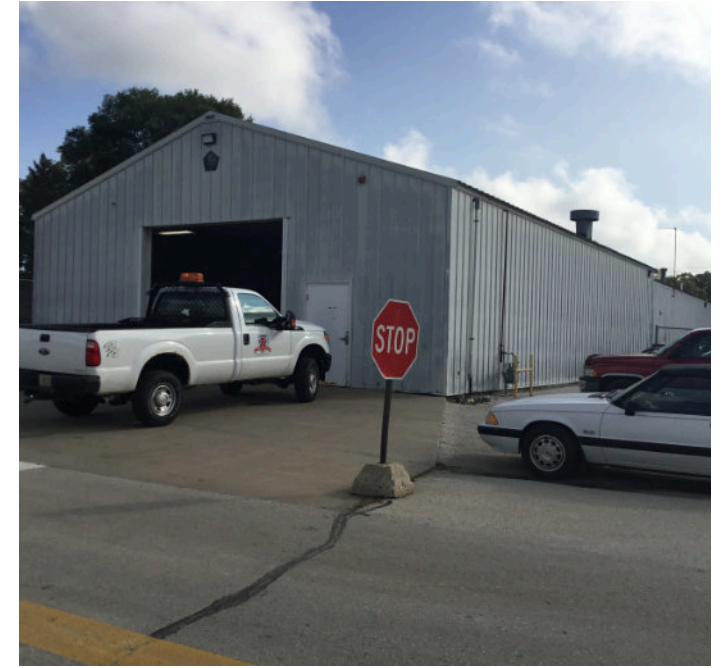
MAINTENANCE FACILITY

GRADES	-	CONDITIONS	2.14
SITE (ACRES)	112	EAA	-
BUILDING SF	4,960	ENROLLMENT	-
YEAR BUILT	1968	CAPACITY	-
ADDITIONS / RENO	1985	UTILIZATION	-

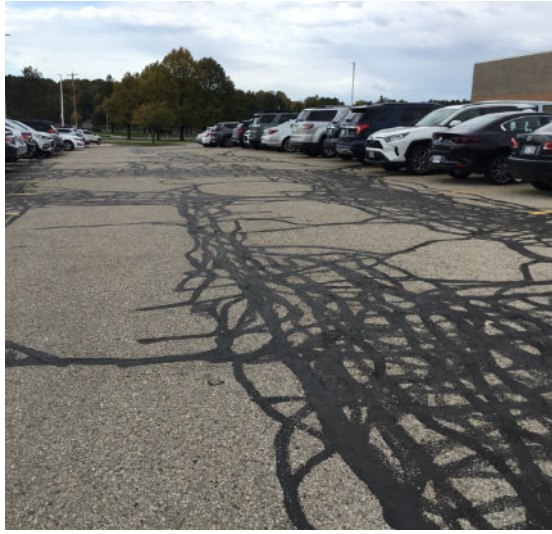
DETERIORATING PAVEMENT

MUCH OF THE MAIN PARKING LOT ASPHALT IS IN POOR CONDITION, WITH A LARGE NUMBER OF CRACKS, ALLIGATORING, AND INDICATIONS OF SUB-BASE FAILURE.

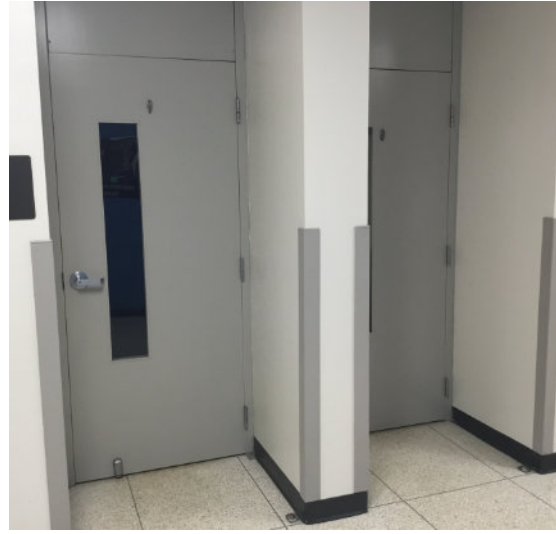
A NUMBER OF ADA DEFICIENCIES EXIST, INCLUDING INADEQUATE MANEUVERING CLEARANCES AT DOORS AND RESTROOMS, AND LACK OF ACCESSIBLE PLUMBING FIXTURES IN SCIENCE AND FACE ROOMS.

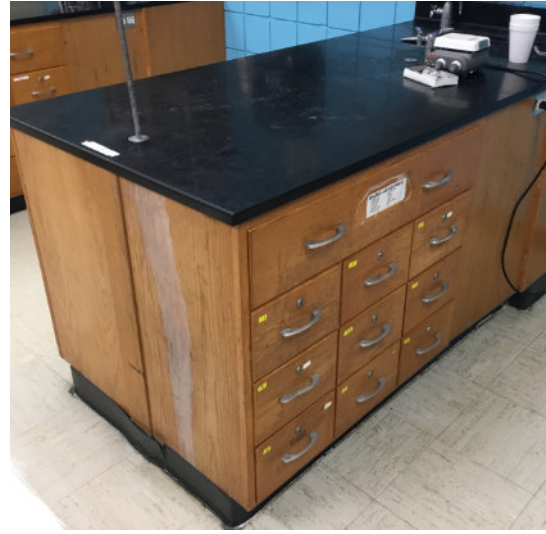
DAMAGED CASEWORK

A MAJORITY OF THE CASEWORK IN THE BUILDING IS AGING, WITH MANY CASES OF DELAMINATION. MANY CLASSROOMS HAVE OLDER CARPETING THAT IS WORN & APPROACHING THE END OF ITS USEFUL LIFE.

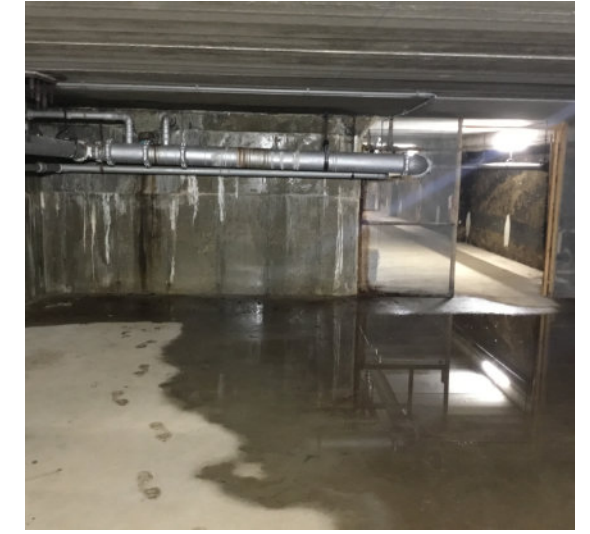
DETERIORATING POOL CONDITIONS

THE POOL HAS A NUMBER OF ISSUES THAT JEOPARDIZE ITS LONG-TERM USABILITY, INCLUDING SEVERE CORROSION OF CAST IRON PLUMBING PIPING, POOR VENTILATION IN THE MECHANICAL ROOM, AND DETERIORATION OF ELEMENTS FROM AGE.

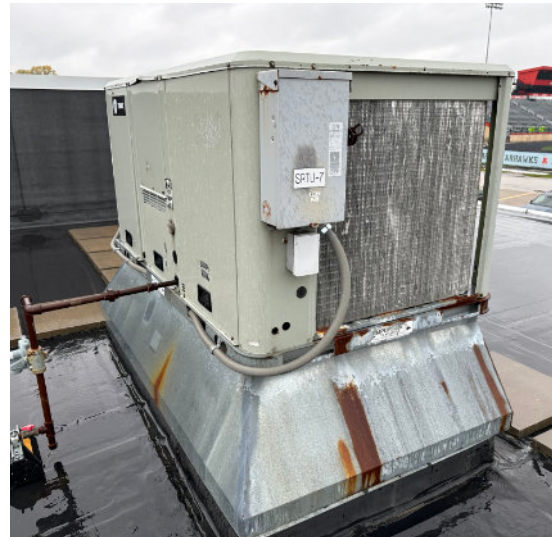
AGED HVAC EQUIPMENT

A MAJORITY OF THE MECHANICAL ROOFTOP UNITS AND THE BOILER PLANT ARE AT OR PAST THEIR LIFE EXPECTANCY.

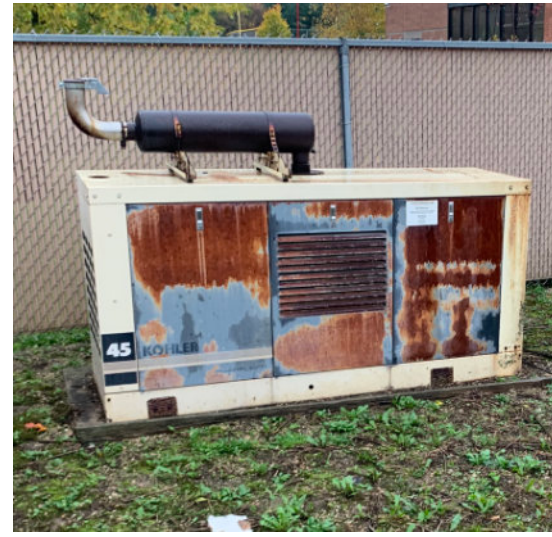
AGED ELECTRICAL SYSTEMS

SOME ELECTRICAL DISTRIBUTION PANEL BOARDS ARE BEYOND THEIR USEFUL LIFE. SOME COMMUNICATIONS SYSTEM COMPONENTS IN THE BUILDING ARE NEARING THE END OF THEIR LIFE EXPECTANCY AND PROVIDE LIMITED FUNCTIONALITY.

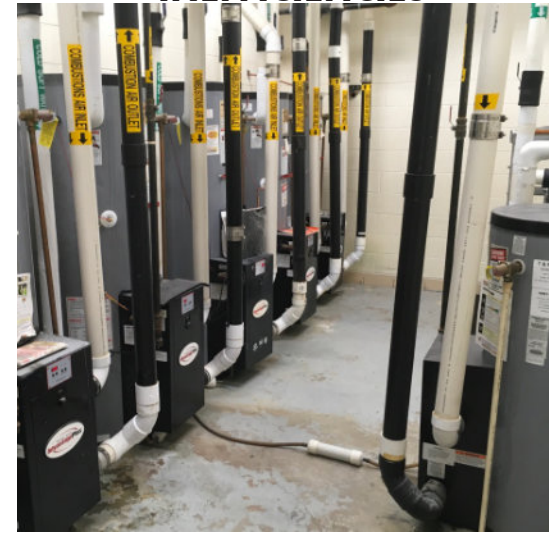
WATER HEATING INEFFICIENCIES

DECENTRALIZED SYSTEM OF WATER HEATERS IS INEFFICIENT, MOST HEATERS STORE WATER AT LESS THAN RECOMMENDED MINIMUM TEMPERATURE.

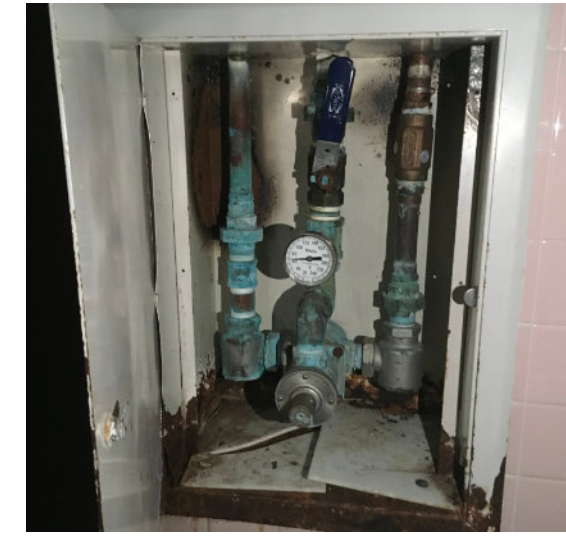
OLD GALVANIZED PIPING

GALVANIZED PLUMBING PIPING IS BEYOND ITS LIFE EXPECTANCY.

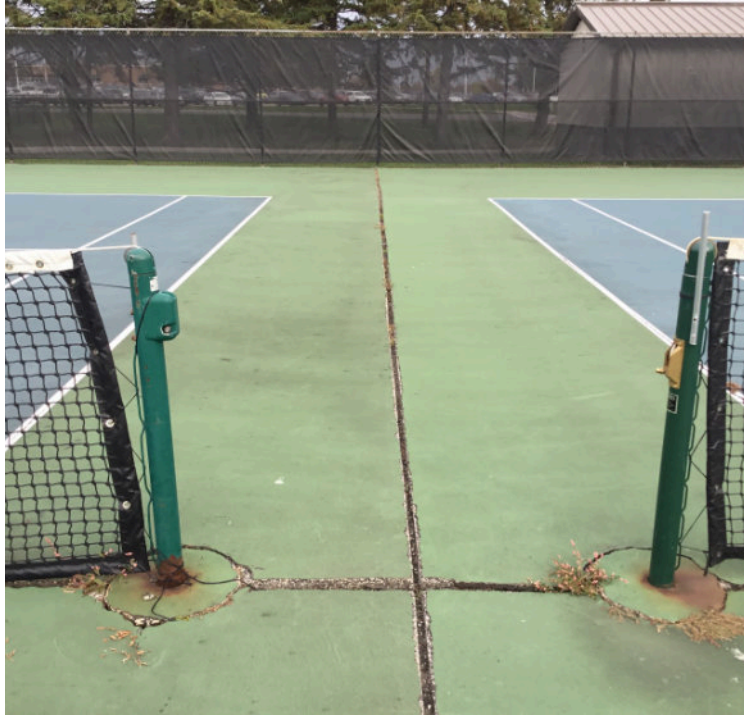
WORN ATHLETIC SURFACES

MUCH OF THE TENNIS COURT PAVEMENT IS DETERIORATING AND IN POOR CONDITION. SOME WATER PONDING OCCURS ON ASPHALT NEAR THE FOOTBALL FIELD TICKET BOOTHS AFTER RAINFALL.

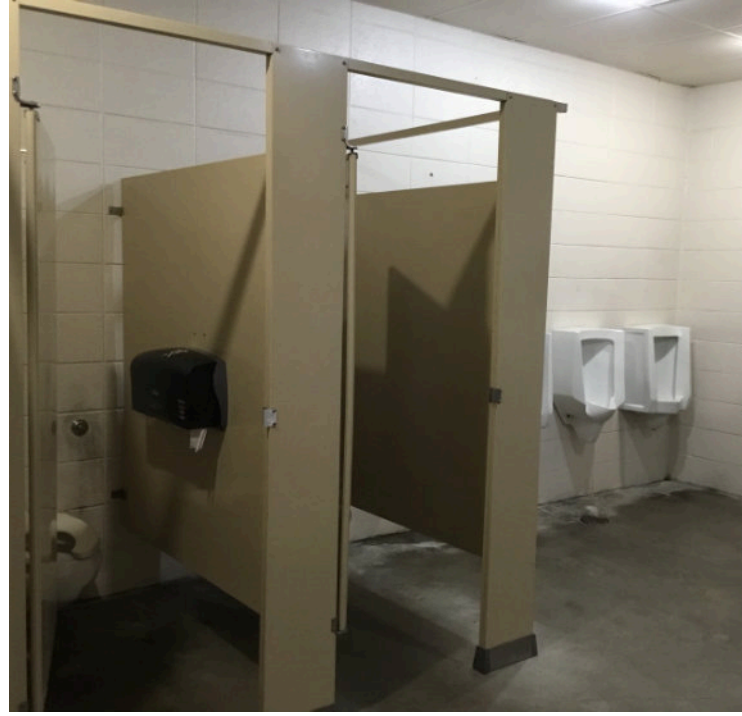
AT THE TOILET ROOM BUILDING, A NUMBER OF ADA DEFICIENCIES EXIST, INCLUDING INADEQUATE MANEUVERING CLEARANCES AT DOORS, A LARGE ELEVATION AT DOOR THRESHOLDS, AND LACK OF ACCESSIBLE TOILET STALLS. THE BLEACHERS AND PRESS BOX AT THE SOCCER STADIUM ARE ONLY REACHABLE BY STAIRS.

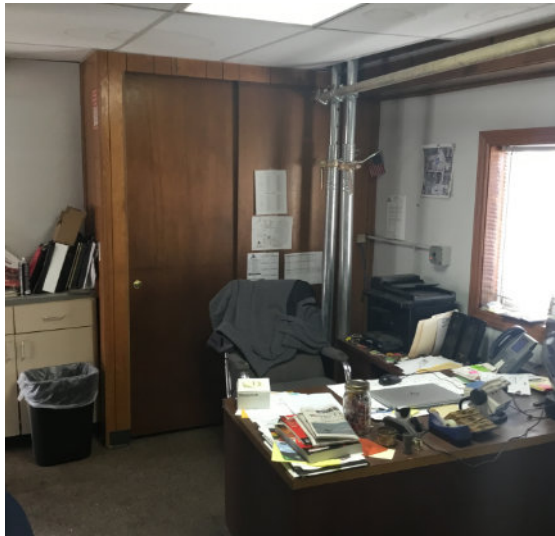
STRUCTURAL DETERIORATION

SOME OF THE WOOD STRUCTURAL ELEMENTS ARE DETERIORATED. TEMPORARY STRUCTURAL SHORING HAS BEEN INSTALLED AT COLUMNS AS A SHORT-TERM MEASURE TO AVOID THE POSSIBILITY OF STRUCTURAL FAILURE.

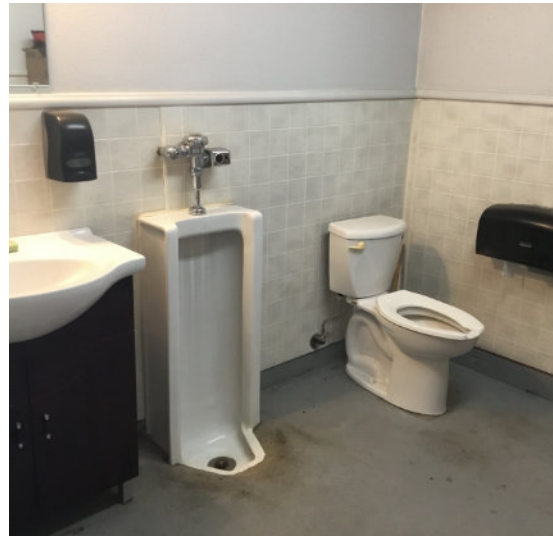
ADA DEFICIENCIES

TOILET ROOMS IN THE BUILDING ARE NOT ACCESSIBLE.

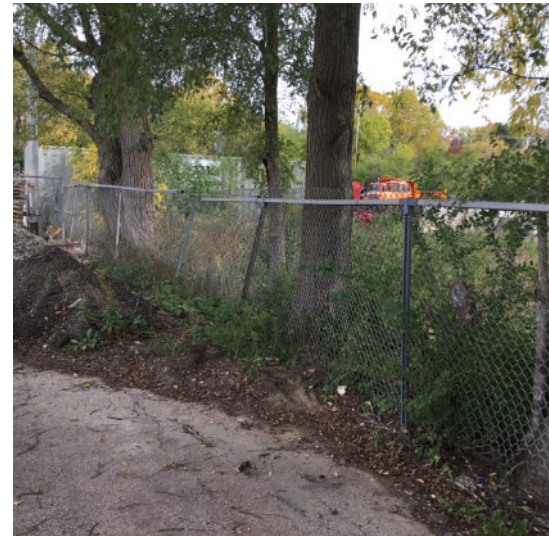
DETERIORATING FENCE

CHAIN LINK FENCING AROUND PERIMETER OF SITE IS DAMAGED IN MANY AREAS AND DETERIORATING.

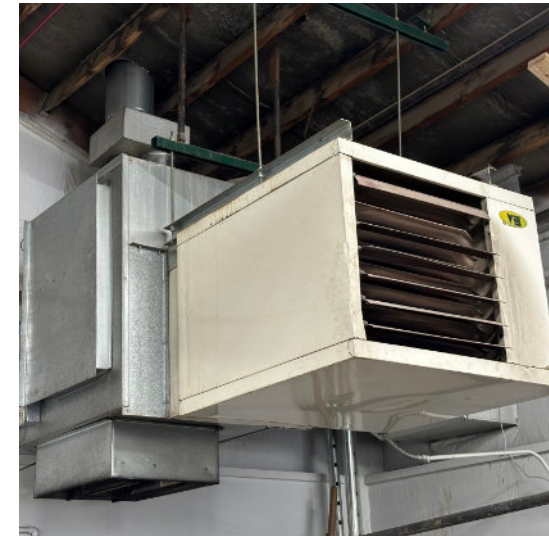
AGED HVAC EQUIPMENT

MECHANICAL EQUIPMENT HAS EXCEEDED ITS LIFE EXPECTANCY, AND THE SERVICE AREAS ARE NOT PROPERLY VENTILATED.

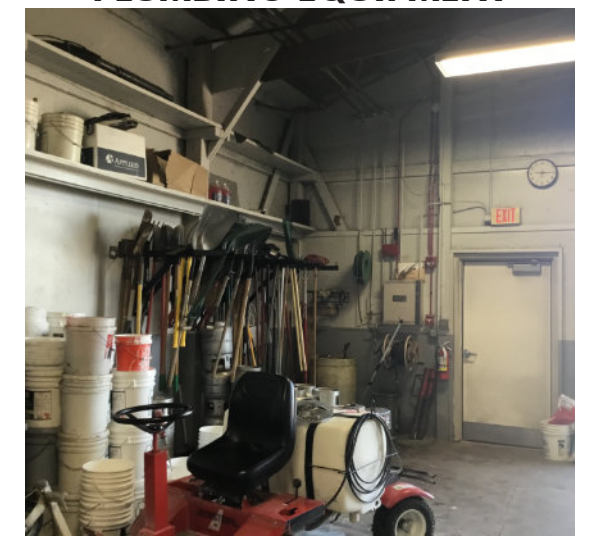
AGED ELECTRICAL AND PLUMBING EQUIPMENT

MUCH OF THE ELECTRICAL AND PLUMBING EQUIPMENT IS NEARING OR HAS EXCEEDED THEIR USEFUL LIFE.

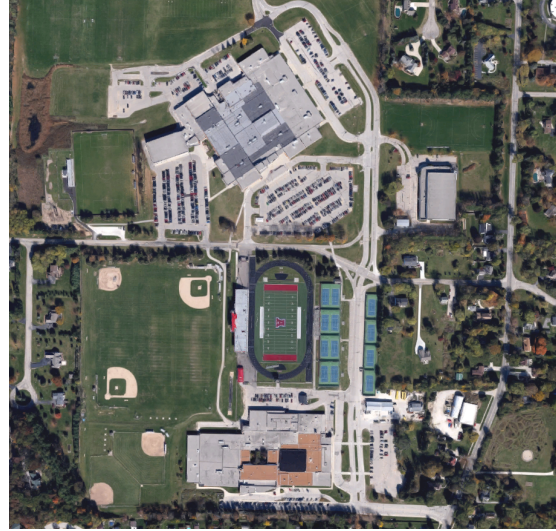
TWO SEPARATE BUILDINGS

SEPARATE CAMPUSES RESULT IN DUPLICATION OF SPACES AND INEFFICIENCIES IN THE CURRENT FACILITIES.

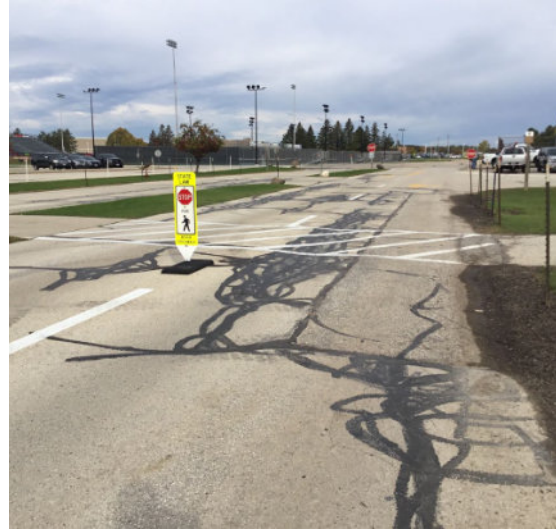
PICK-UP/DROP-OFF CONCERNS

GENERAL CIRCULATION CONGESTION ISSUES RELATED TO TRAFFIC FLOW OF VARIOUS MODES OF TRANSPORTATION.

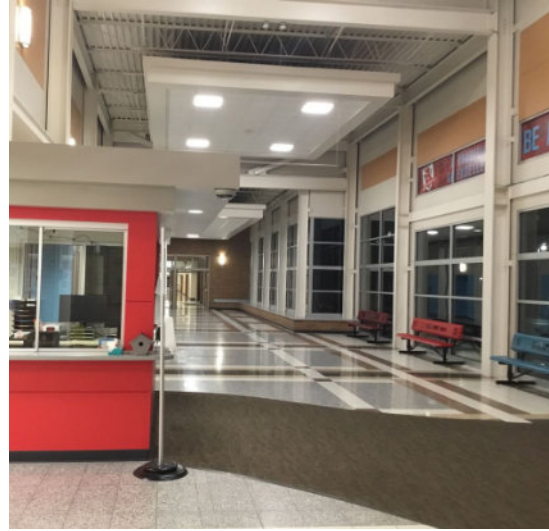
LACK OF SECURE ENTRIES

BUILDING ACCESS COULD BE IMPROVED AT BOTH CAMPUSES WITH THE CREATION OF SECURE, CONTROLLED MAIN ENTRANCES THAT BRING VISITORS DIRECTLY INTO THE MAIN OFFICE PRIOR TO ACCESSING THE SCHOOL. (2016)

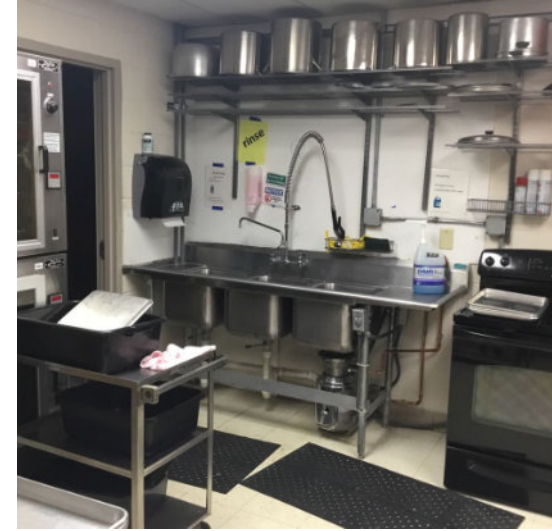
UNSAFE + UNDERSIZED SPECIAL ED SPACES

SPECIAL ED SPACES ARE NOT DESIGNED FOR THEIR CURRENT USE. THEY ARE UNDERSIZED AND THEIR CURRENT CONFIGURATION IS UNSAFE FOR EXITING.

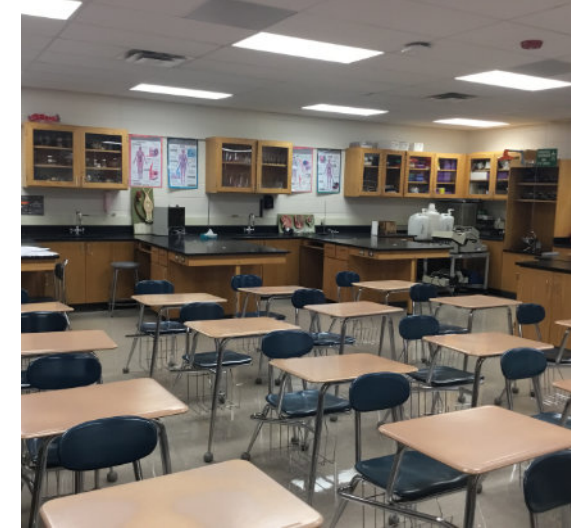
LACK OF NATURAL LIGHT

COMPACT BUILDING FOOTPRINTS RESULT IN MANY INBOARD CLASSROOMS AND SPECIALTY SPACES WITHOUT ACCESS TO DAYLIGHT OR VIEWS.

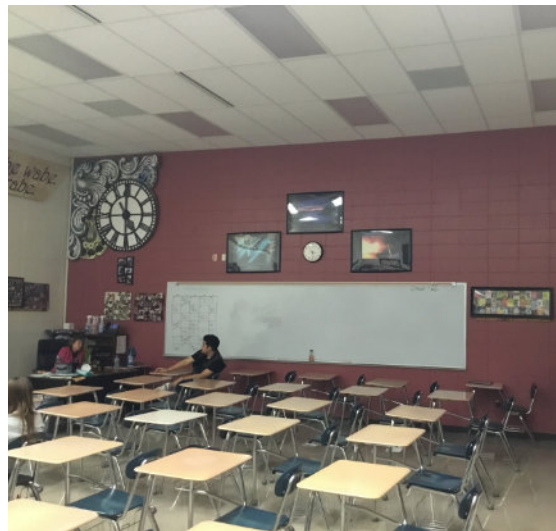
CLASSROOM SIZES

MANY CLASSROOM AREAS ARE UNDERSIZED AND FAIL TO PROVIDE THE FLEXIBILITY DESIRED FOR TODAY'S TEACHING & LEARNING STRATEGIES. SMALL, IRREGULARLY SHAPED CLASSROOMS ALSO CREATE CONGESTION, SAFE EXITING CONCERNS, VISIBILITY ISSUES, AND LIMIT ACCESS TO IN-ROOM STORAGE. (2016)

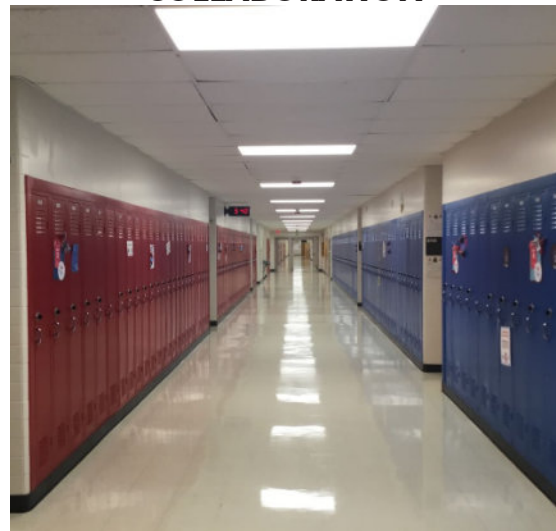
LACK OF BREAKOUT/ COLLABORATION

TEACHING METHODOLOGIES ARE LIMITED DUE TO LACK OF SUPERVISABLE BREAKOUT SPACE TO ALLOW FOR GROUP WORK OUTSIDE, YET ADJACENT TO THE CLASSROOM.

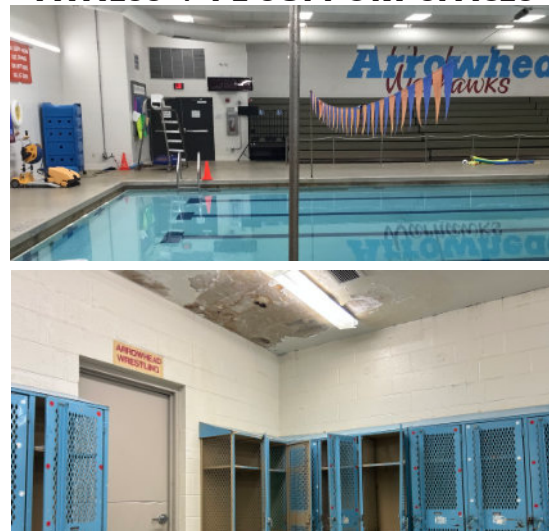
UNDERSIZED CAFETERIA, POOL, GYM, FITNESS + PE SUPPORT SPACES

THE BUILDING'S LARGE SPECIALTY SPACES ARE GROSSLY UNDERSIZED AND INADEQUATELY DESIGNED. THEREFORE, THESE SPACES ARE UNDERUTILIZED BOTH FOR SCHOOL AND COMMUNITY FUNCTIONS.

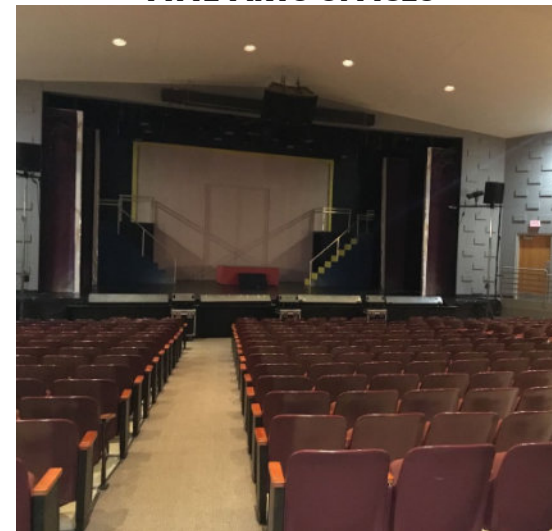
UNDERSIZED AUDITORIUM + FINE ARTS SPACES

THE FINE ARTS PROGRAM SPACE (THEATER AND MUSIC) IS UNDERSIZED, OUTDATED AND LACKS PRACTICE ROOMS, STORAGE, LARGE PERFORMANCE SPACE, AND STUDENT DISPLAY AREAS. (2016)

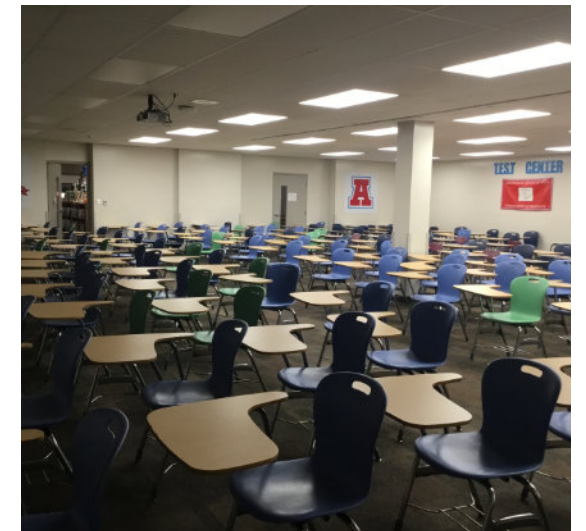
OUTDATED FURNITURE

FURNITURE IS OUTDATED AND DOES NOT PROVIDE THE NEEDED LEVEL OF FLEXIBILITY TO ACCOMMODATE STUDENT-CENTERED LEARNING.
